WANG MANUFACTURING
TEST PROCEDURE

310-8826-A

2200 SERIES DS DPU BOARD

2 IN-SYSTEMS TEST

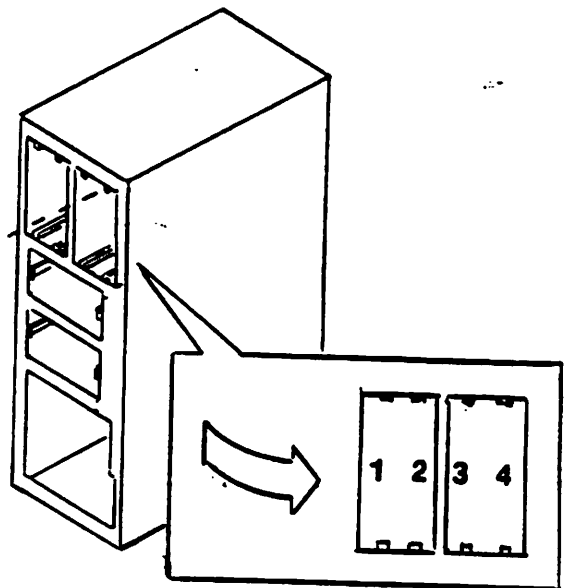
THIS VISUALLY IS OUT OF PROPORTION TO CABINET. I ASSUM THIS IS FRONT VIEW IF FRONT VIEW SHOW MORE CABINET ON RIGHT THEN LEFT.

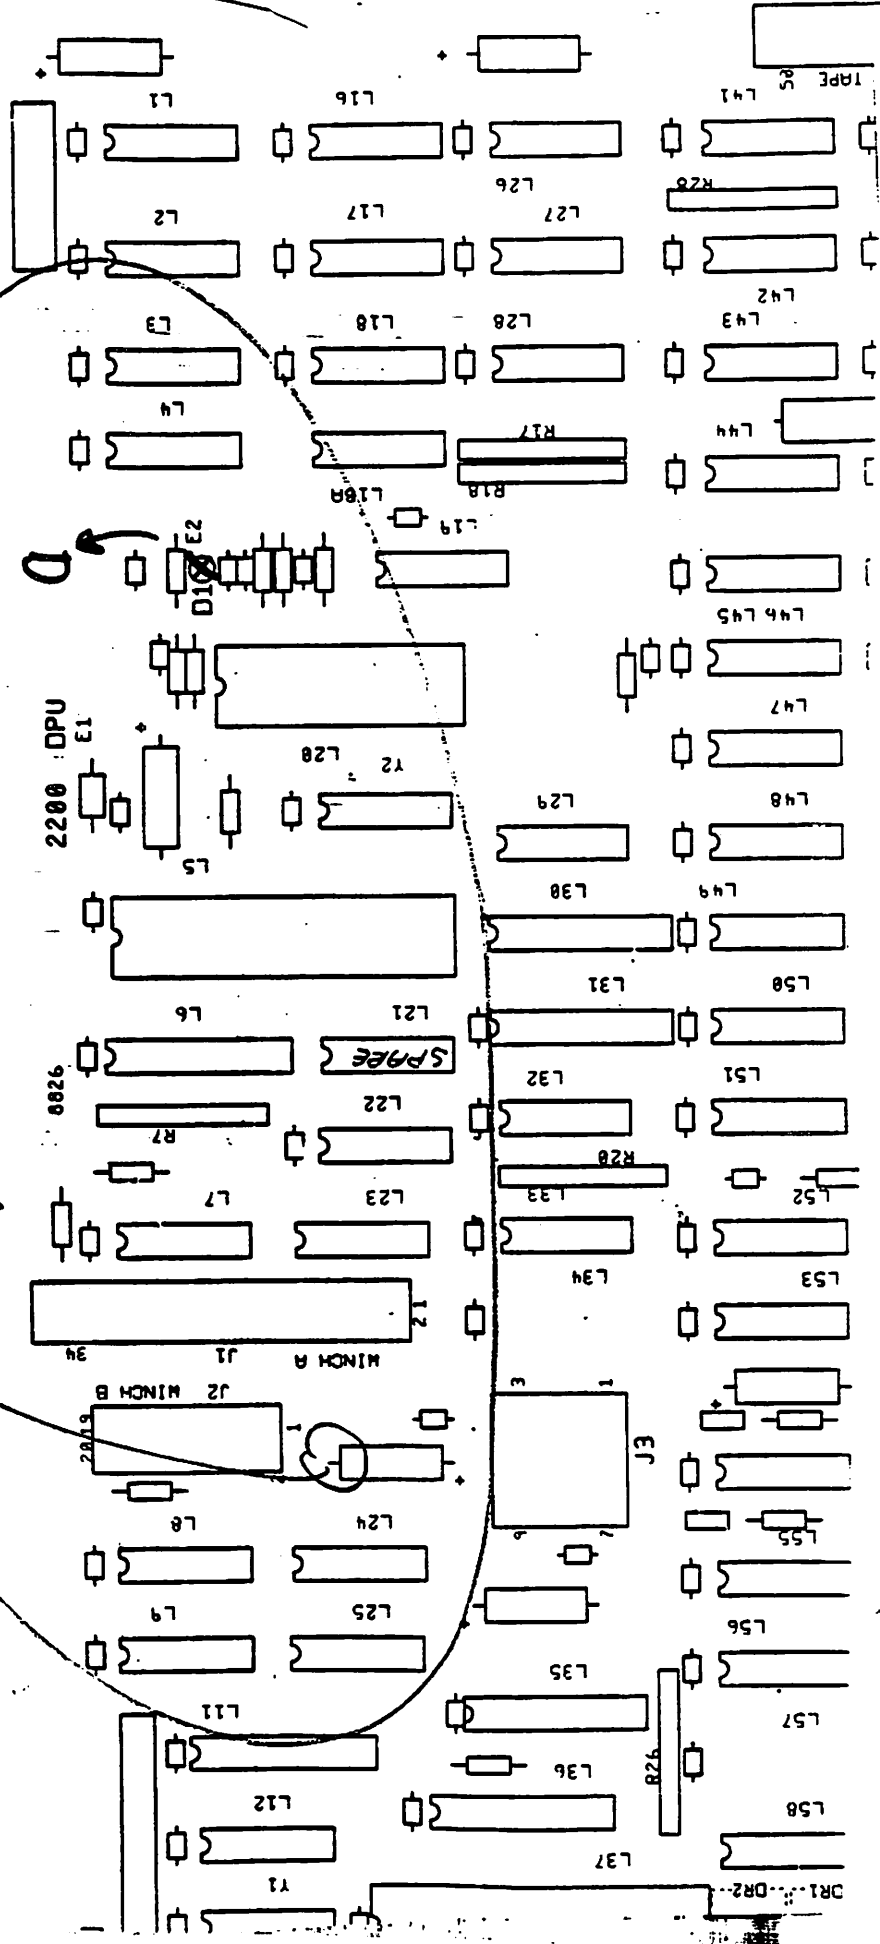
move to left
- interfere with J2

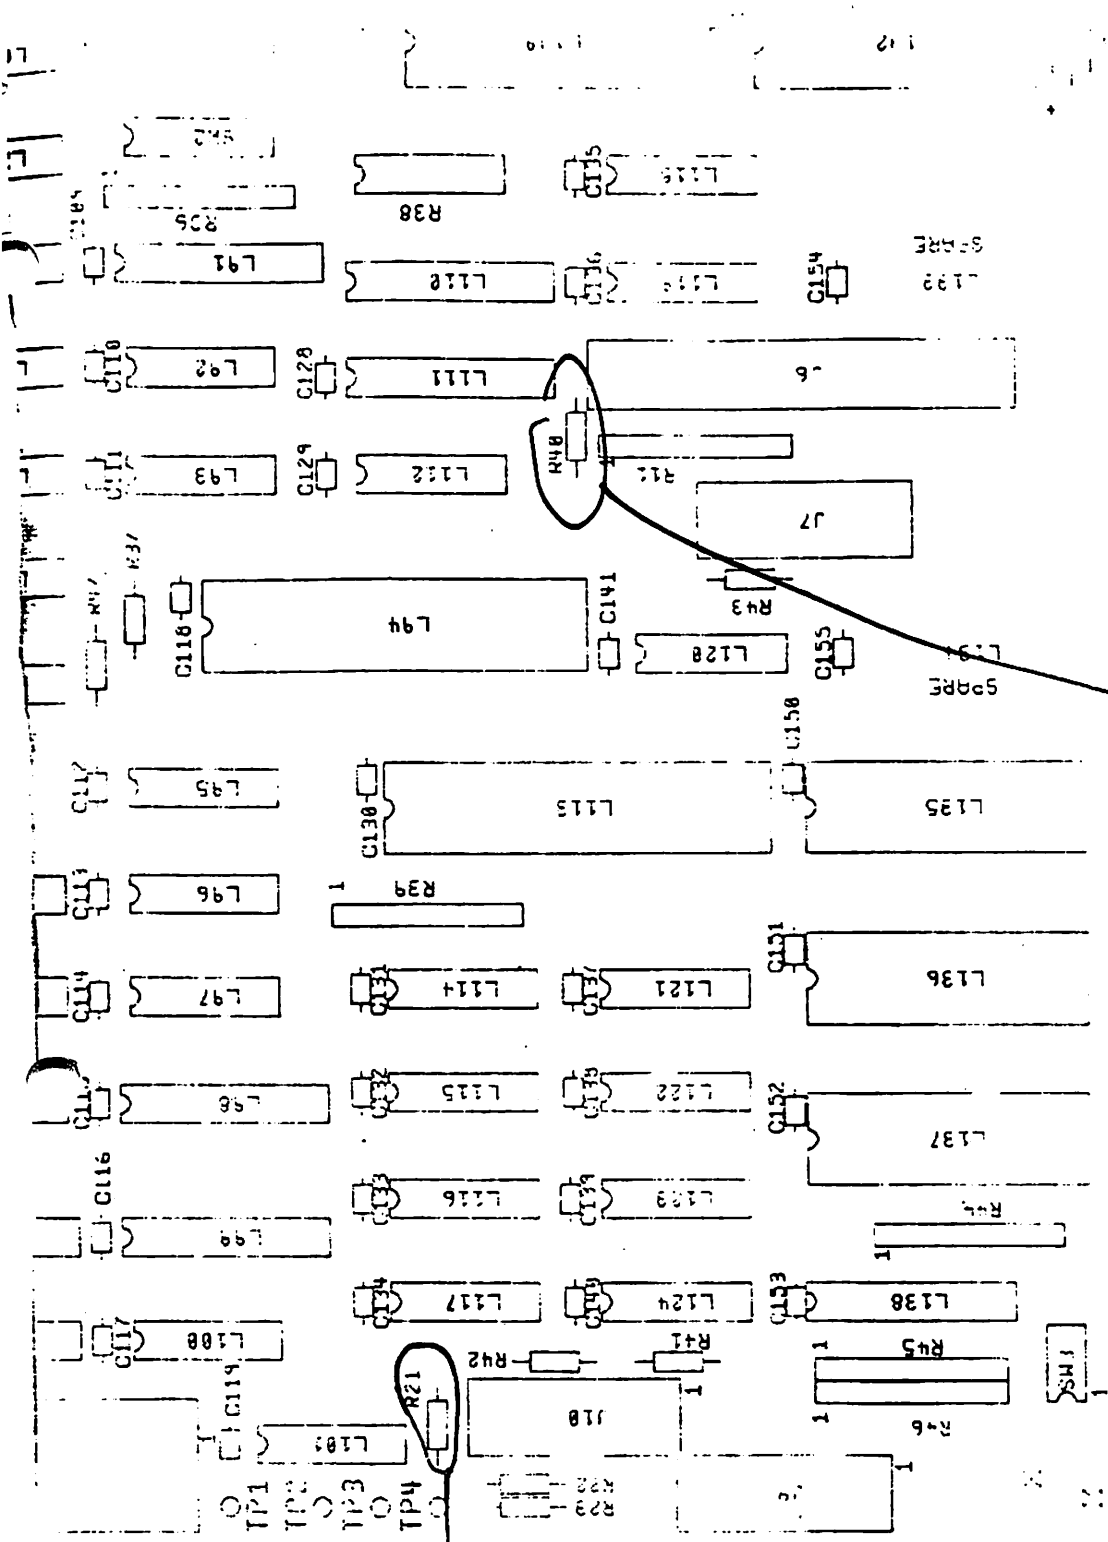
RELOCATE:
 CANNOT BE
 INSERTED
 BECAUSE IT IS
 LOCATED
 UNDERNEATH
 J10

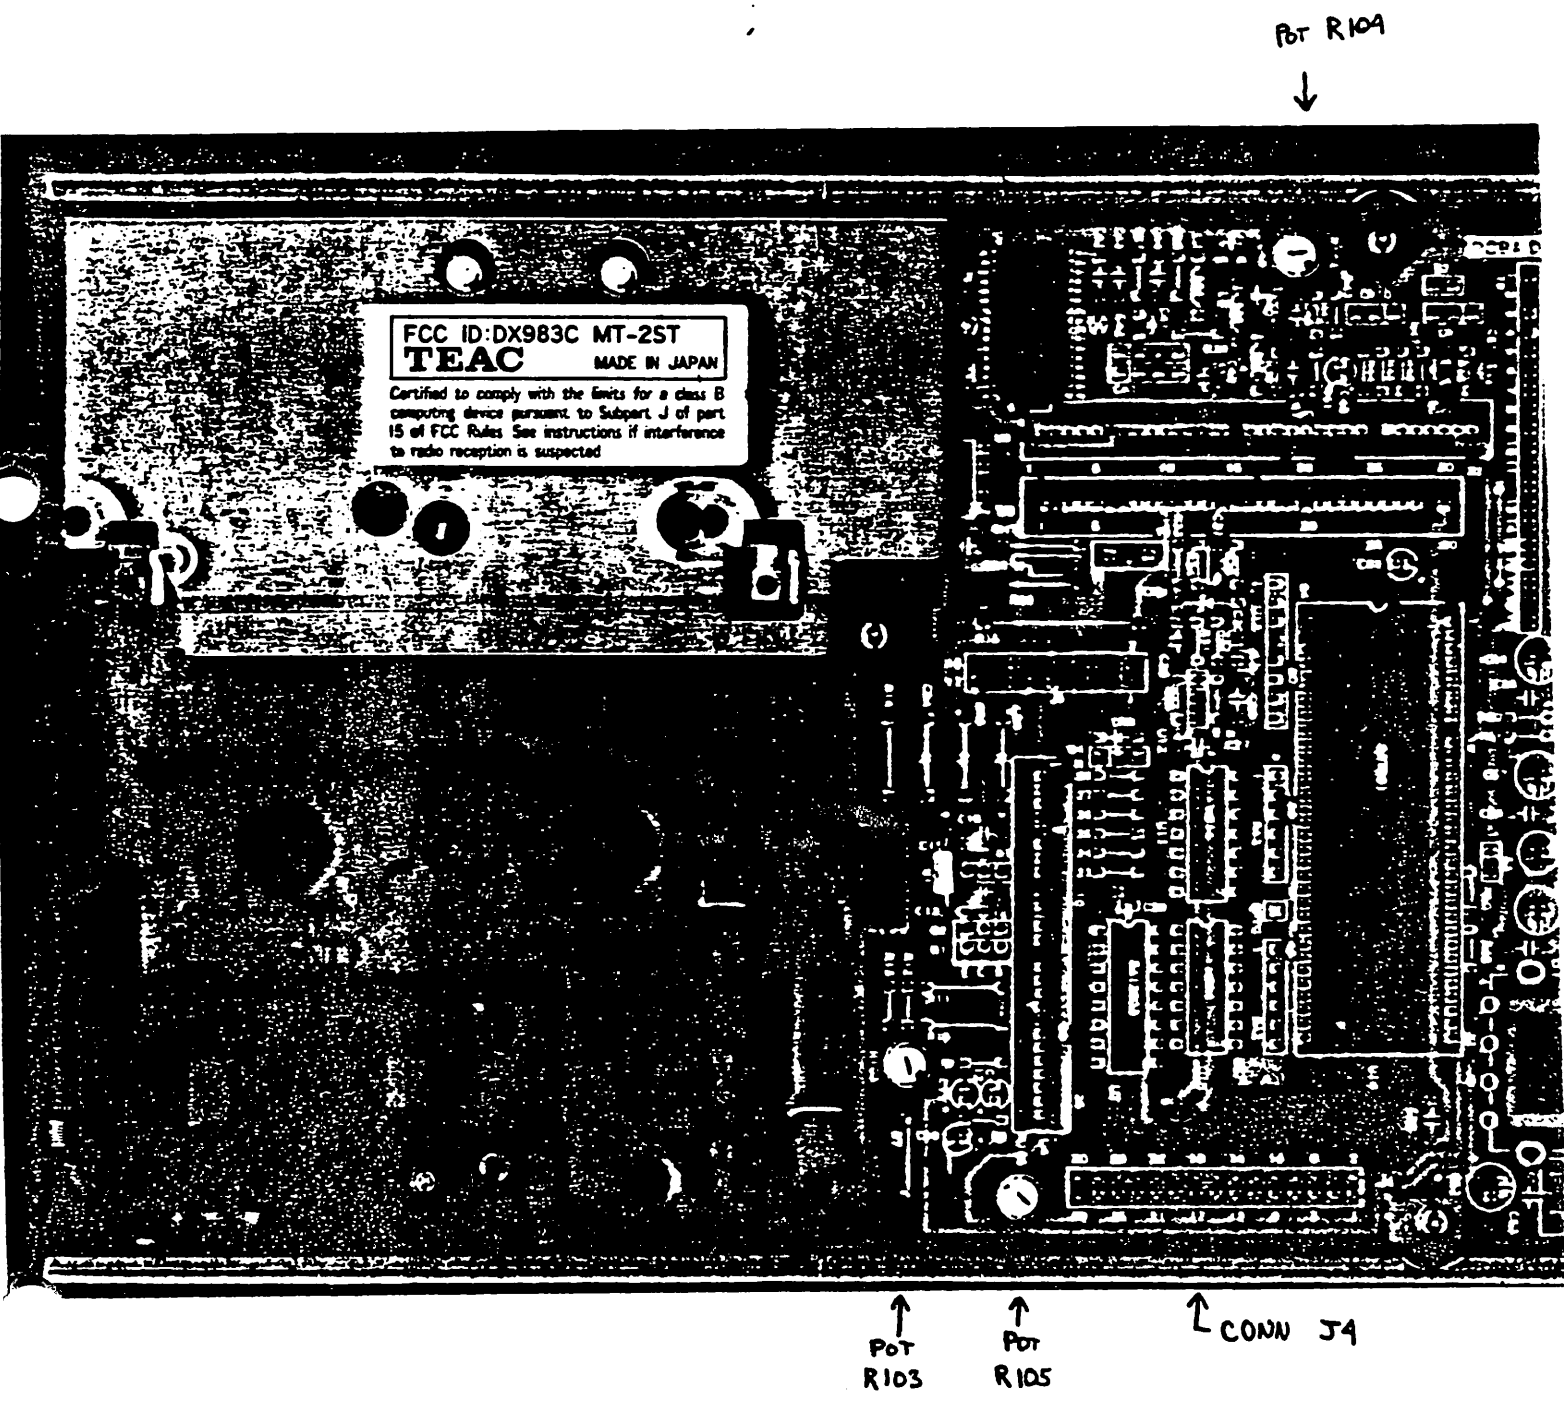
) ← WHILE RUNNING A BACKUP
- * Hanging tape drive will read about 110 μ sec
Adj. Pot R103 for 128 μ sec.
