PUBLICATION UPDATE BULLETIN

This Publication Update Bulletin (PUB) documents the phase-lock-loop (PLL) adjustment procedure for the 210-8694/8794 board in the 2200LVP/SVP Disk Processing Unit (DPU). The adjustment procedure in this PUB supercedes the one in Section 11.3 of the Model 2200LVP Product Maintenance Manual (729-0602-A). This PUB also serves as an addendum to the 2200SVP Product Maintenance Manual (729-0935-A).

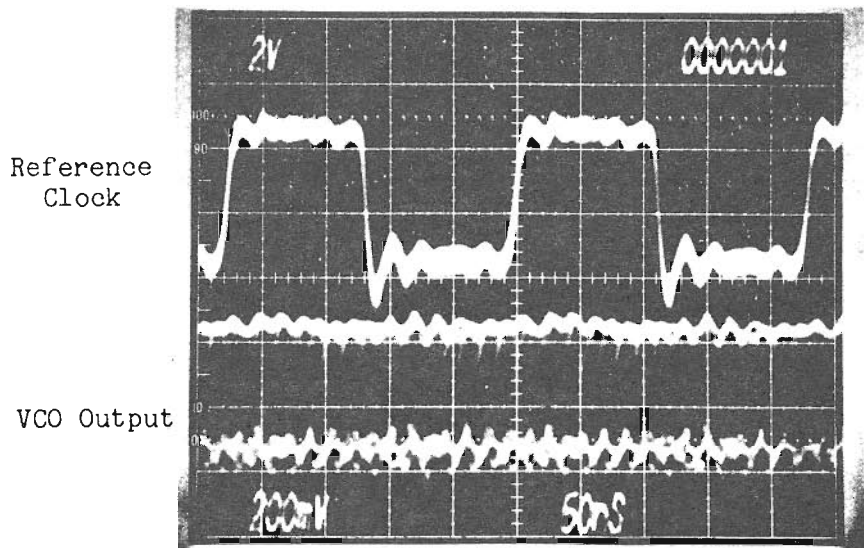
FIGURE 4 PLL NOT "LOCKED"

12. Verify that the adjustment is correct by connecting a jumper from TP6 to +0V (GND) and then removing the wire. This momentarily selects the diskette drive frequency. The PLL should "lock back up" on the Winchester disk drive frequency (figure 2) when the jumper is removed as indicated by the VCO output automatically returning to a stable, not free-running state. If the PLL does not "lock up" (figure 4), continue adjusting R7 in the clockwise direction until the conditions in step 11 are met and the PLL "locks up".

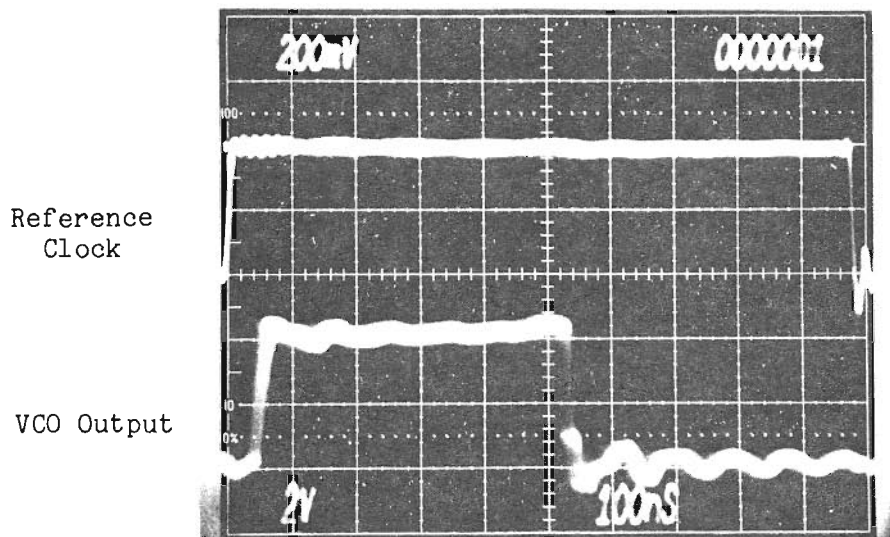
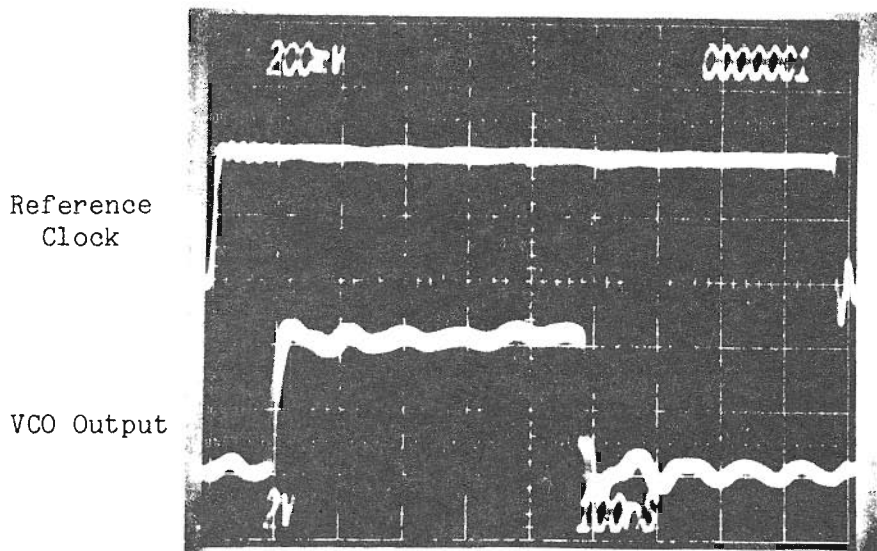
FIGURE 6 PLL INCORRECTLY ADJUSTED FOR DISKETTE DRIVE

FIGURE 7 PLL INCORRECTLY ADJUSTED FOR DISKETTE DRIVE

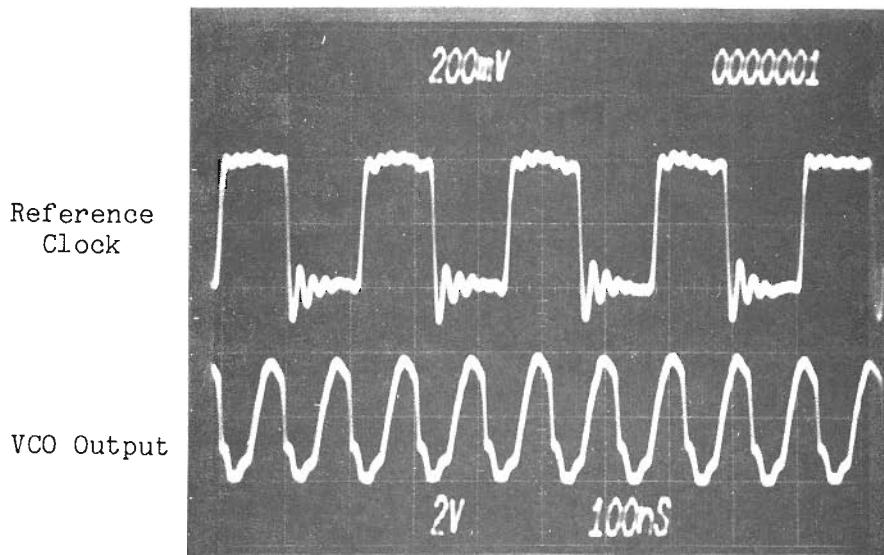
FIGURE 3 PLL INCORRECTLY ADJUSTED FOR WINCHESTER DISK DRIVE

10. Turn potentiometer R7 (Winchester drive adjustment) completely counterclockwise, and then slowly adjust R7 clockwise until the VCO output signal (Channel 2) is stable--not free running. Continue adjusting R7 until all the VCO output pulses are centered with respect to the phase detector reference clock pulses (ref: FIGURE 2). When this condition occurs, the PLL is said to be "locked". When the output pulses are centered, the signal will have a period of approximately 0.115 usec (ref: FIGURE 2). FIGURE 3 shows an incorrect VCO output signal. Note that the higher frequency of the VCO output in the figure results in an extra pulse (ten instead of nine) in the VCO output.

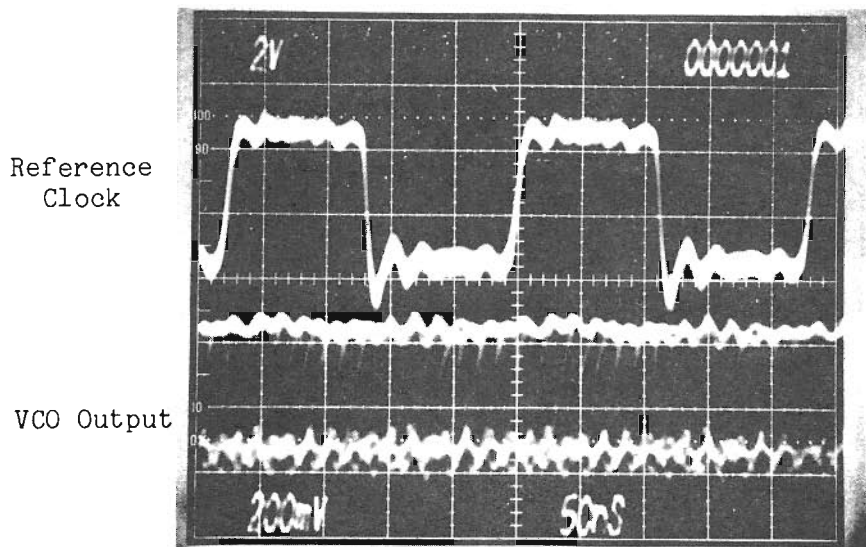
FIGURE 4 PLL NOT "LOCKED"

Verify that the adjustment is correct by connecting a jumper wire from TP6 on the 210-8694 board or L6-9 on the 210-7694 board to $+0V$ and then removing the wire. This momentarily selects the diskette drive frequency. The PLL should "lock back up" on the Winchester disk drive frequency when the jumper is removed. That is, the VCO output should automatically return to a stable, not free-running, display. If the PLL does not "lock up" (ref: FIGURE 4), continue adjusting R7 in the clockwise direction until the conditions in step 10 are met and the PLL "locks back up" as stated above.

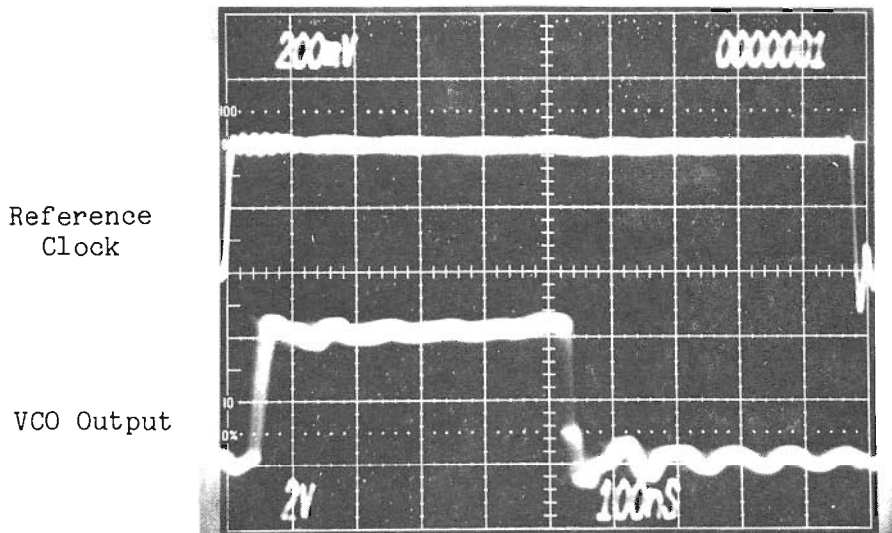
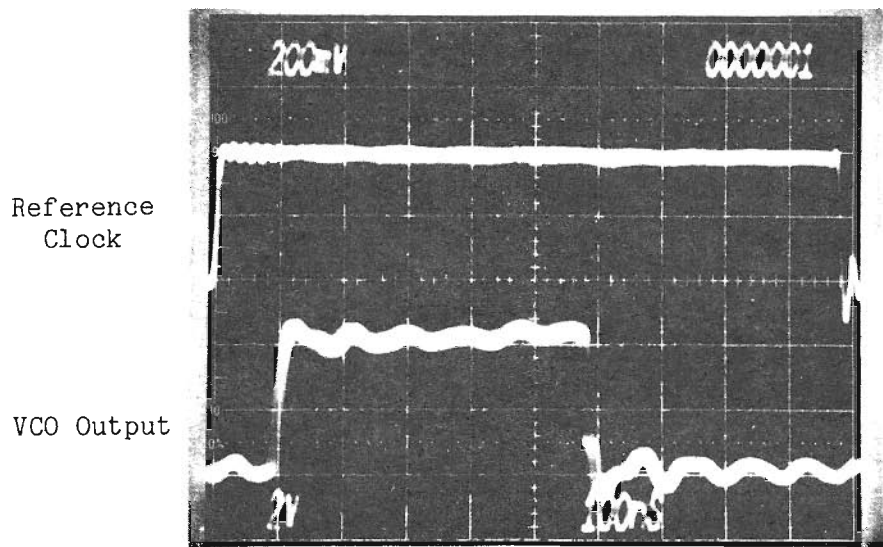
FIGURE 6 PLL INCORRECTLY ADJUSTED FOR DISKETTE DRIVE

FIGURE 7 PLL INCORRECTLY ADJUSTED FOR DISKETTE DRIVE

14. Slowly adjust potentiometer R8 (diskette drive adjustment) until the leading edge of the VCO output pulse (Channel 2) occurs 0.075 usec after the leading edge of the phase detector reference clock (ref: FIGURE 5). FIGURE 6 and FIGURE 7 show incorrect VCO output signals.
