Service Newsletter

No. 121

2200/2600 #23

2200VP/MVP FAN REPLACEMENT WITH LARGE I/O CONTROLLERS

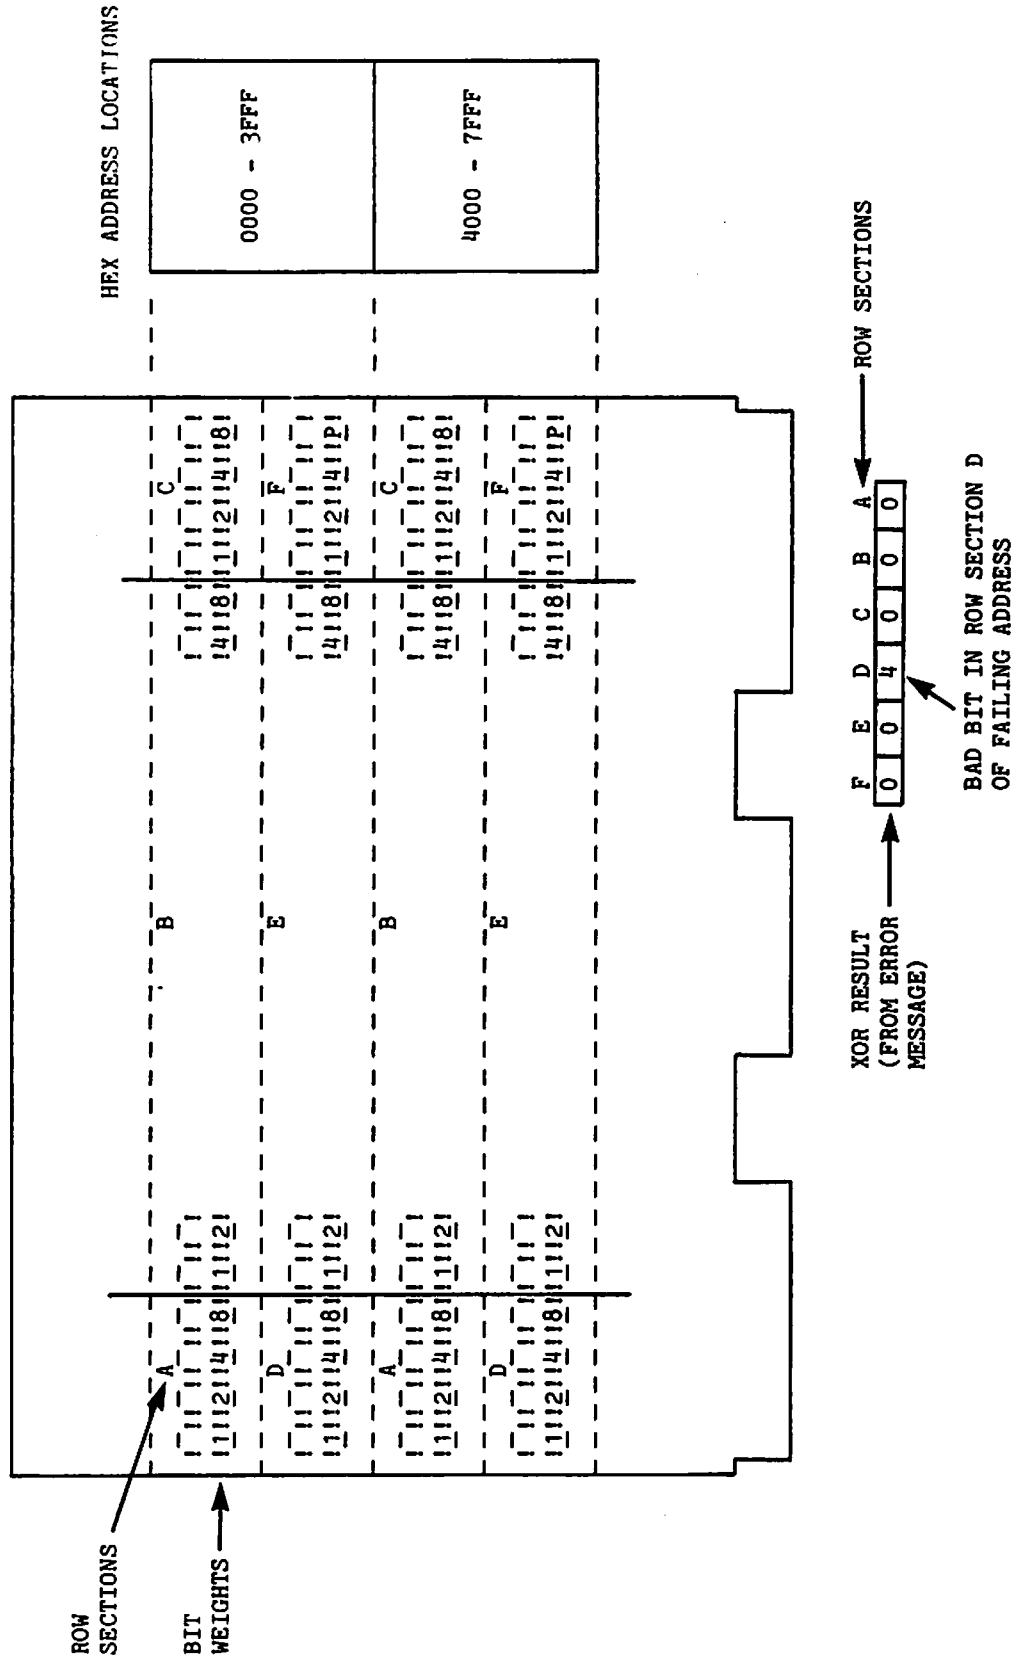
FIGURE 3 WL #210-7588 CONTROL MEMORY ADDRESS CONFIGURATION

FIGURE 3 shows that the failing location is contained in the top two rows of RAM's (error was between 0000 and 3FFFF (HEX)).

The bits that failed were 4 and 8 (from XOR--HEX(C) is equal to bits 4 and 8 ON); therefore, the bad RAM's are in the second row from the top of the board, and are the fifth and sixth RAM's from the right side of the board.

If the failing address was between 4000 and 7FFF (HEX), the procedure for determining which RAM was faulty is the same as described above, except the RAM would be located in the bottom two rows.

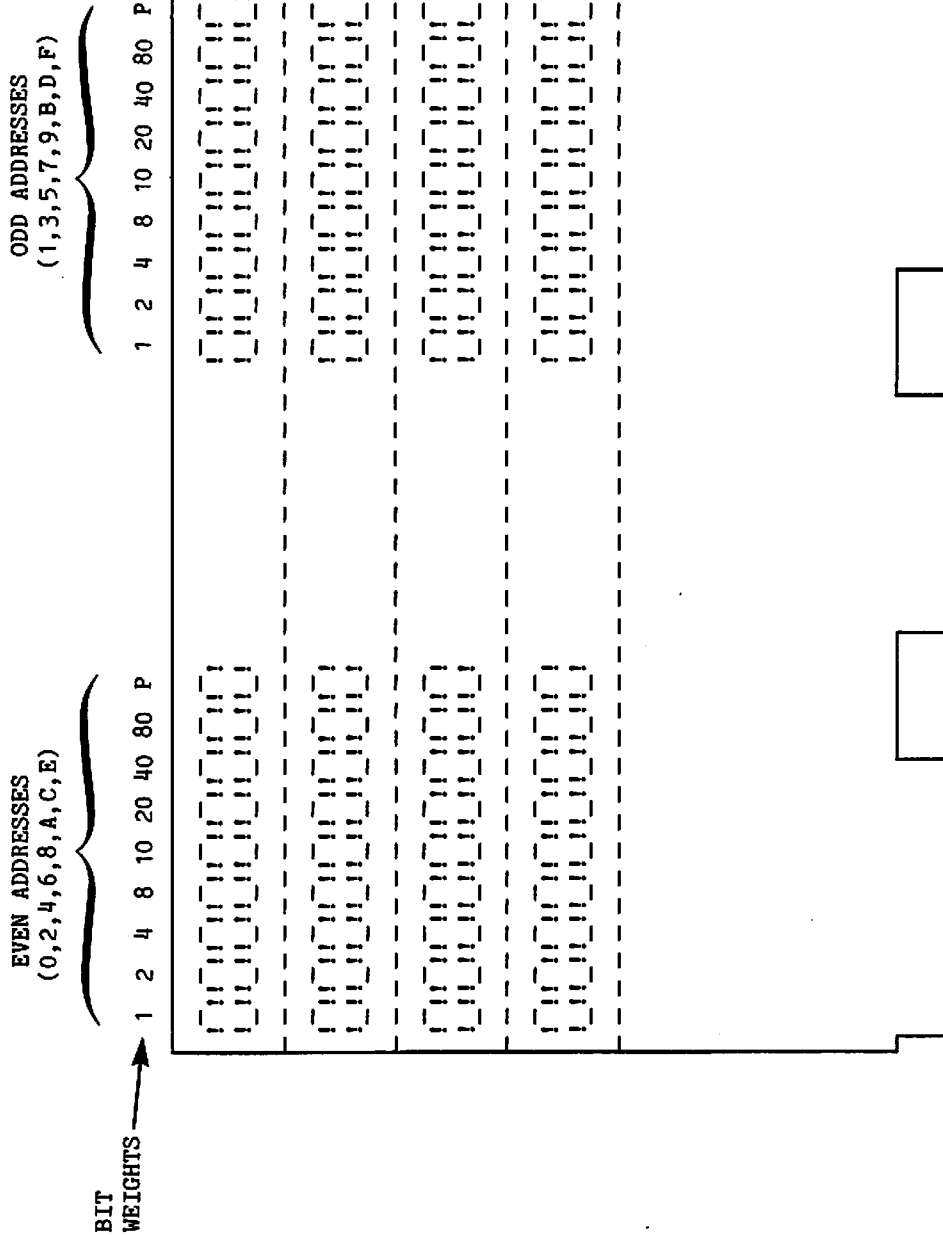
FIGURE 5 WL #210-7587 DATA MEMORY ADDRESS CONFIGURATION

FIGURE 5 shows that the failing address is in the top two rows of RAM's (error was in bank #2).

The figure also shows that the failing location is contained in the top row of RAM's (error was between 8000 and FFFF (HEX)).

The failing address was even (A3C4); therefore, the faulty RAM('s) is somewhere on the left side of the top row of RAM's.

The bits that failed were 2 and 80 (from first two digits of XOR--HEX(82) is equal to bits 2 and 80 ON); therefore, the bad RAM's are in the top row, and are the second and eighth RAM's from the left side of the board.

In this example there is one additional RAM that failed.

The last two digits of the XOR (04) indicate that bit 4 in location A3C5 (address + 1) also failed.

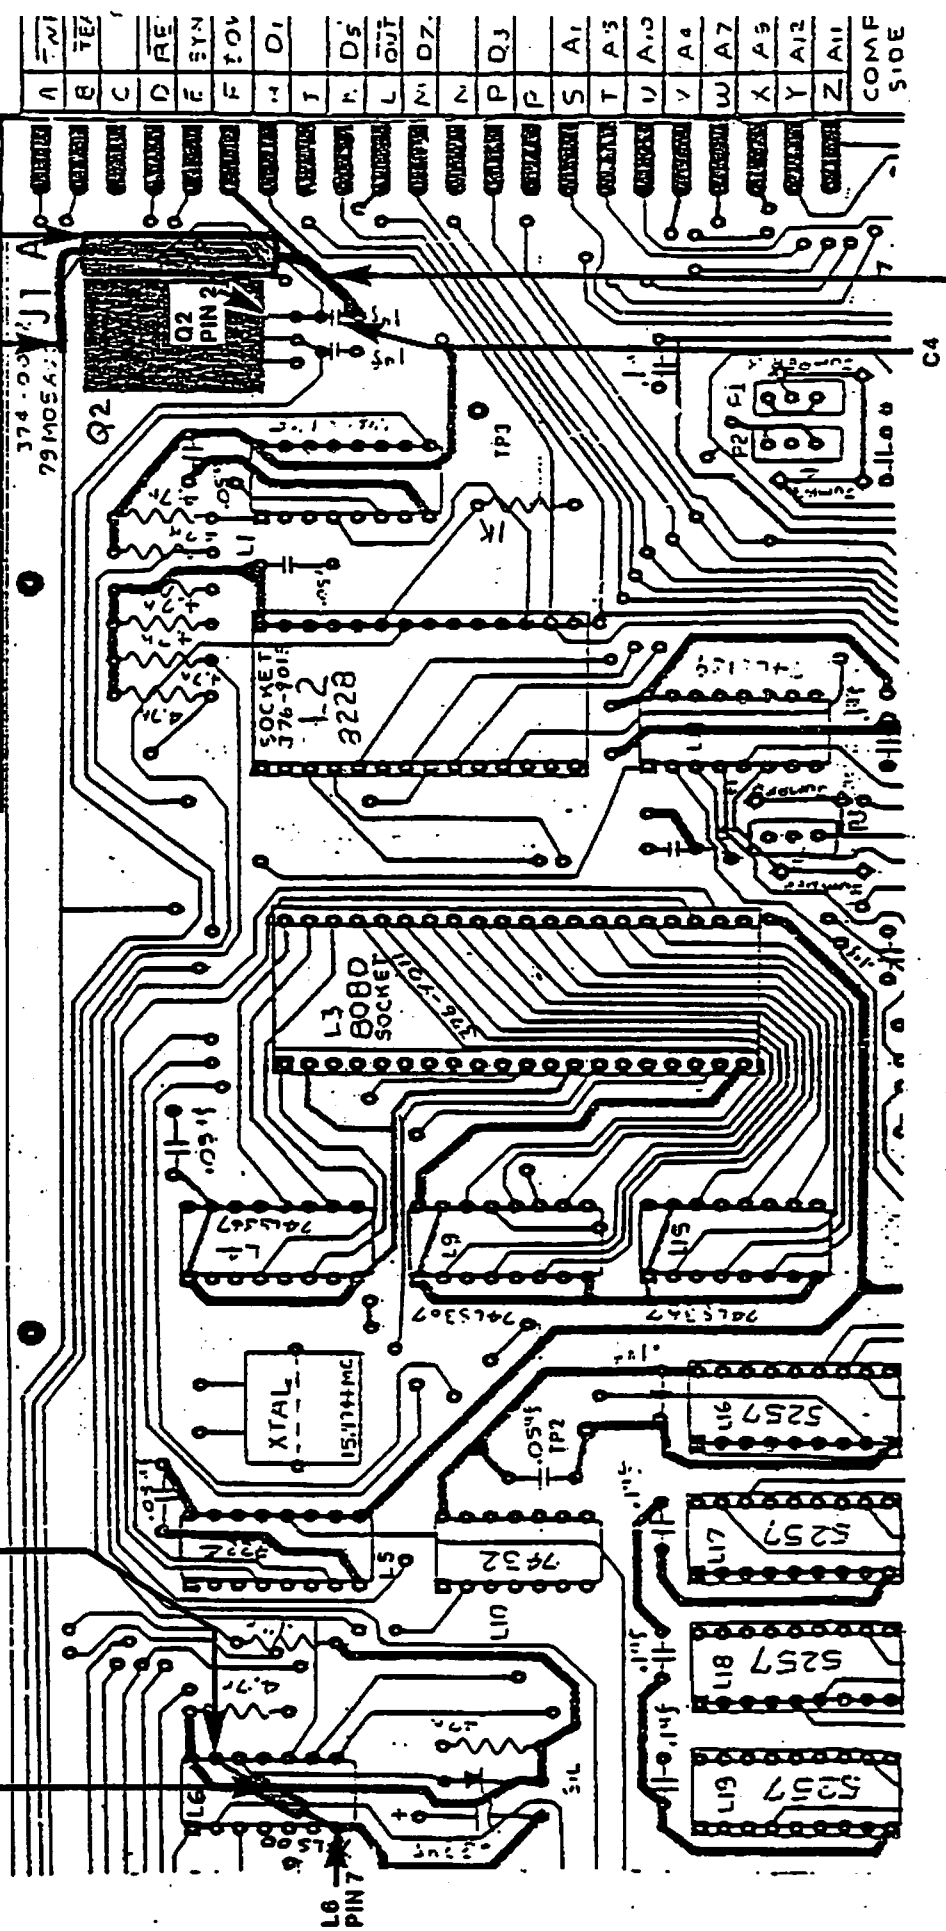
FIGURE 1 210-7591-A PCB ASSY, CAP LOCATIONS

A legitimate solution has been found for terminals hanging up using the MUXD board with 210-7591 daughterboard and R7 proms. Previously the solution was to either downgrade the proms or the daughterboard if both weren't needed for 2200 Word Processing.

- 1 Add a 390 pf capacitor (WLI 300-1390) between L6-pin 13 and plus/minus 0 volts. (use L6 pin 7 for +/- 0V)
- 2 Add a 35uf capacitor (WLI 300-3009), negative side to Q2 - pin 2 (-5V output) and positive side to plus/minus 0V. (use Q2 pin 1 for +/- 0V).
