# PRODUCT SERVICE NOTICE

PRODUCT/APPL. WANG MATRIX MODEL 77

PCB #210-7131, ECN's #11307 and #11497, E REV 2  
for 2261V and 2261W Matrix Printers

PERIPHERALS #29  
MODEL 77 (2261W) MATRIX PRINTER  
STATIC CAUSING DESELECTING

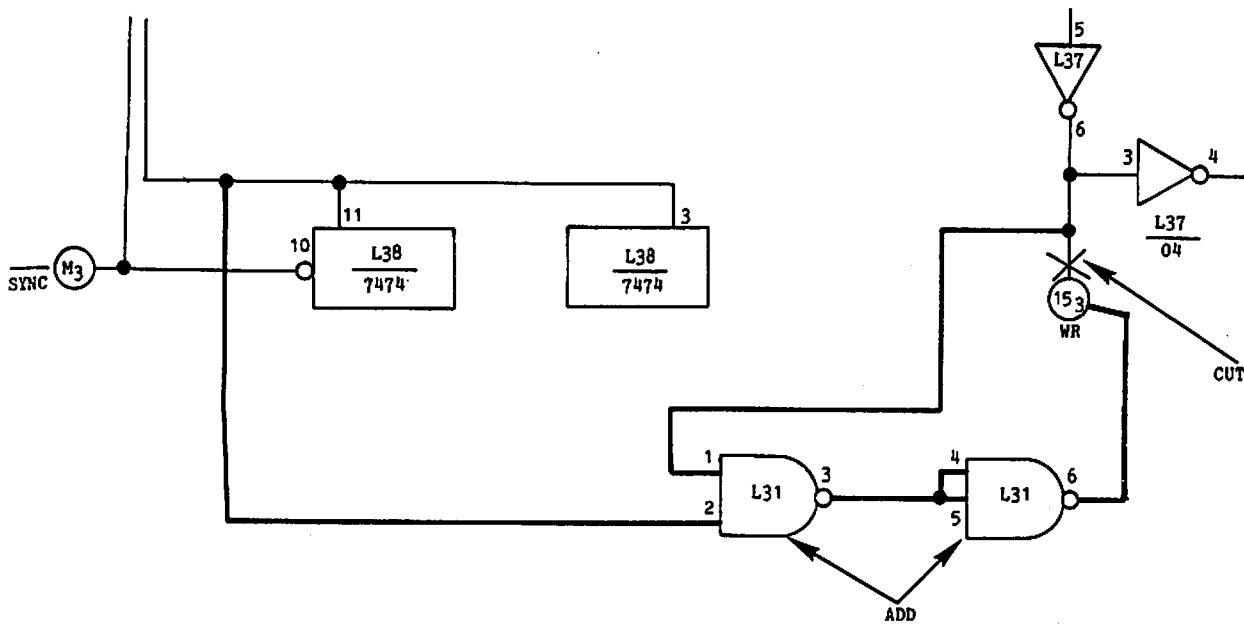
To enable the use of Texas Instrument PROMs in Character Font locations L1, L4, L6 and L8.

1. Cut the etch at the base of L37 pin 6.
2. Add a wire from L37 pin 6 to L31 pin 1.
3. Add a wire from L38 pin 3 to L31 pin 2.
4. Add a wire from L31 pin 3 to L31 pin 4.
5. Add a wire from L31 pin 4 to L31 pin 5.
6. Add a wire from L31 pin 6 to pin 15 of connector 3.
7. Increment the E-REV to 2.
8. Update the 7131 schematics to reflect this change. Refer to Figure 1.

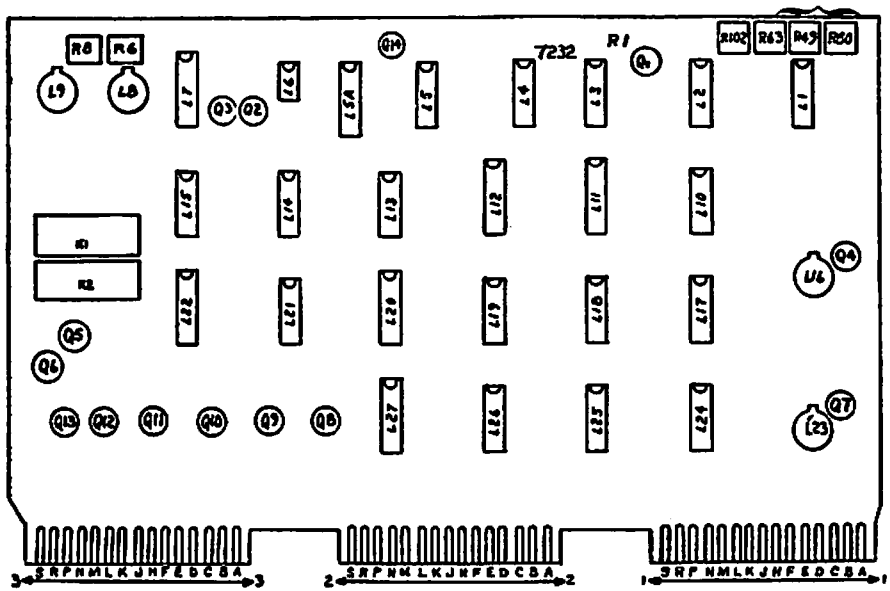
7232/7232-1 COMPONENT LAYOUT

Intensity adjustments to the LEDs in the photocoupler amplifiers on 7232/7232-1 boards are too sensitive with the 100-Kohm potentiometers (pots) presently used. Original specifications call for the use of 100-ohm pots in the LED-intensity adjustment circuits.

1. Replace 100-Kohm pots at locations R49 and R80 with 100-ohm pots. (See Figure.)
2. Perform adjustments described in Section 5.2.2, Paragraph 2 (Window Signal Duty Cycle), of the Model 77 Quad Head Maintenance Manual (03-0061, III.C.2). This procedure was written for the 210-7132 board; however, except for changes in component callouts, it applies to the 7232/7232-1 boards as well. In the maintenance manual, R46 is the 12-pitch LED adjustment pot and R24 is the 10-pitch LED adjustment pot. In the 7232/7232-1 schematics, these pots are labeled R80 and R49 respectively.
3. Increment the E-Rev. sticker on the 7232 board to level 4. Increment the E-Rev. sticker on the 7232-1 board to level 1.

Replace 100K Ohm POTs  
At These Locations (R49, R80)  
With 100 Ohm POTs

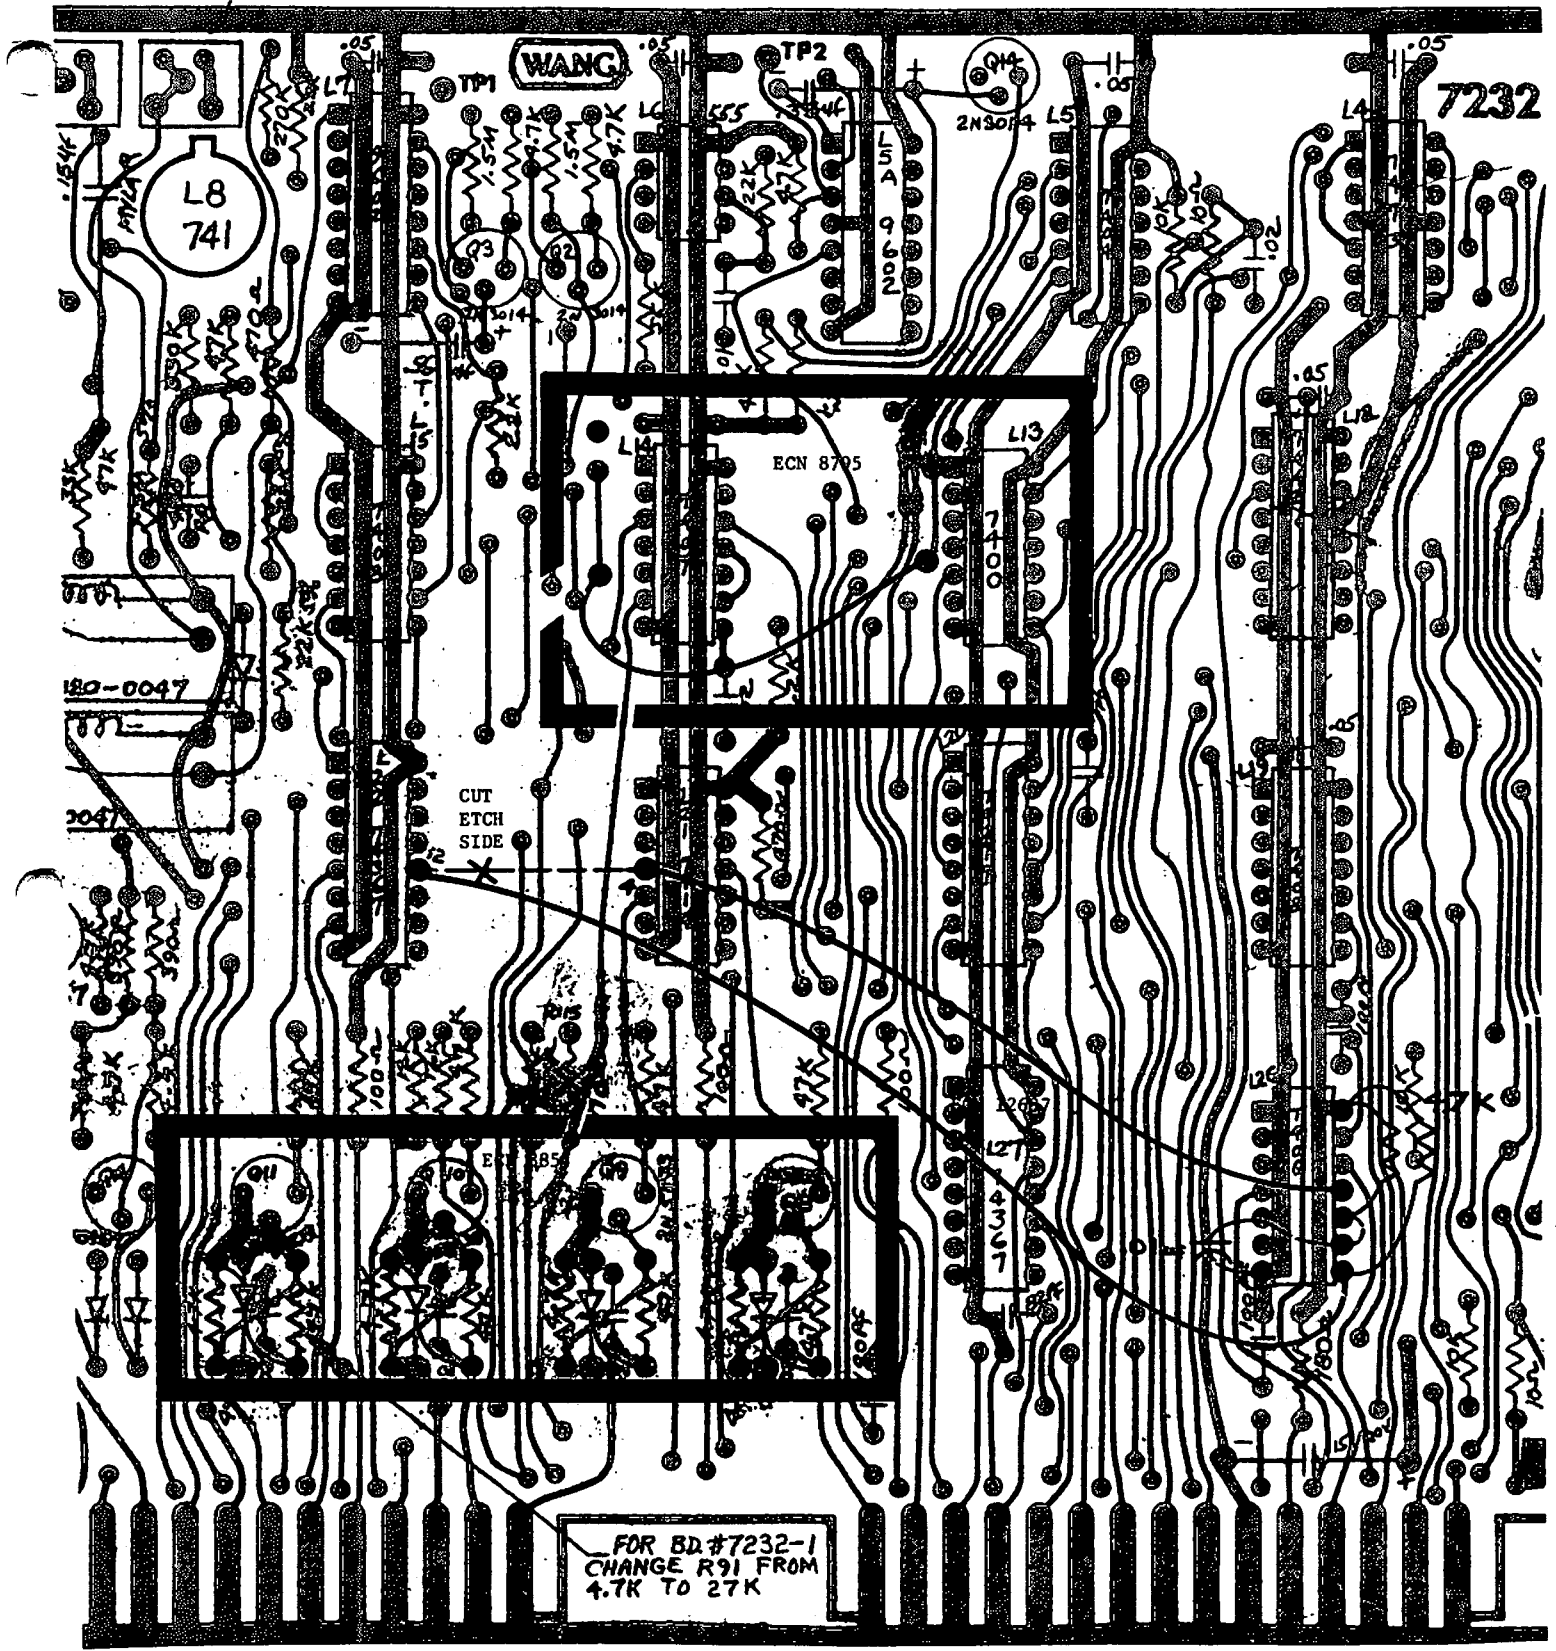
FIGURE 1 210-7232 PCB, COMPONENT SIDE

To eliminate top and bottom of form problems.

To eliminate intermittent top-of-form problems

1. Remove the 22K resistor located below Q8 and replace it with a 4.7K resistor (WL #330-3047).
2. Remove the 47K resistor located below Q8 and replace it with a 4.7K resistor.
3. Connect a diode (WL #380-1001-4B), between pin S<sub>2</sub> an Q8's emitter, with the anode connected to Q8, as shown in the figure.
4. Repeat steps 1, 2 and 3 for the identical circuits associated with Q9, Q10 and Q11.

1. On the non-component side of board, cut the etch between L21 pin 4 and L22 pin 12.
2. On the component side of board, perform the following:
  - a. Jumper L21 pin 4 to L26 pin 11.
  - b. Jumper L26 pin 9 to L26 pin 10.
  - c. Jumper L26 pin 8 to L22 pin 12.
  - d. Add a 4.7-kohm resistor between pin 10 and pin 14 of L26.
  - e. Add a 4.7-kohm resistor between pin 8 and pin 14 of L26.
  - f. Add a .01-uF capacitor between pin 7 and pin 9 of L26.
3. Increment the E REV sticker to 3.
4. Update the schematic to reflect this change. Refer to Schematic.

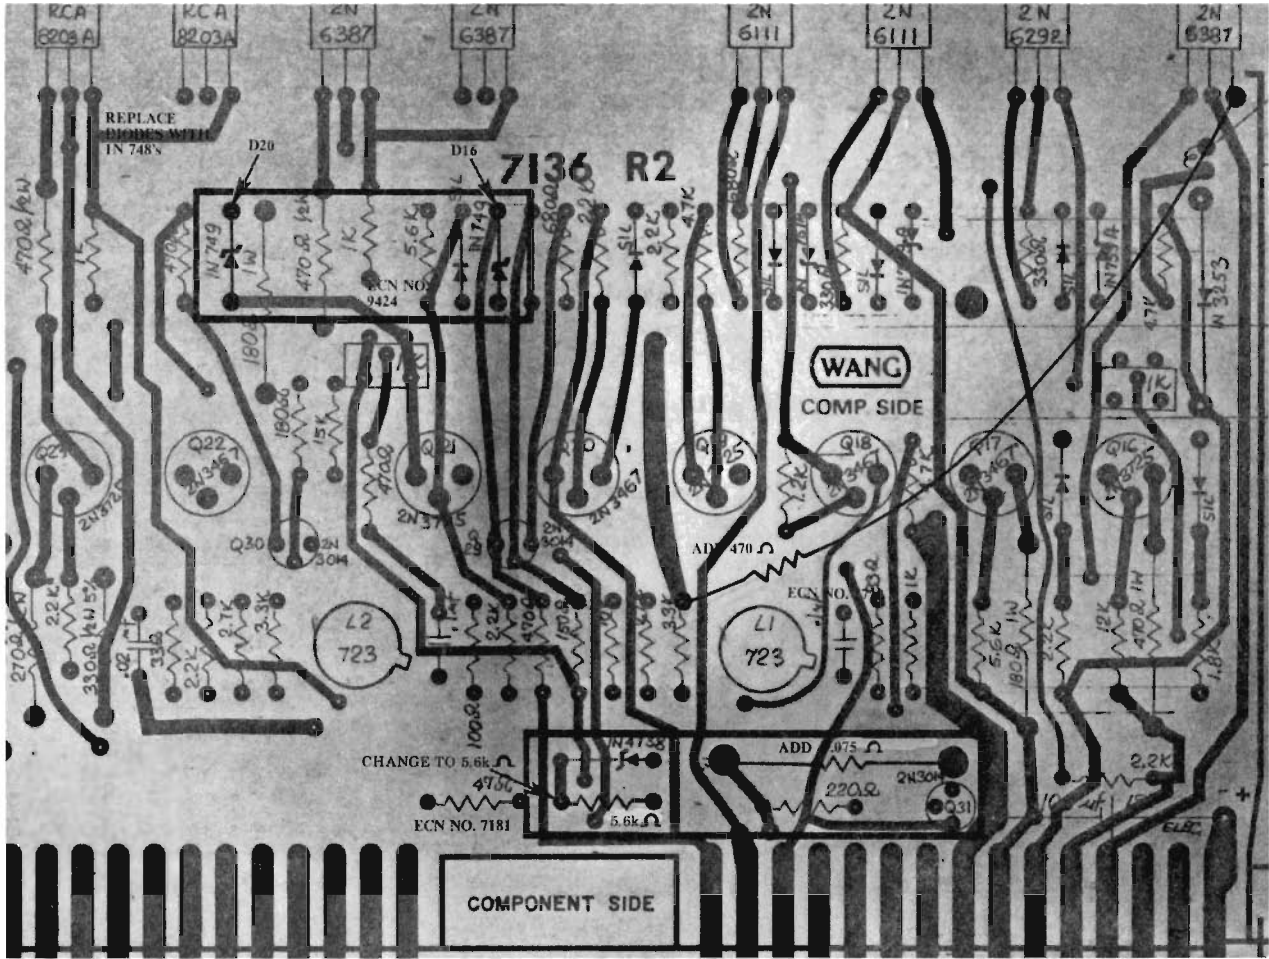
FIGURE 1 ECN's #7181, #7712 and #9424

Design improvement for better regulation.

To eliminate solenoid misfiring when the printer power is turned off.

The +12 VR and the -12 VR switching control is too critical.

1. Replace R66 (3.3K ohm) with the 5.6K ohm resistor.
2. Add the .075 ohm resistor between 13<sub>1</sub> (+5VR) and the emitter of Q31 (2N3014). This resistance was previously attained by installing two 0.15 ohm resistors in parallel.
3. Increment the E REV from 0 to 1.

1. Insert the 470 ohm resistor between L1 pin 5 and the +12 volt run at the emitter of Q1.
2. Increment the E REV from 1 to 2.

1. Remove D20, located above Q22, and, observing the same polarity, replace it with a 1N748 diode.
2. Remove D16, located directly above Q29, and, observing the same polarity, replace it with a 1N748 diode.
3. Increment the E REV from 2 to 3.

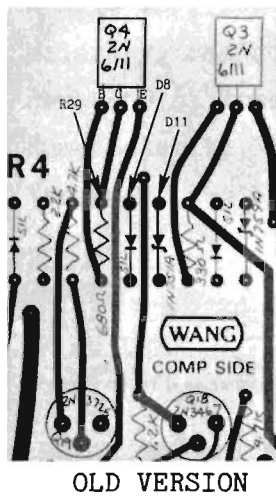
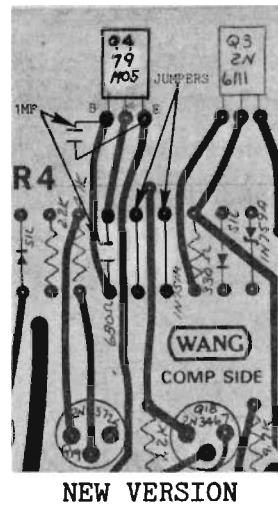
FIGURE 2 ECN #10883

To improve the -5V regulator circuit. The existing component tolerances cause high failure rates.

To change the tolerances of the transistor regulator and the associated -5V regulator circuit components.

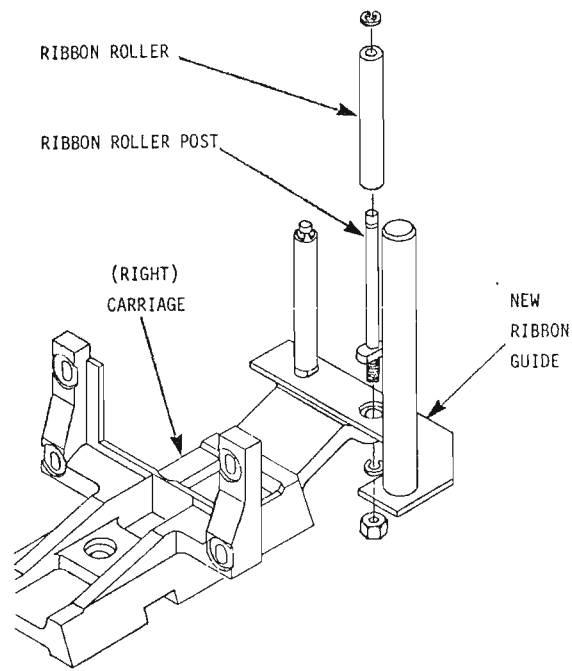
A new ribbon has been designed that supercedes the ribbon guide described in ISN #100. The new ribbon guide is designed to prevent paper streaking and to prevent the ribbon from jumping out of position. This new ribbon guide is available in limited quantity, in the Area offices. If additional ribbon guides are required they may be ordered from William Dorazio, Home Office by submitting request for a *MODEL 2261 RIBBON GUIDE* and the name of the customer where the ribbon guide(s) will be installed.

1. Remove old ribbon guide (if installed).
2. Remove two ribbon rollers.
3. Remove two ribbon roller posts.
4. Align new ribbon guide over roller post holes.
5. Reassemble in reverse order (step 4 to step 2).

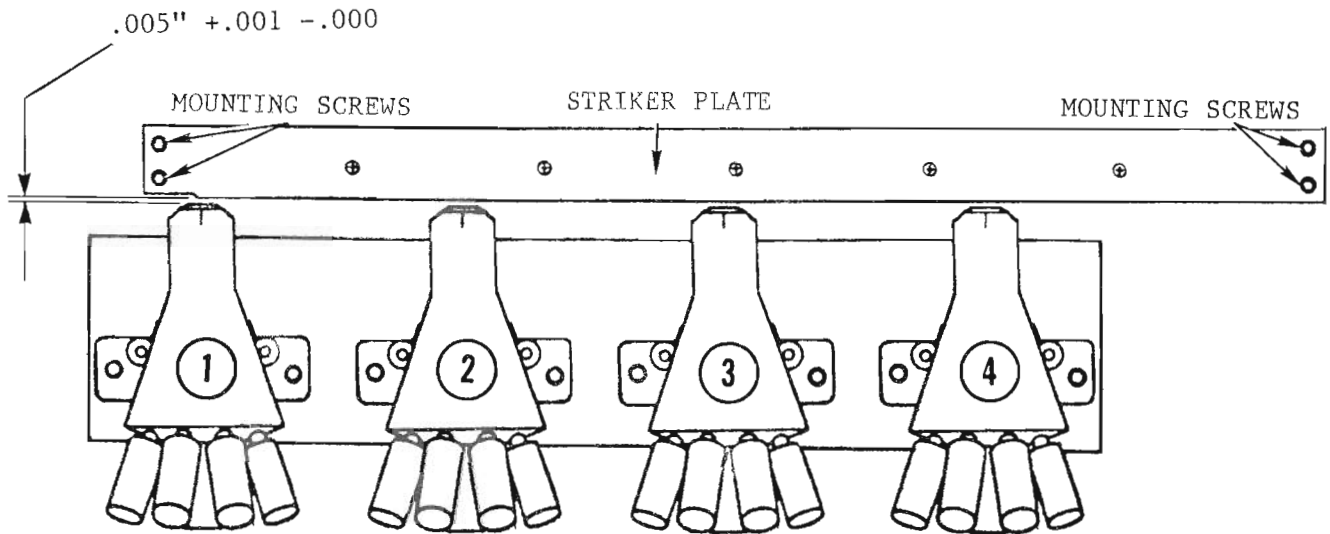
FIGURE 1

Some Model 77 (2261W) Matrix Printers have experienced solenoid wire breakage problems. The most common cause of these print head failures is incorrect striker plate alignment. If the print head bearing to striker plate clearance is less than .005" when the head adjustment arm is set to maximum penetration (due to incorrect alignment), the solenoid wires may break during firing.

4. Move the carriage assembly to the left margin.
5. Using a feeler gauge, measure the gap from print head bearing #1 (leftmost head) to the striker plate. See Figure 1. This gap should be  $.005'' + .001'' - .000''$ . Note the exact measurement and continue with the next step.
6. Move the carriage assembly to the right margin. Again measure the gap from print head bearing #1 to the striker plate. The second measurement should be within  $.001''$  of the first, but never less than  $.005''$ .
7. Repeat this procedure for each of the remaining print heads. For each individual print head, the difference in gaps at the left and right margins should not exceed  $.001''$ , nor should any head be closer than  $.005''$  to the striker plate. If any heads vary more than  $.001''$ , proceed with a striker bar adjustment or print head adjustment as required.

1. Loosen the two Allen head screws at each end of the striker plate.
2. Move the striker plate forward or back (the rear paper guide will also move) until it is parallel to the main carriage. Tighten the Allen head lock screws and perform the striker plate adjustment check.
3. Repeat steps 1 and 2 until the gap from the striker plate to the print head bearings changes less than .001" as each print head moves from margin to margin.

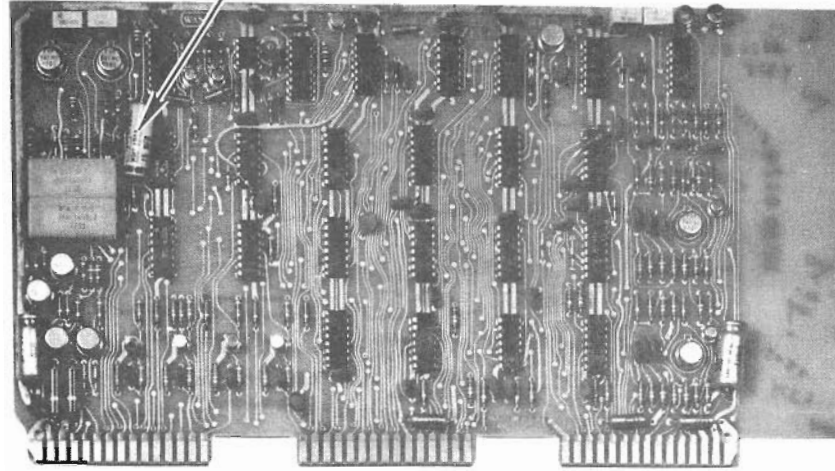
FIGURE 1 7132 PCB OPTICAL SIGNAL, PAPER FEED & MOTOR CONTROL

Some Model 77 (2261W) Matrix printers have experienced failures in the 7132 OPTICAL SIGNAL, PAPER FEED & MOTOR CONTROL PCB. The symptom of this problem is excessive carriage speed.

The capacitor is damaged when the board is shipped or handled improperly. To prevent this problem, do not stack any boards on the component side of the 7132 board. Always isolate the 7132 board by wrapping it in Styrofoam packing material or by keeping it separate in its own shipping envelope.

Figure 1 shows the location of capacitor C7 on the 7132 board. On artwork Rev 2 boards, the capacitor is closer to the edge of the board, near potentiometers R5 and R7.

Capacitor C7 is the yellow, 100VDC, .15 Microfarad mylar capacitor near the side of the board (See Figure 1). If these symptoms occur, replace the capacitor (WLI #300-2215).

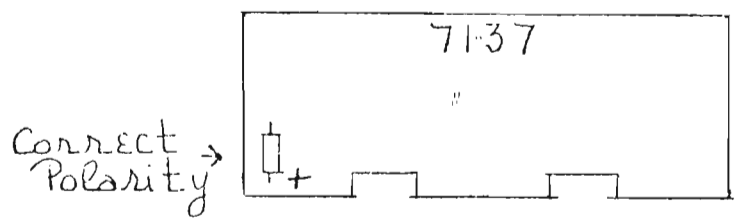
Change sample board as follows:  
 The direction of the 15uf/20V tantalum capacitor on the lefthand component side of the board is reversed. The correct polarity is + towards the fingers (See Below)
