CUSTOMER ENGINEERING
SERVICE HANDBOOK

CARTRIDGE TAPE DRIVES

MODELS: 2229
2529
6529

2229/2529/6529 TAPE DRIVES

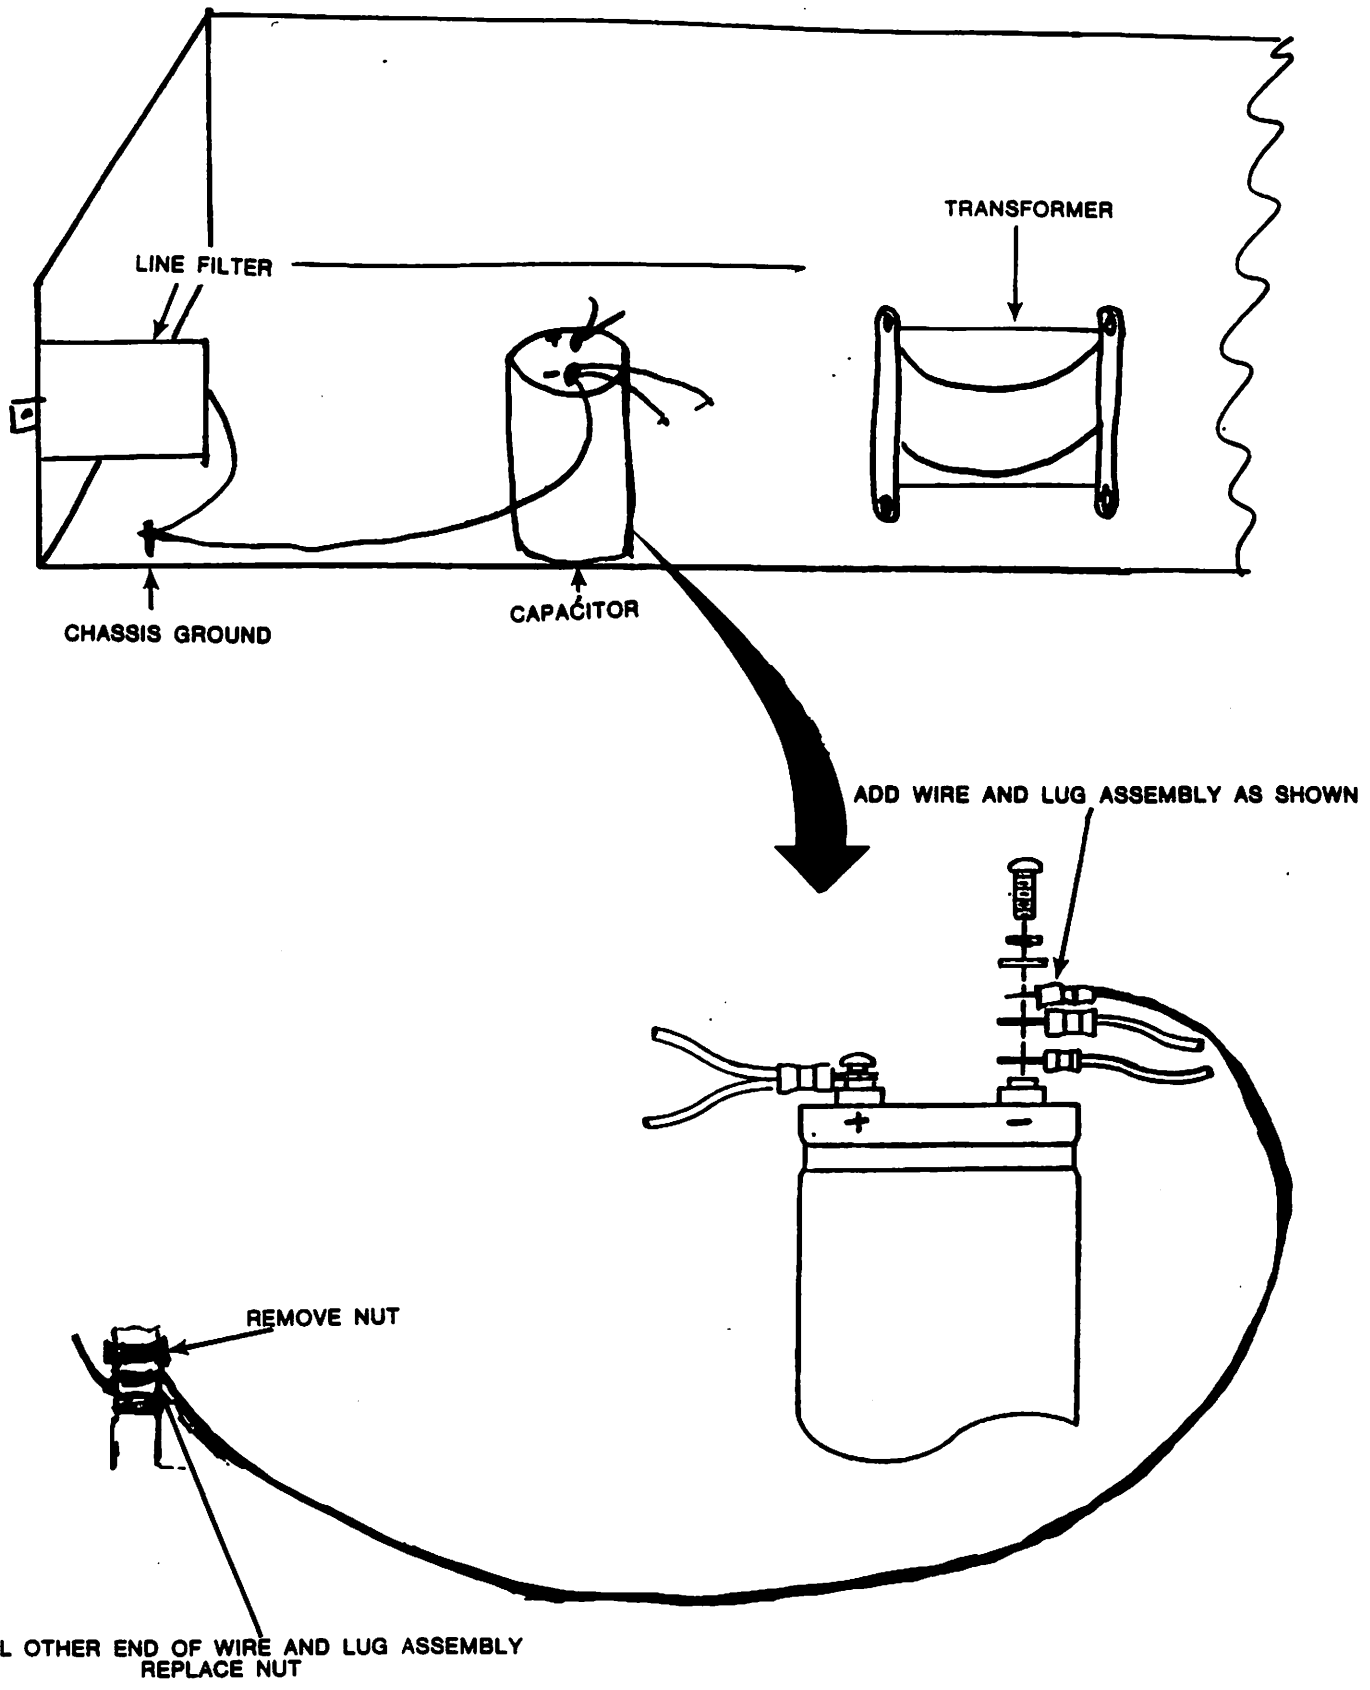
FIGURE 1: TAPE DRIVE, SIDE VIEW
WIRE AND LUG ASSEMBLY INSTALLATION

To prevent glitches that can cause phantom errors by tying the CPU and the tape drive to the same ground point.

- C. Add the wire and lug assembly between the capacitor and chassis ground as follows: (Figure 1)
1. Remove the screw on the negative post of the cap. (The negative post is not marked, but it has black wires and a blue wire with a black stripe attached.)
 2. Add one end of the wire and lug assembly. Insert the screw through the two washers and three lugs and thread the screw back into the cap.
 3. Remove the nut from the chassis ground screw located under the line filter at the back of the unit. Place the other end of the wire and lug assembly over the screw and replace the nut.
- D. Replace the cover of the unit by reversing the procedure described in step B.
- E. Perform check-out procedure described in Section 6.
- F. Document installation of this FCO by completing a Call Report or Activity Report.

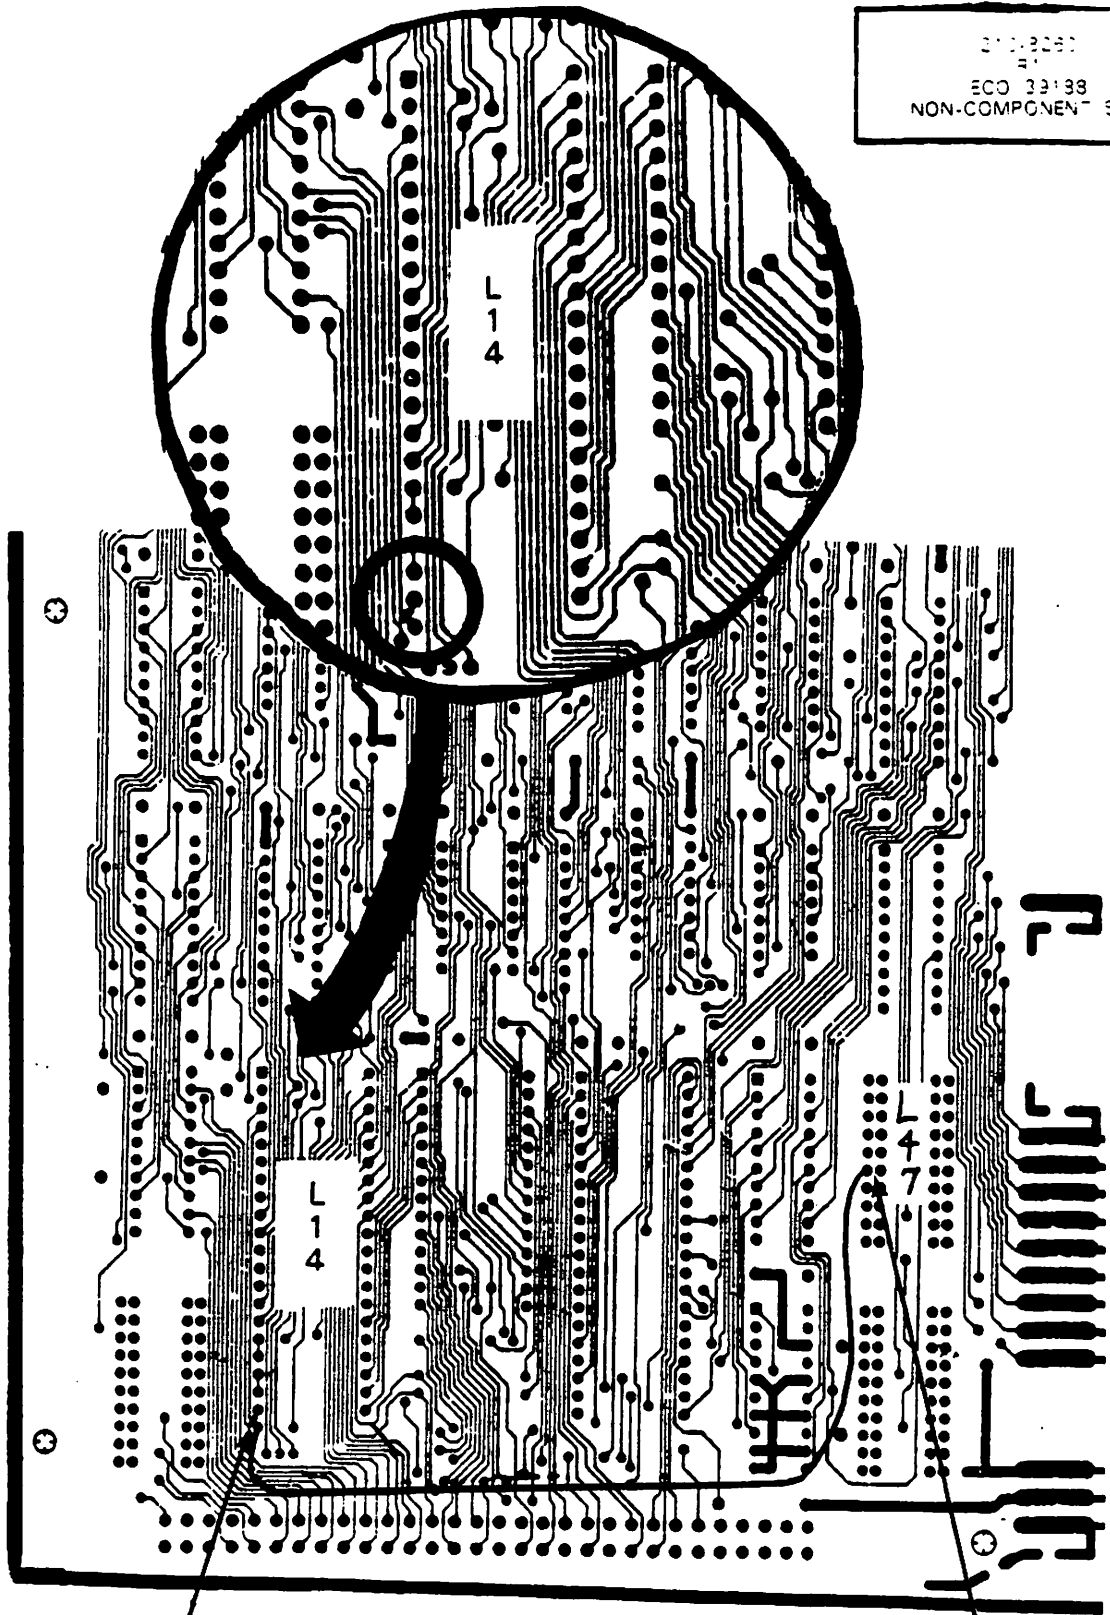
ILLUSTRATION A

CUT ETCH OF L14-4 ABOVE
PLATETHRU LOCATED BELOW
L14-20, AS SHOWN

JUMPER FROM L47-6 TO
PLATETHRU BELOW L14-20,
AS SHOWN

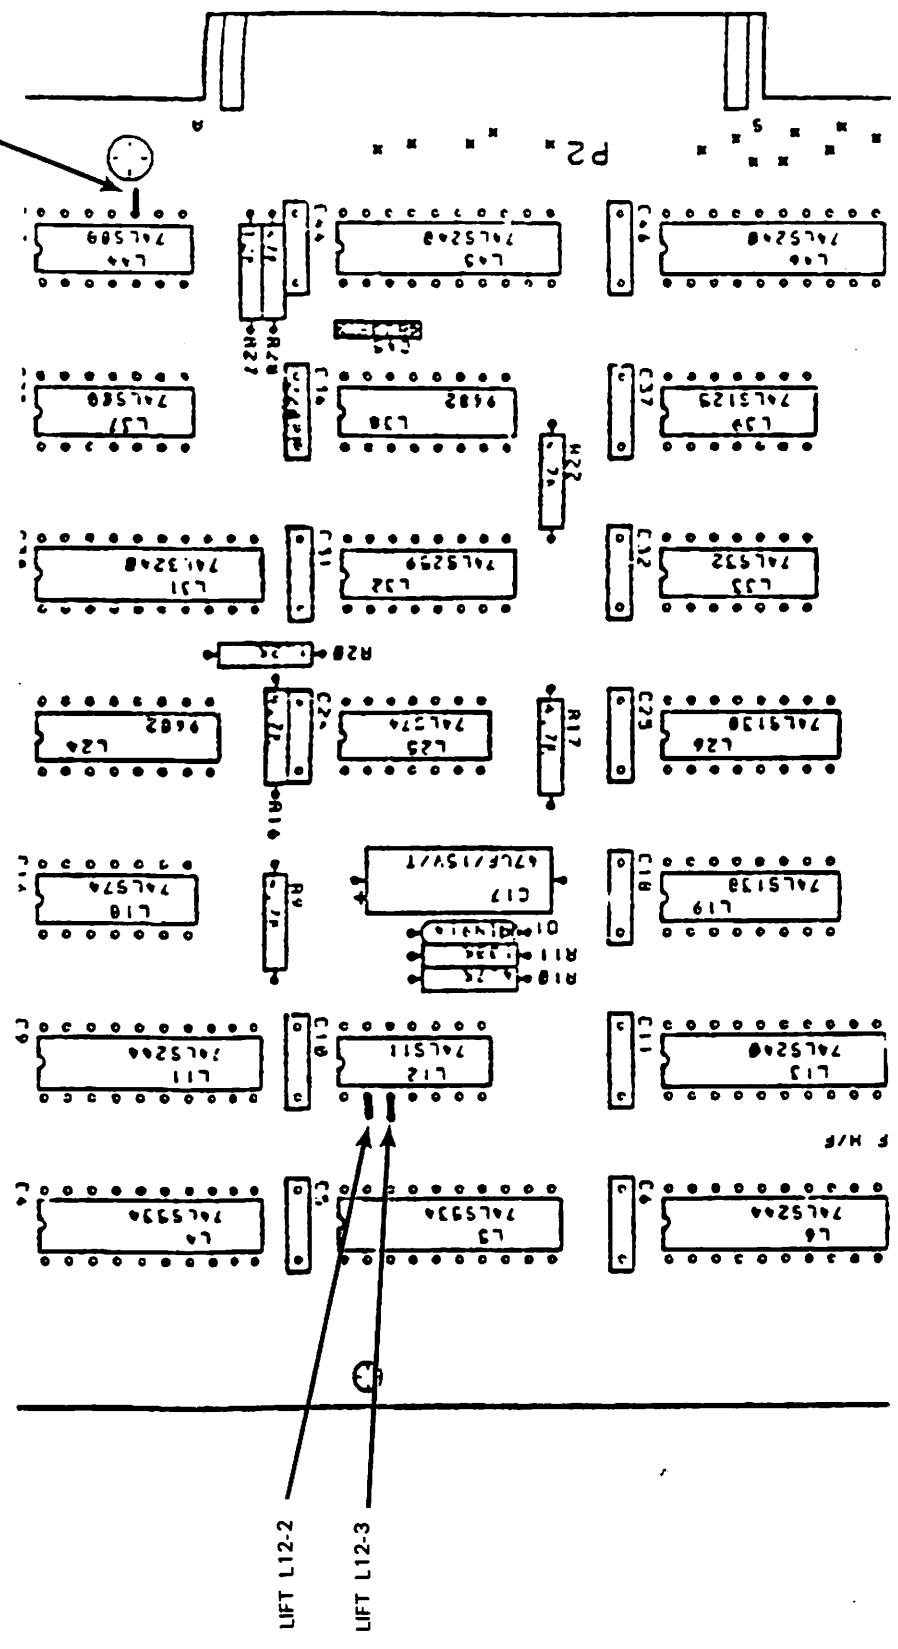
ILLUSTRATION C

LIFT L44-10

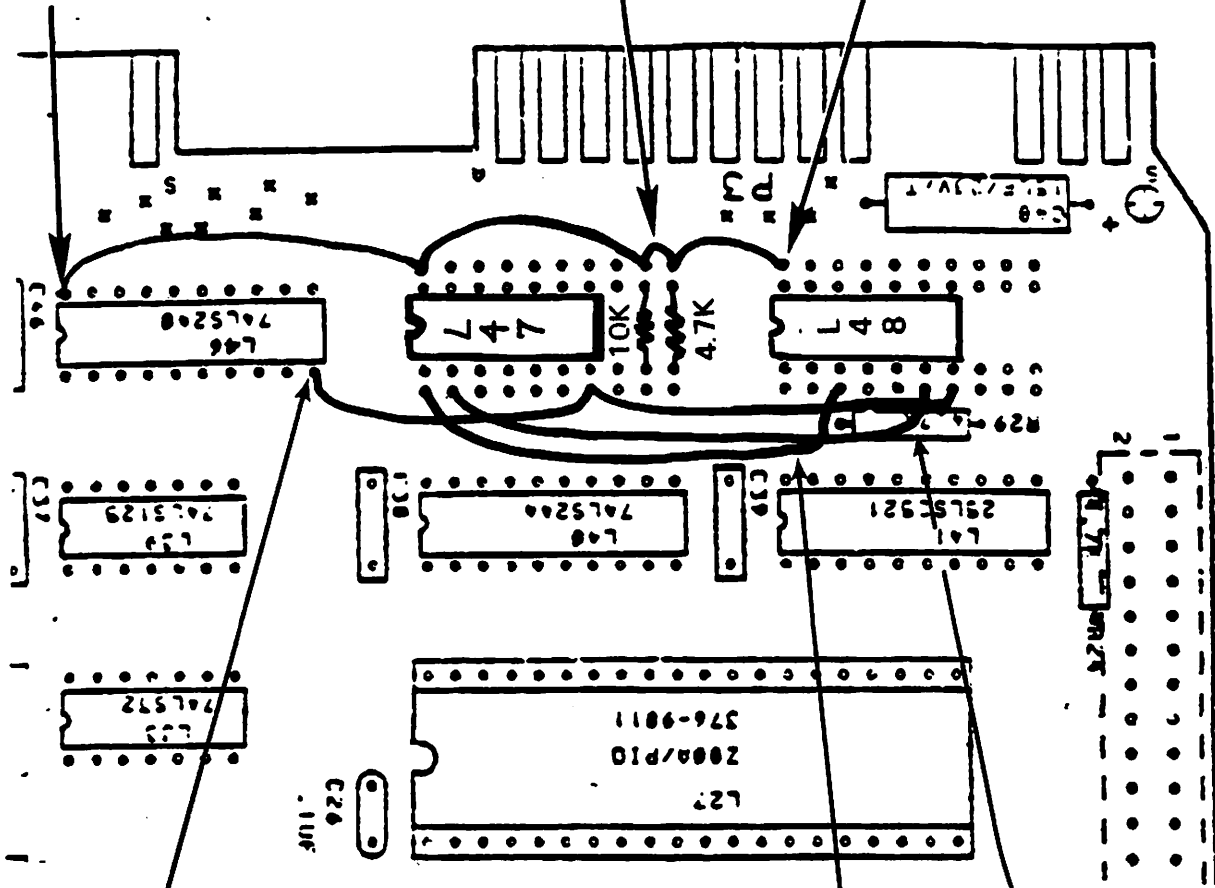
ILLUSTRATION E

JUMPER L48-6
TO L47-2

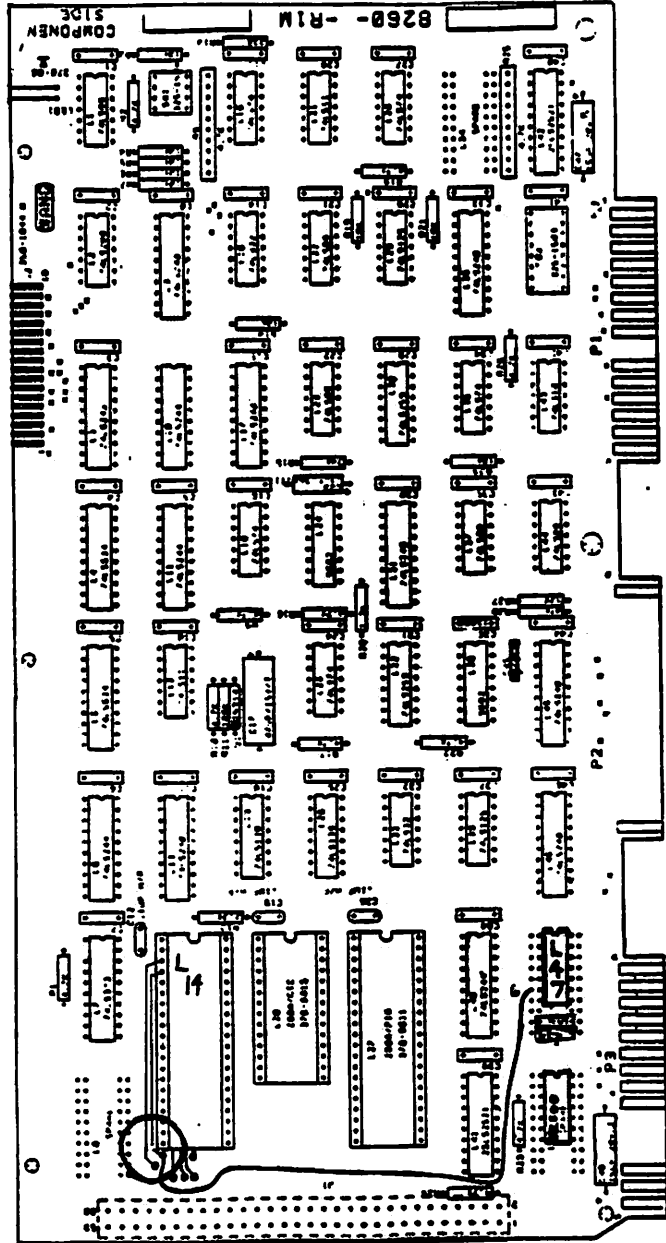
TITLE: IMPROPERLY WIRED 2229 TAPE CONTROLLERS

Recently a problem was identified with the 212-3037 tape controller being improperly wired for ECO # 39188. The problem resulted in a loss of data. In this particular situation the customer was backing up to the tape drive. It appeared to be backing up successfully as no errors were reported. However when the tapes were checked they were found to be blank.

The board improperly wired can be identified by the following:

proper location
of cut etch and
jumper

Any controller not repaired on site and returned for repair, should be accompanied with a repair tag clearly stating this problem.
