# WANG FIELD CHANGE ORDER

FCO NO.  
1004

Equipment Affected 2280 AND 6580 PHOENIX DRIVES (BLOCK POINT 3 AND BELOW)  
Class NEXT CALL FCO Kit # 728-0018-25 Page 1 of 9  
Org. Code III.A.7 FCO Doc. # 729-1090 Approval Date:  
Est. Install. Time 45 MINUTES Ref. ECO # CDC# 33779 **JUN 28 1982**

To provide protection to heads and media in the event of severely restricted air flow or blower motor failure.

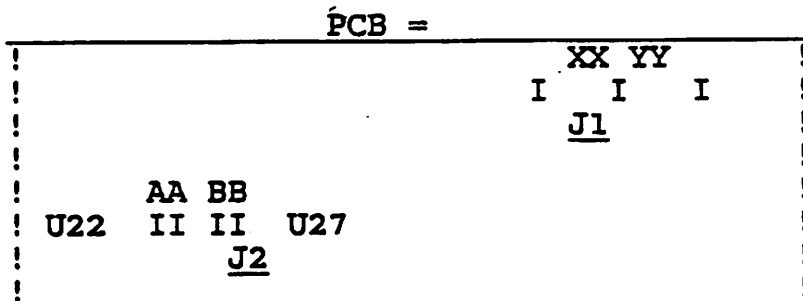
The Head load timing jumper (J2 4 pin) is located in the middle of the PCB between U22 and U27

This delay was incorporated to allow extra purge and stabilization time for the cartridge; the lower particle count can reduce head crashes.
