LABORATORIES, INC.

M-E-M-O-R-A-N-D-U-M

TO: Northeast Area ATS's & DTS's
FROM: Bill Dini
DATE: April 24, 1981
SUBJECT: Series 24 TB216A FTU

PERIPHERALS-DISK DRIVES-CDC PHOENIX 9448 CMD.

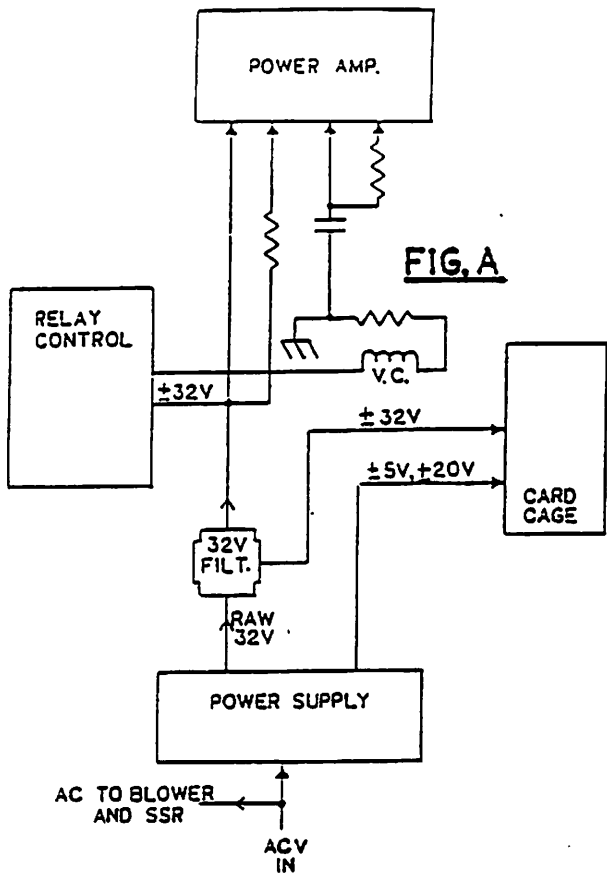
FIG. A

1. The voltages produced by the CMD power supply are effectively interlocked to protect the drive electronics. In nearly all cases where it appears that the power supply has failed, the 32 volt load (power amplifier circuitry) is actually the culprit. Figs. A & B are basic and less basic drawings of the power circuitry.

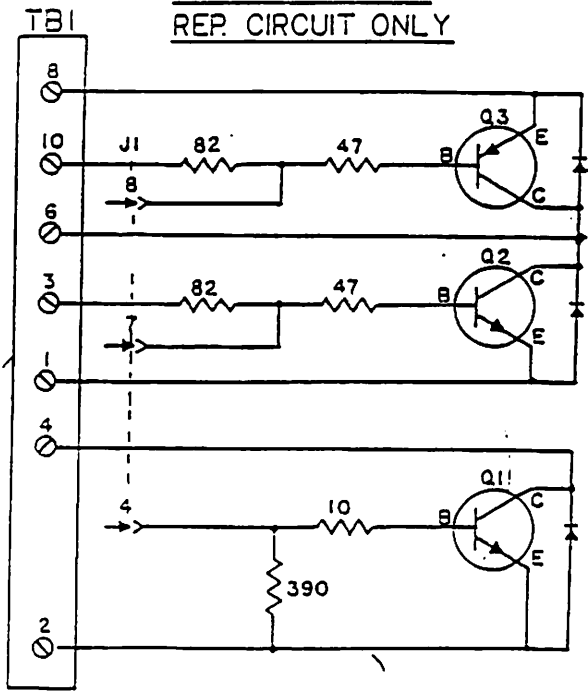
FIG. C

5. Now, you can shut down the power, disconnect terminals 1,3,8 & 10 from the power amp; reconnect the input to the 32 volt filter, then bring up the power again. This will reconnect all 32 volt circuitry except the power amplifier. If the power amp was the only problem left to be repaired, the front door lock will open (click) and the ready lite will flash once, the fault light will be off and CR6 will not be lit. If this is the case, replace the power amp or replace the determined defective transistors which are bad using the power amp representative schematic and resistance chart, (Figs. C&D), included with this blurb as a guide.

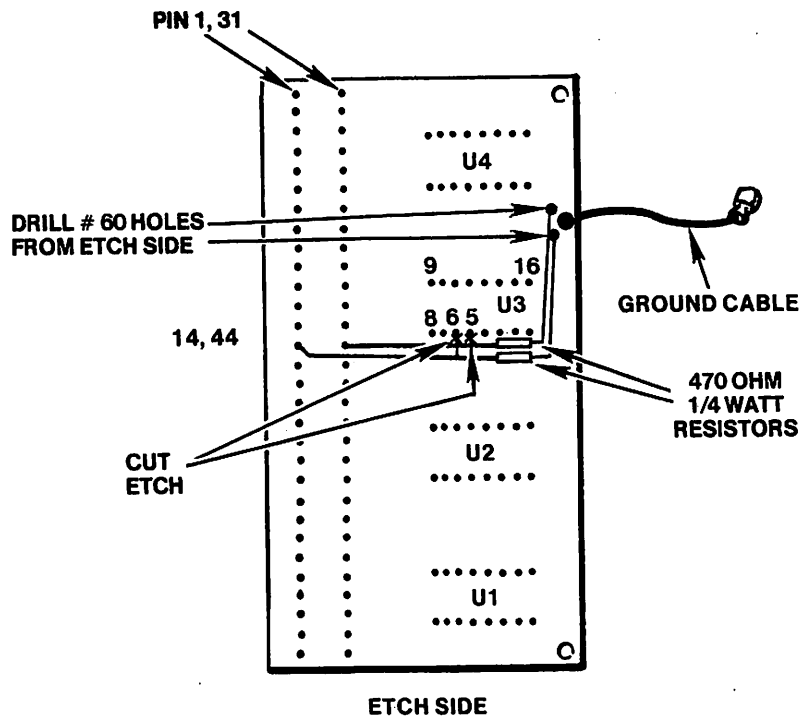
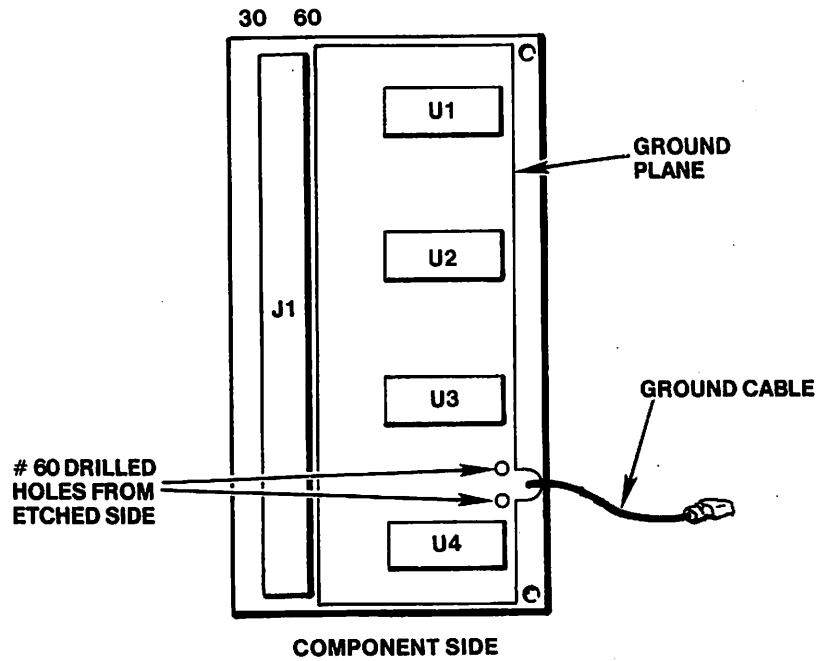
FIGURE 2 MODIFICATION OF INCOMPATIBLE TERMINATORS 726-5790 AND 75886100.

Using a VOM on RX1 scale, check for zero (0) ohms resistance between resistor leads at ground plane connection and ground cable to ensure continuity. A cold solder connection will cause input/output problems.
