# PRODUCT BULLETIN

# NO. 172

## THE MODEL 2260BC AND MODEL 2260C SERIES DISK DRIVES

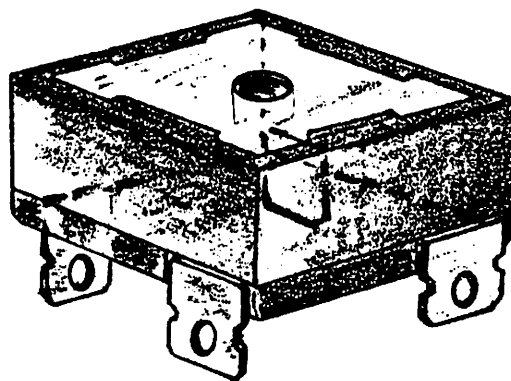
FIGURE 3

1. Power Supplies manufactured by General Instruments may have bridge rectifiers that are sensitive to low frequency noise. These rectifiers are identified by a metallic silver casing. The correct rectifiers are manufactured by Varo Semiconductors, Inc., and have a black epoxy casing. When changing the General Instruments rectifiers, label connections to ensure correct replacement.

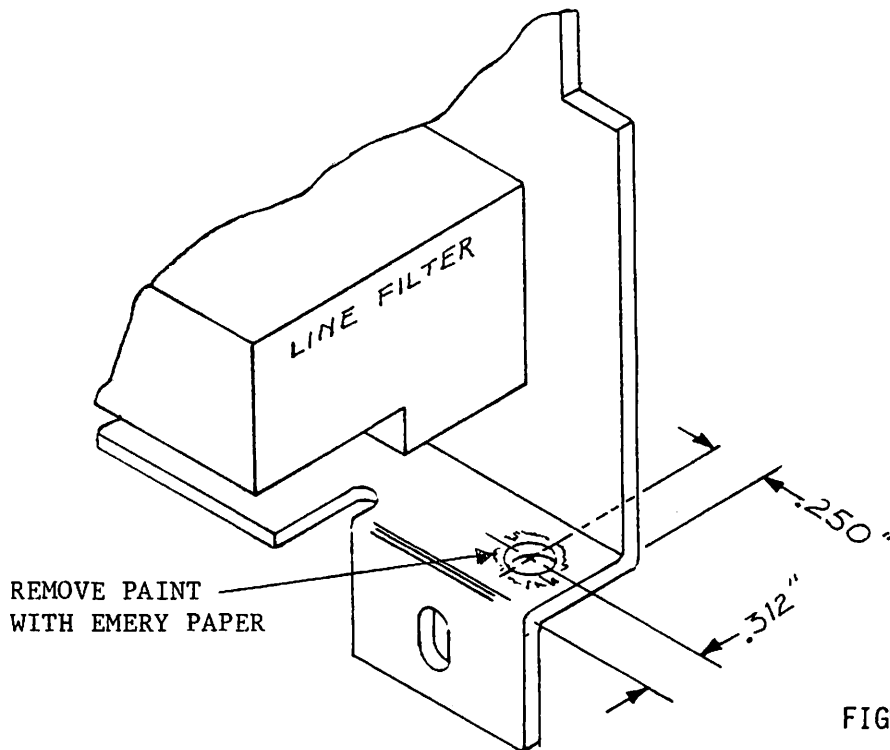
FIGURE 4

2. Some power supplies were assembled using Potter or Hopkins AC line filters. These two filters are inadequate for the application, and should be changed to a Corcom filter. The filter type can be determined as follows:
  - a) Corcom - Silver-colored, with a schematic of the filter printed on top of the casing. A green safety wire lug

1. Remove the power supply assembly from the disk drive (refer to Diablo 44B Maintenance Manual, Section 5.7.1.5).
2. Remove the filter by depressing the tabs on each side of the filter, and sliding the filter out towards the rear of the power supply assembly.
3. Label and remove the wires connected to the filter.
4. Drill a 3/16" hole in the power supply chassis in the outside rear corner as shown in Figure 4. Remove paint from around the drilled hole with emery paper.

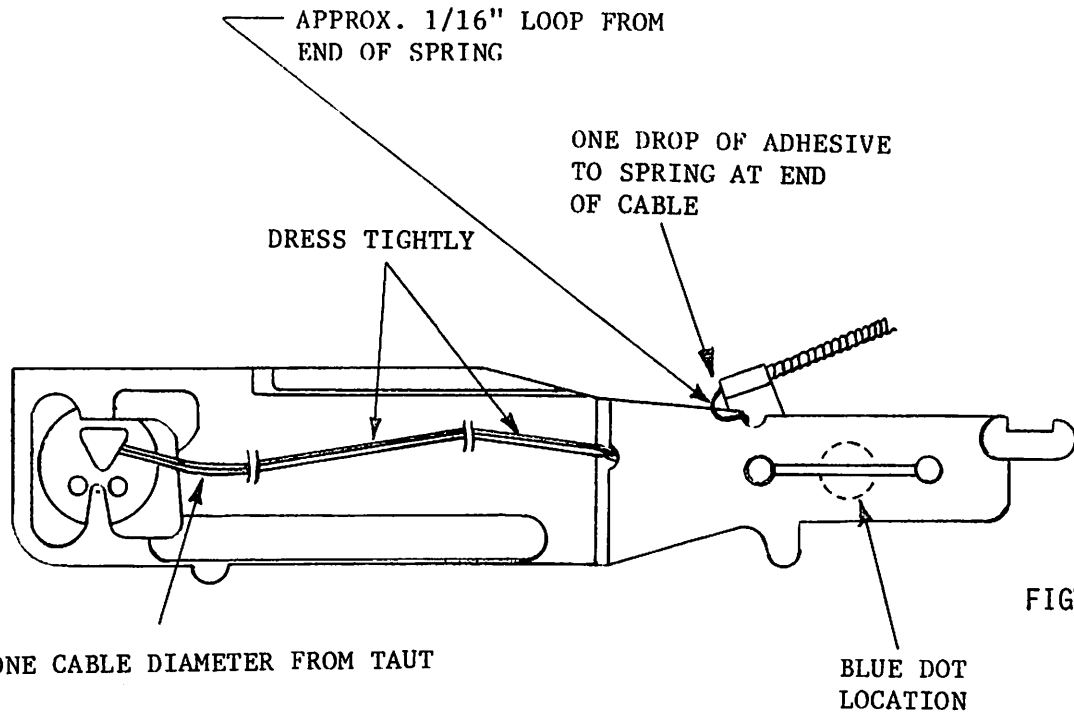
FIGURE 6

The R/W head cables have a tendency to 'creep', due to mechanical action of the R/W heads when seeking. If the insulation on these cables is made of Teflon (which is the case after Oct., 76), this creeping motion causes a static charge to build up. Subsequent static discharge causes errors.

To prevent the R/W head cables from creeping, apply 1 drop of Loctite 414 adhesive (provided by Diablo in kits) as shown in Figure 6. Secure the head cable as shown in Figure 6.

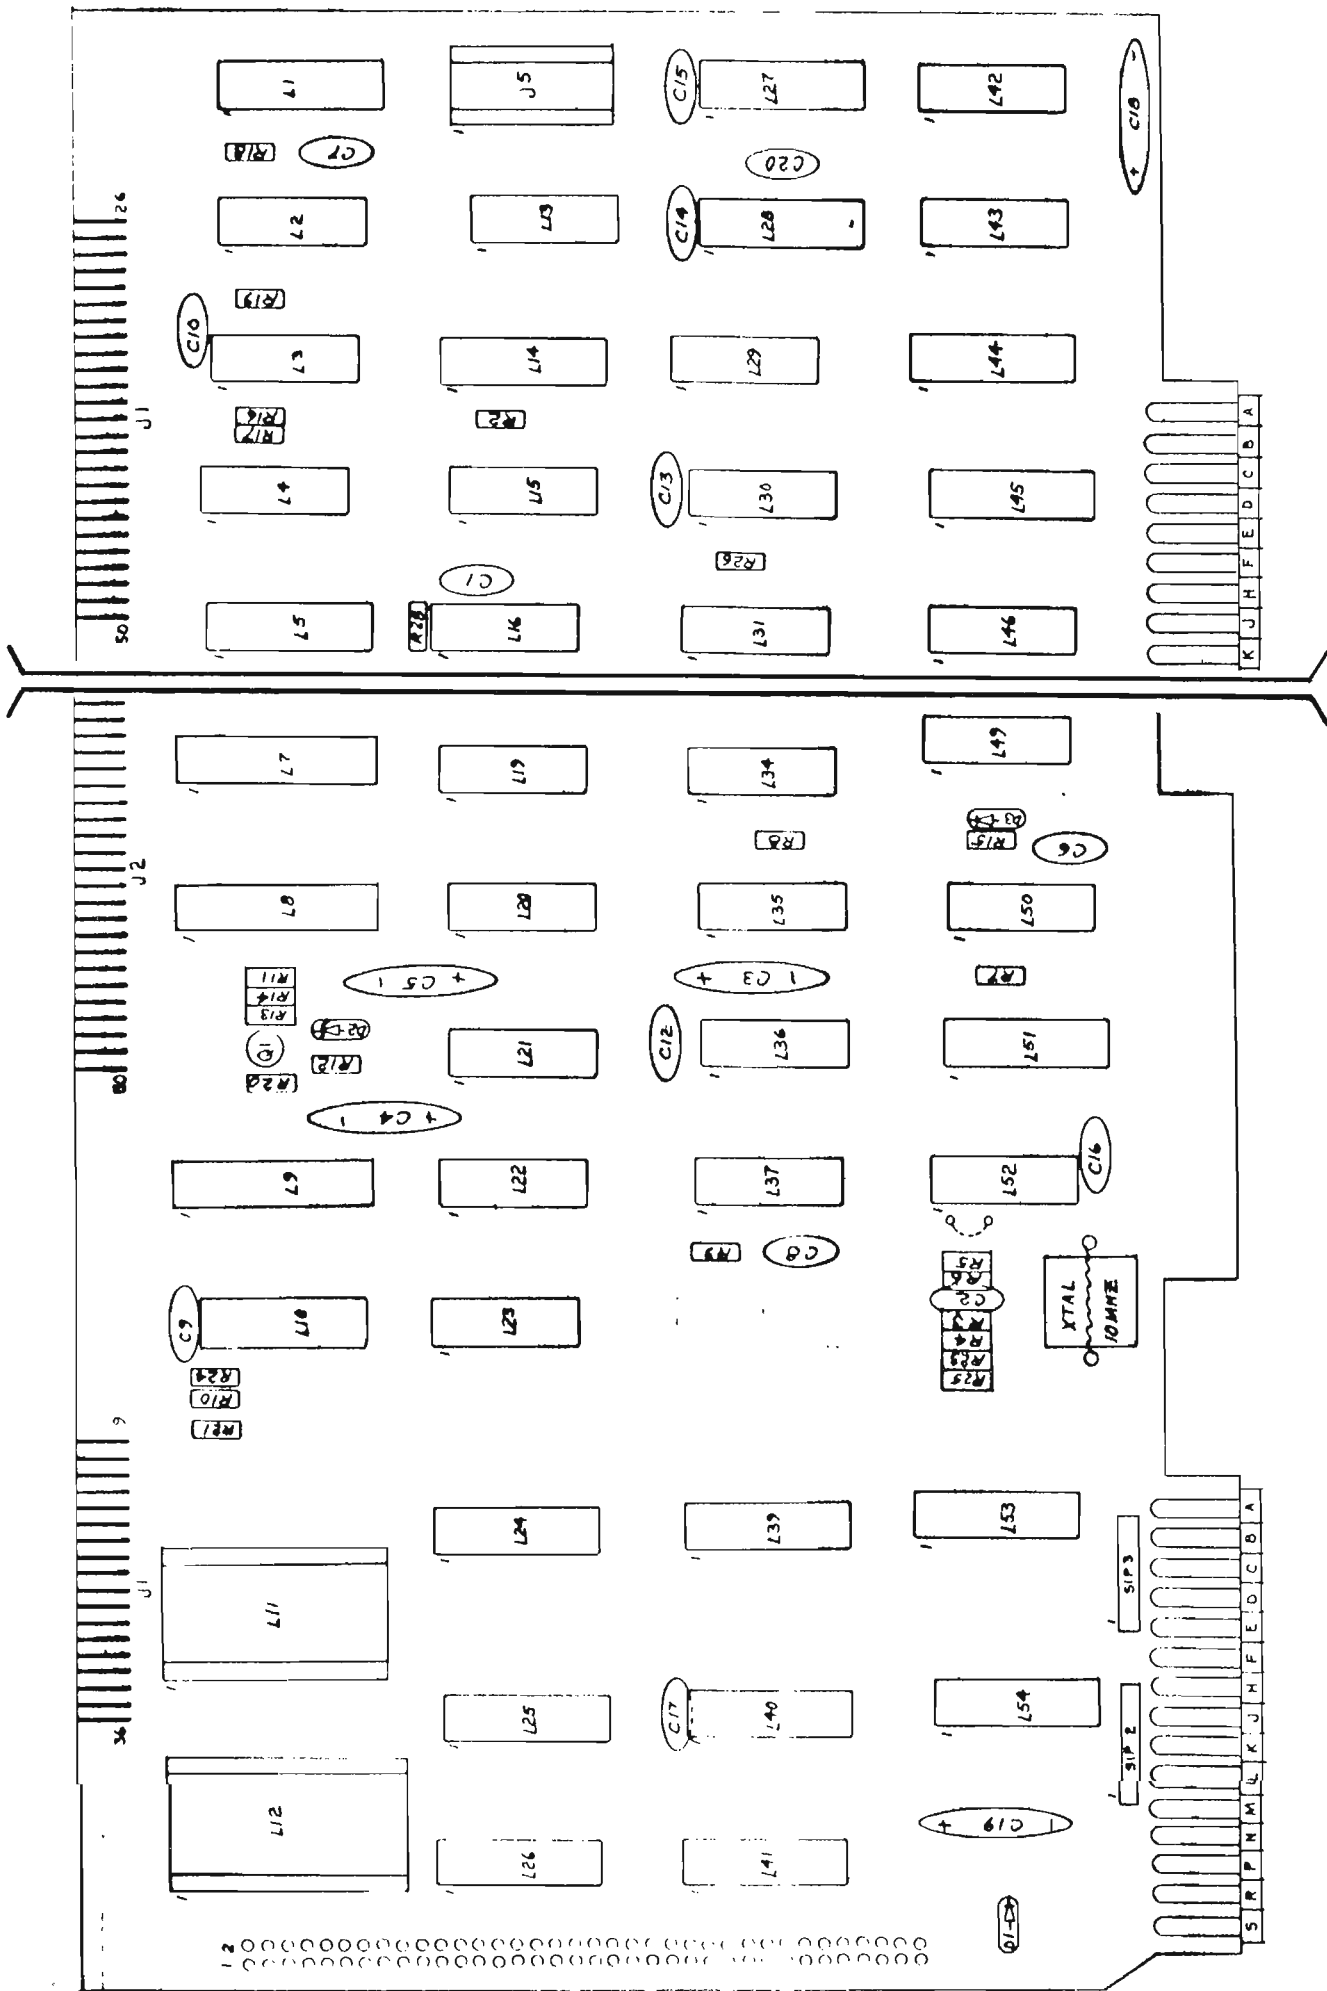
FIGURE 6 7488 BOARD

- 2) ECN #9500 - Change C1 from .01 uf to .002 uf (WL #300-1913). On the schematic diagram for this board, the capacitor can be found at coordinates 2F10 (Sheet 2, @ F10). Without this change, intermittent error 61's (I92) may occur. This ECN changes the 7488 E REV level from 0 to 1.

This ECN changes the 7488 E REV level from 1 to 2.

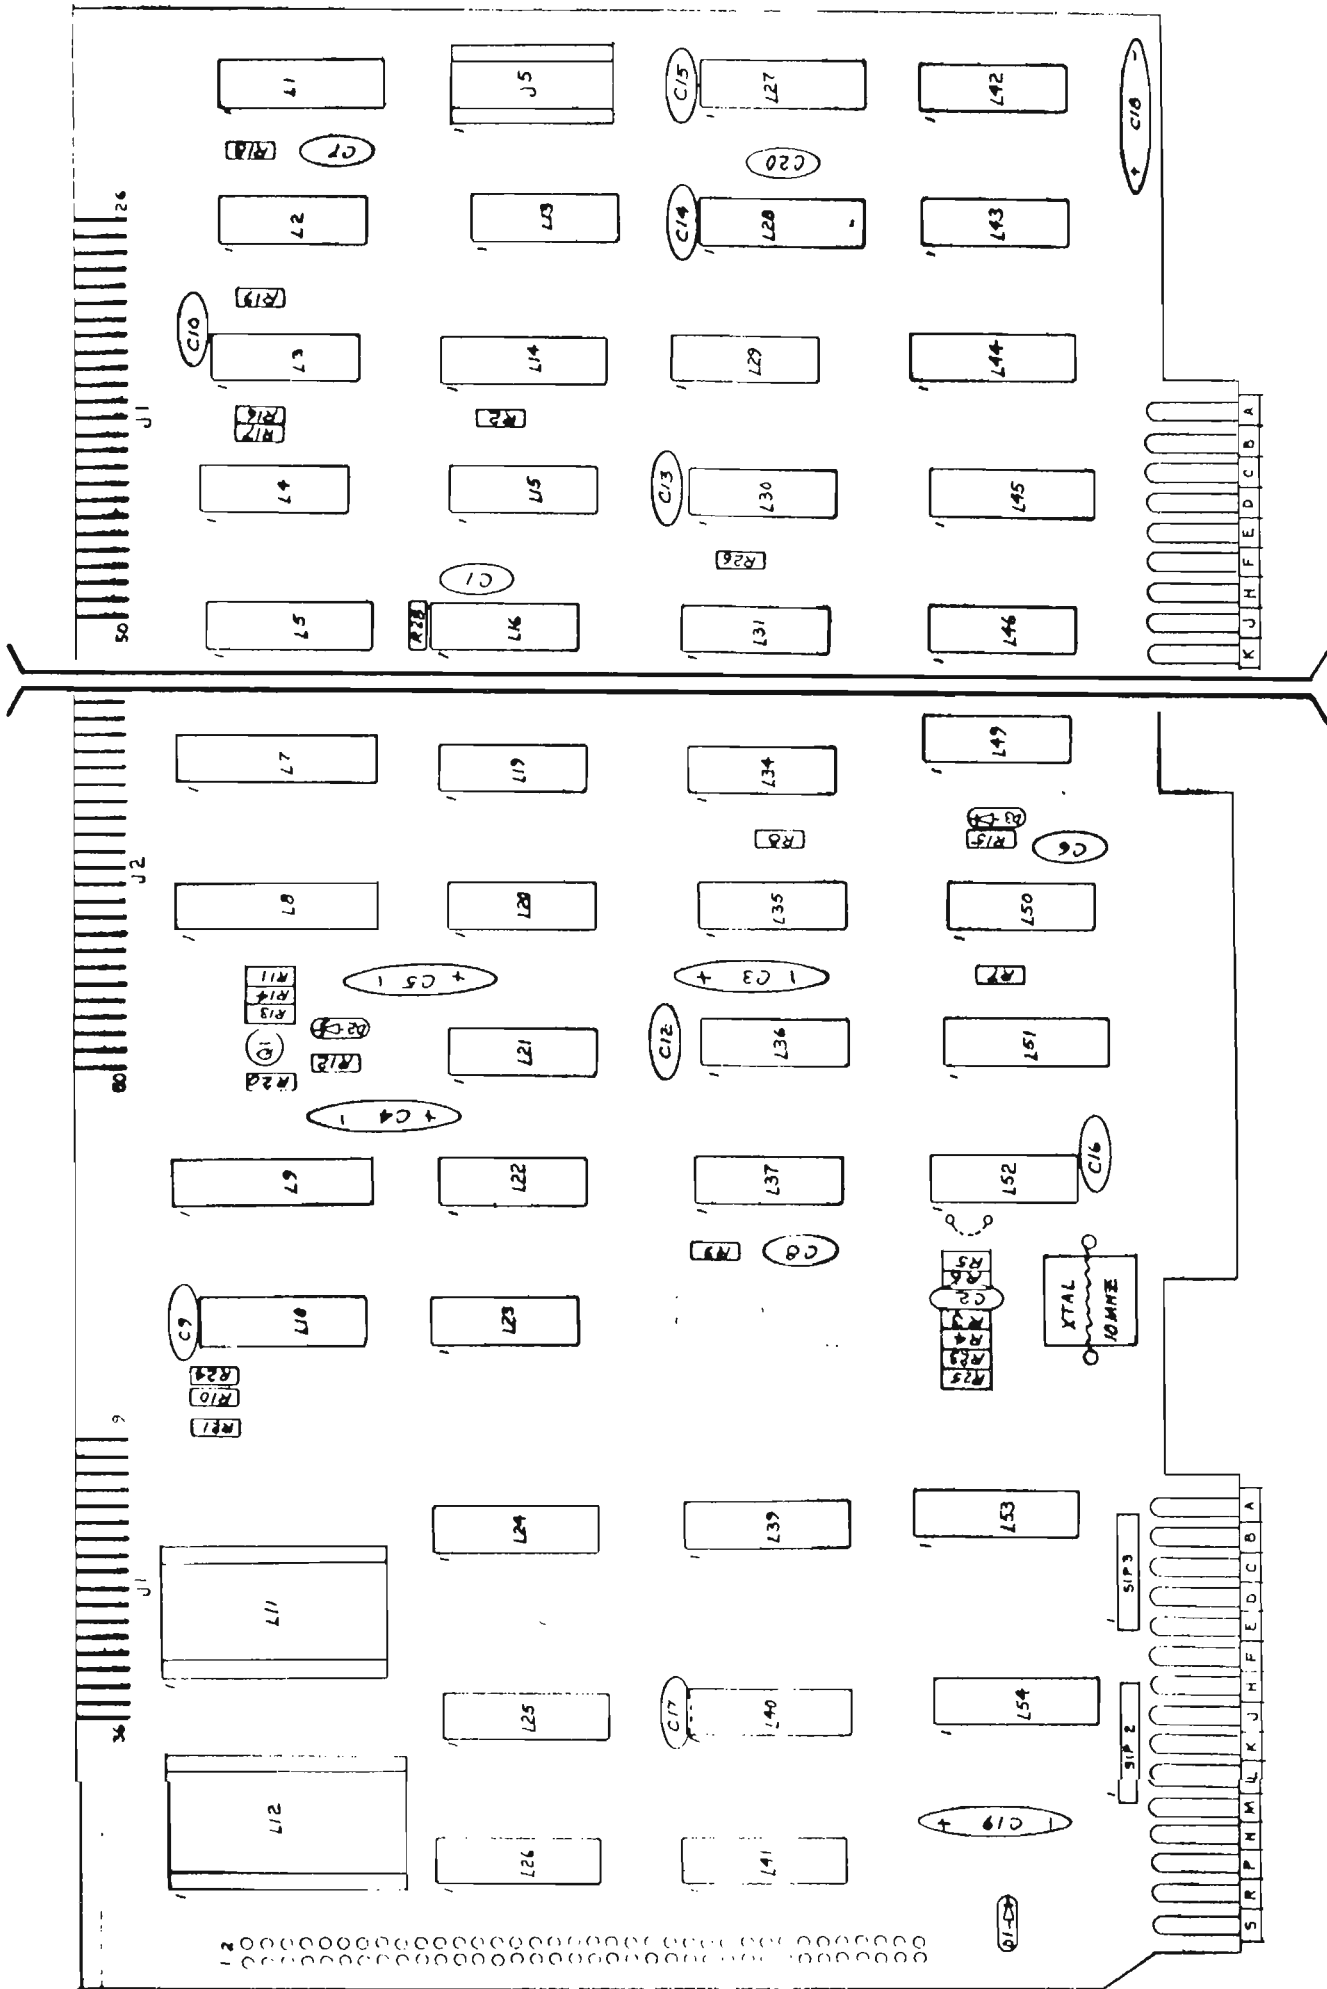
FIGURE 6 7488 BOARD

- 2) ECN #9500 - Change C1 from .01 uf to .002 uf (WL #300-1913). On the schematic diagram for this board, the capacitor can be found at coordinates 2F10 (Sheet 2, @ F10). Without this change, intermittent error 61's (I92) may occur. This ECN changes the 7488 E REV level from 0 to 1.

This ECN changes the 7488 E REV level from 1 to 2.
