2275MUX & 2275MUXE

2275MUX/MUXE DISK MULTIPLEXER

PART NO.	210-8824	DESCRIPTION	2275 MUX MASTER
DWG NO.	8824	PEP #	PEP# HU
MODEL NO.	2275 MUX	PEP #	
CLASS	I (11) III		PRIMARY

PART NO. 210-8824	DESCRIPTION 2275 MUX MASTER
DWG NO. 8824	PEP #
MODEL NO. 2275 MUX	
CLASS I	III

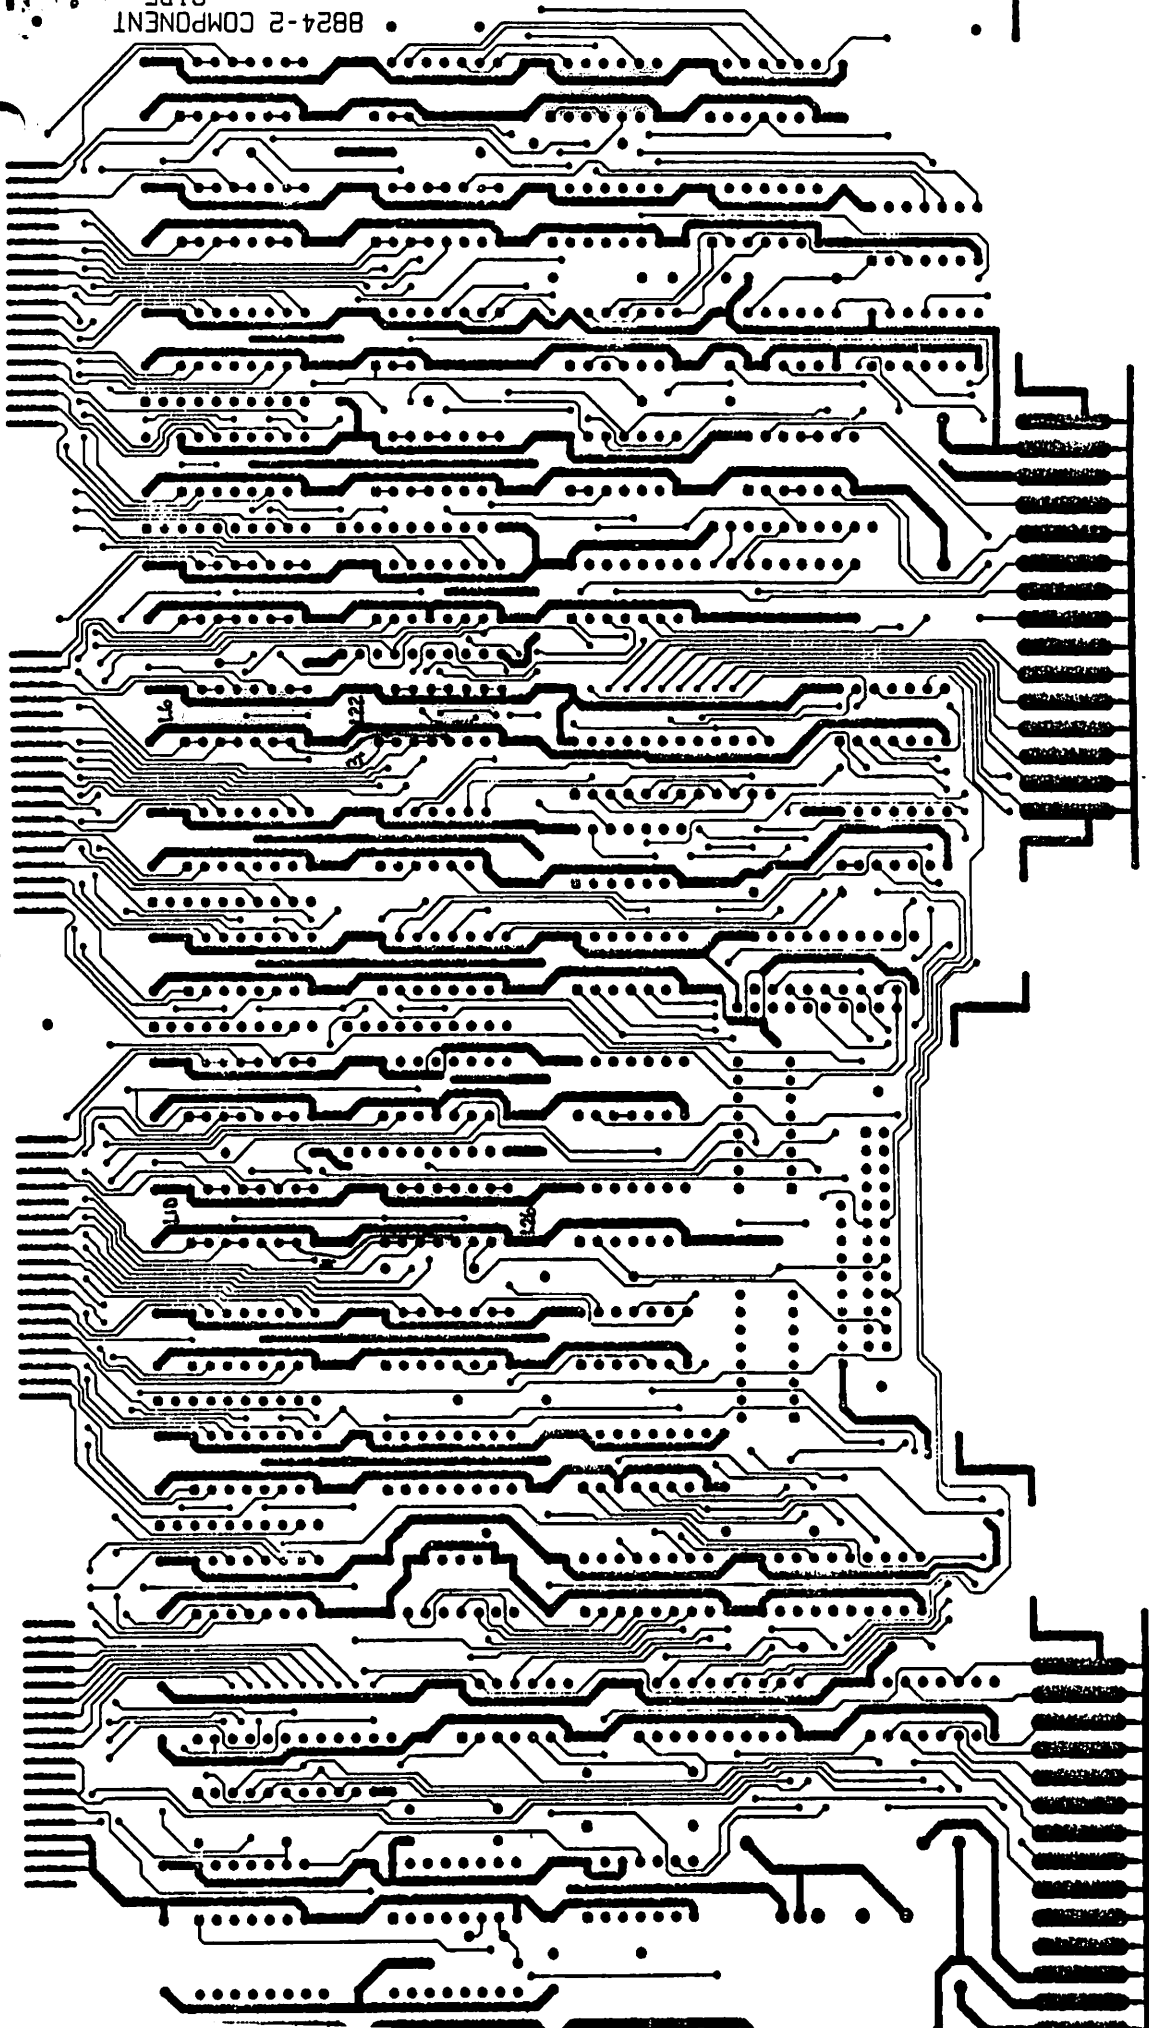
8824-2 COMPONENT SIDE

- To correct Artwork error on Artwork 2 Board.
- To correct SCHEMATIC

- Rework Artwork 2 Board as follows:
 On circuit side cut etch to L30 Pin 13 on both sides of Pin 13.
 Add wire from L31 Pin 10 to L33 Pin 5.
 On circuit side add wire from L2 Pin 9 to L18 Pin 5.
 On component side add wire from L6 Pin 7 to L22 Pin 5.
 On component side add wire from L10 Pin 7 to L26 Pin 5.
- Make following correction to schematic, sheet 3 of 3, loc C12:
 Line from L2 Pin 10 (3I2) should tie to line between L30 Pin 2 and L18 Pin 5 (3C12). It should not connect to L18 Pin 7 (3C12).

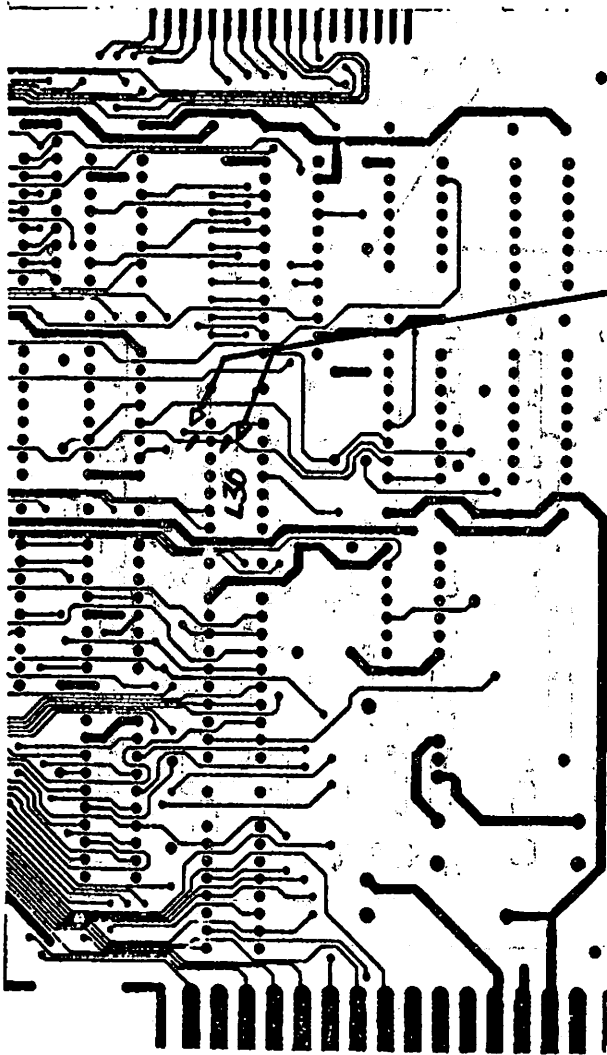
PAGE 2
CIRCUIT SIDE
ECO 58244
210-8824 R2

- To correct Artwork error on Artwork 2 Board.
- To correct SCHEMATIC.

1.) CUT ETCH ON BOTH SIDES
OF L30-13.

2.) ADD WIRE FROM
L10-7 TO L26-5.

3.) ADD WIRE FROM
L6-7 TO L22-5.

4.) ADD WIRE FROM
L2-9 TO L18-5.
