TECHNICAL NOTE #2605

Author: 2200 Development Group
Date: March 26, 1979
Subject: 2280 Disk Drives

TECHNICAL SERVICE BULLETIN
SECTION: HardWare Technical

NUMBER: HWT 5160 REPLACES: _____ DATE: 08/13/85 PAGE 1 OF 1
MATRIX ID. 3107 PRODUCT/RELEASE# 2200 Disk Function
TITLE: FCO 1168, 2280 DPU/MUX

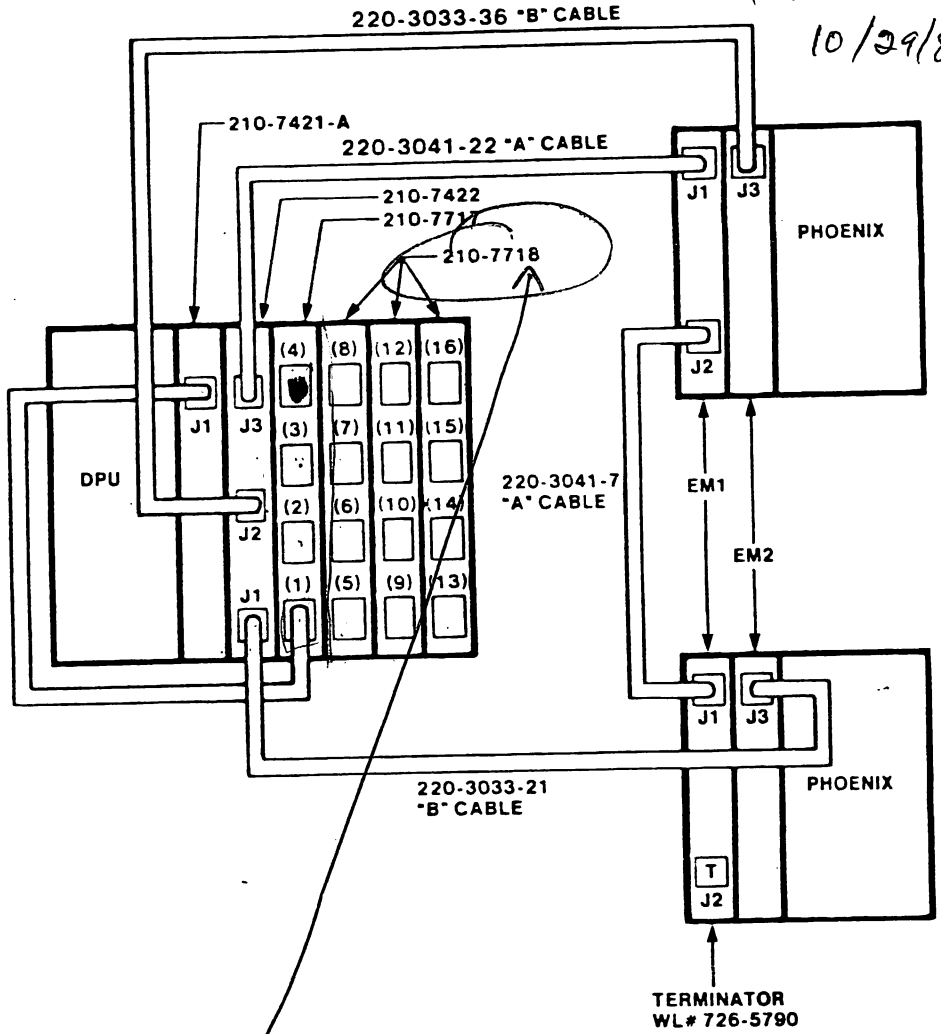
NOTE: UP TO 15 CPU'S CAN BE MUXED INTO THE DPU.

EXCESSIVE STATIC } PER GEN. MANTON BEYOND 3 CPU'S.

FIELD SERVICE WILL NOT SUPPORT BEYOND 3 CPUS/48WS.

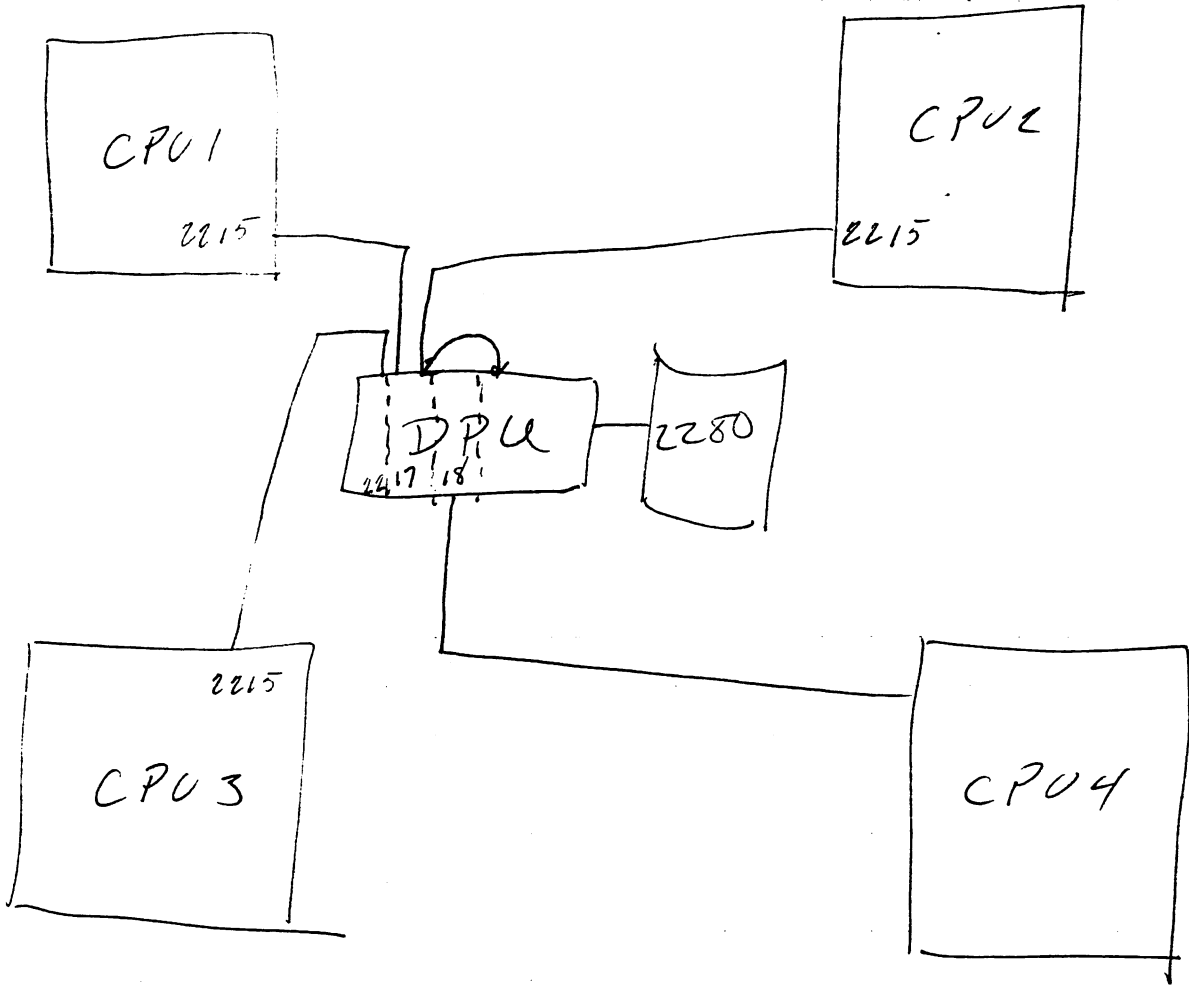
Figure 2-13. MUX System Interconnection Diagram

7717 3 CPUs
1 DPU Port

210- 7718 4 CPUs Ports

2280 DPU MUX 1st 7717
MAX Configuration 3rd 7718

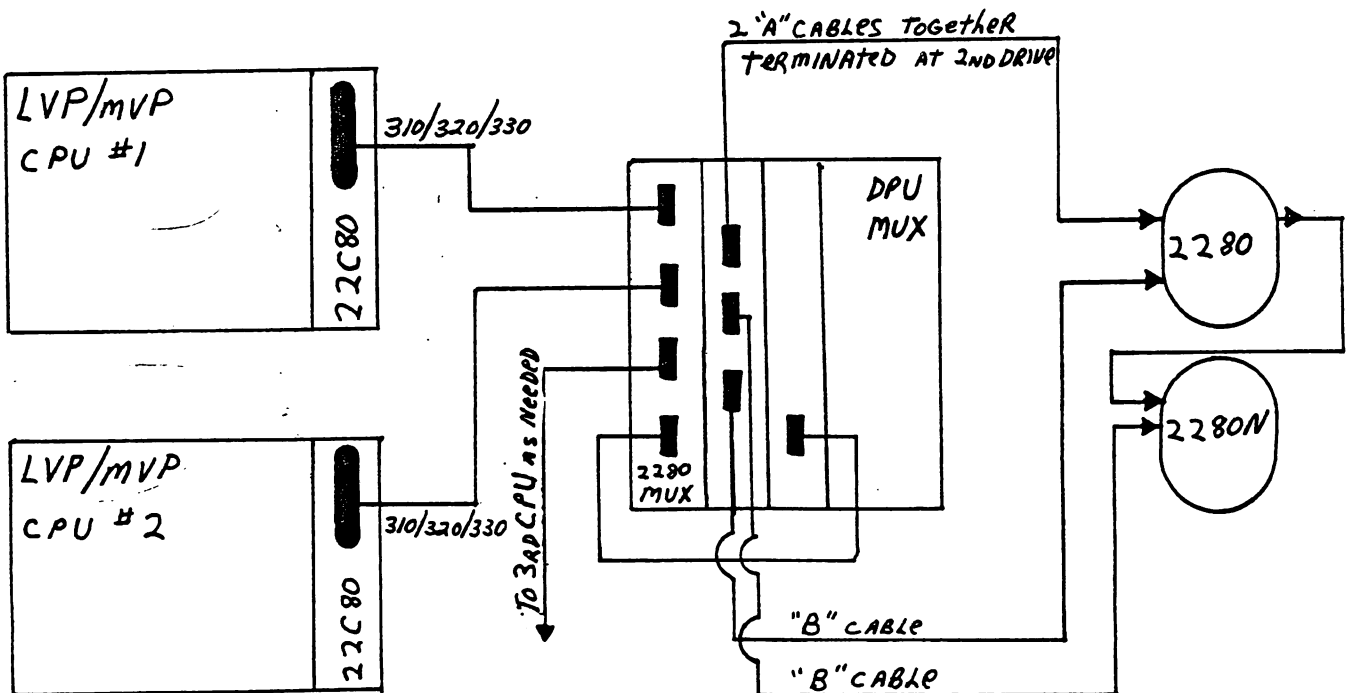
DAISY CHAIN CONFIGURATION AS SHOWN ON DATA SHEET

DAISY CHAINING WILL ADD A Hex (40) TO THE PRIMARY DEVICE ADDRESS. IF SET UP 310/320/330 THE 2ND DRIVE WOULD BE 350/360/370.
