TECHNICAL NOTE #2605

Author: 2200 Development Group
Date: March 26, 1979
Subject: 2280 Disk Drives

NUMBER: HWT 5160 REPLACES: _____ DATE: 08/13/85 PAGE 1 OF 1
MATRIX ID. 3107 PRODUCT/RELEASE# 2200 Disk Function
TITLE: FCO 1168, 2280 DPU/MUX

TITLE: Phoenix Door Assembly Repair

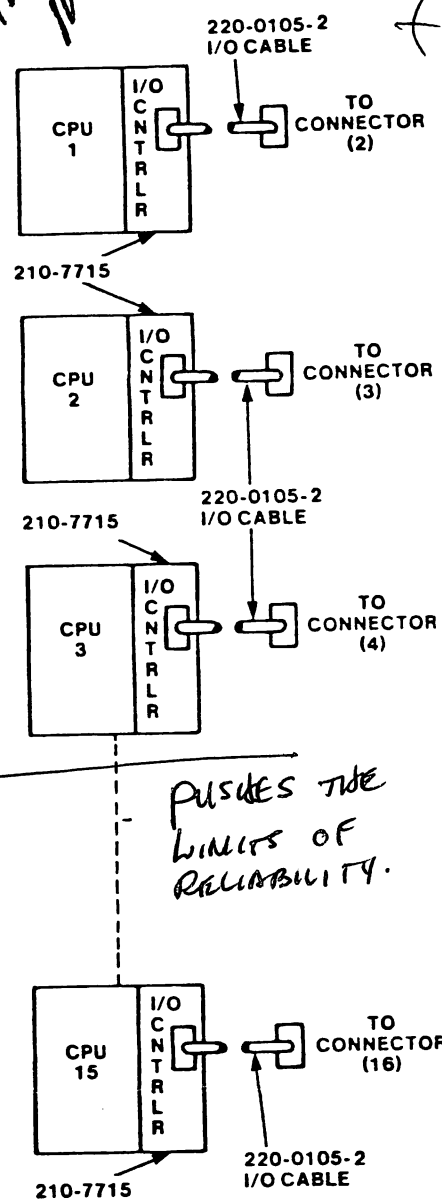
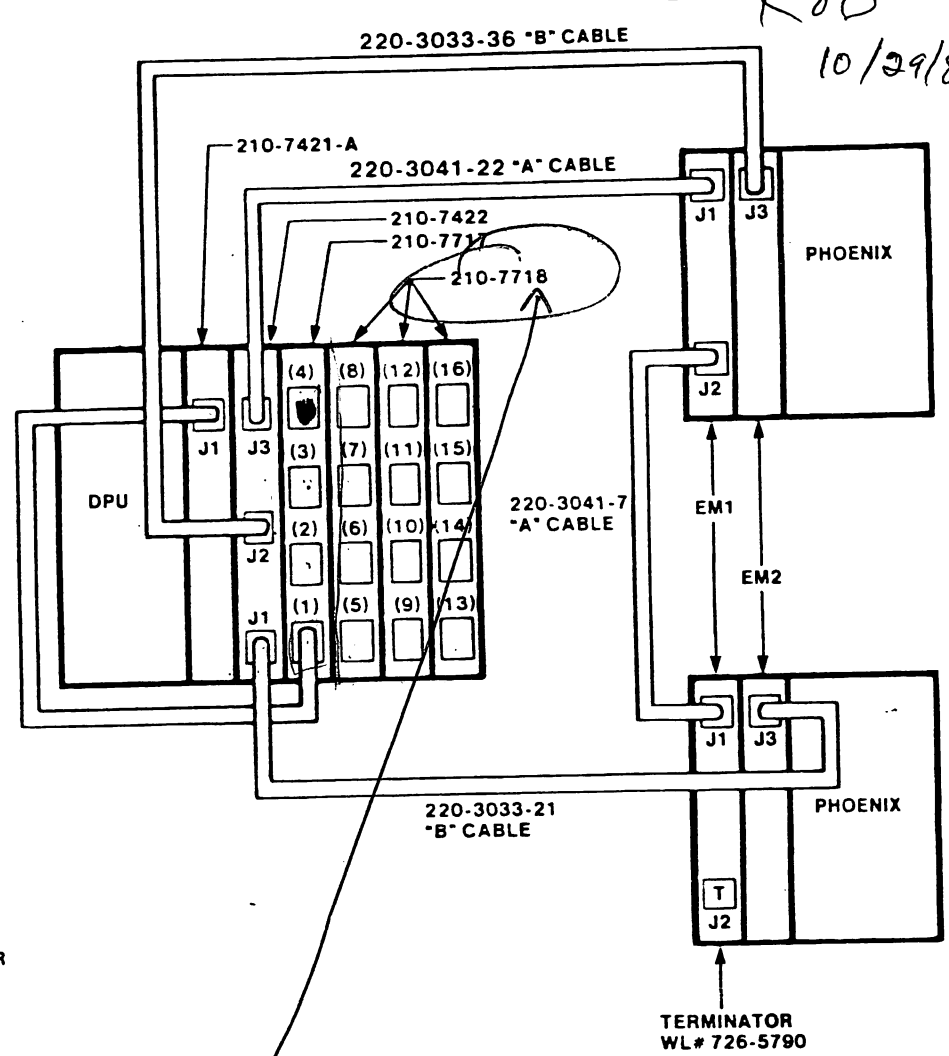
Figure 2-13. MUX System Interconnection Diagram

PUSHES THE LIMITS OF RELIABILITY.

NOTE: UP TO 15 CPU'S CAN BE MUXED INTO THE DPU.

EXCESSIVE STATIC } PER GEN. MANTON BEYOND 3 CPU'S.

FIELD SERVICE WILL NOT SUPPORT BEYOND 3 CPUS/48WS.
