WANG MANUFACTURING
TEST PROCEDURE

310-8826-A

2200 SERIES DS DPU BOARD

2 IN-SYSTEMS TEST

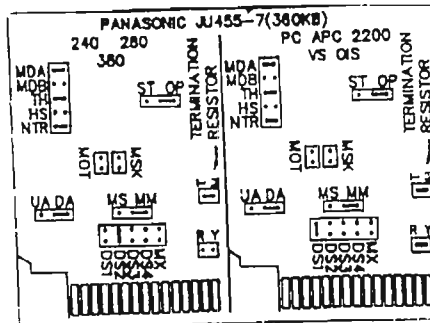
PANASONIC JU-455-7

RY MUST BE IN, OTHERWISE
WHEN CHANGE DISKETTS, CACHE IS
NOT CLEARED. WHEN LIST 1
DISK IS ANOTHER, STILL SEE
1ST DISK.

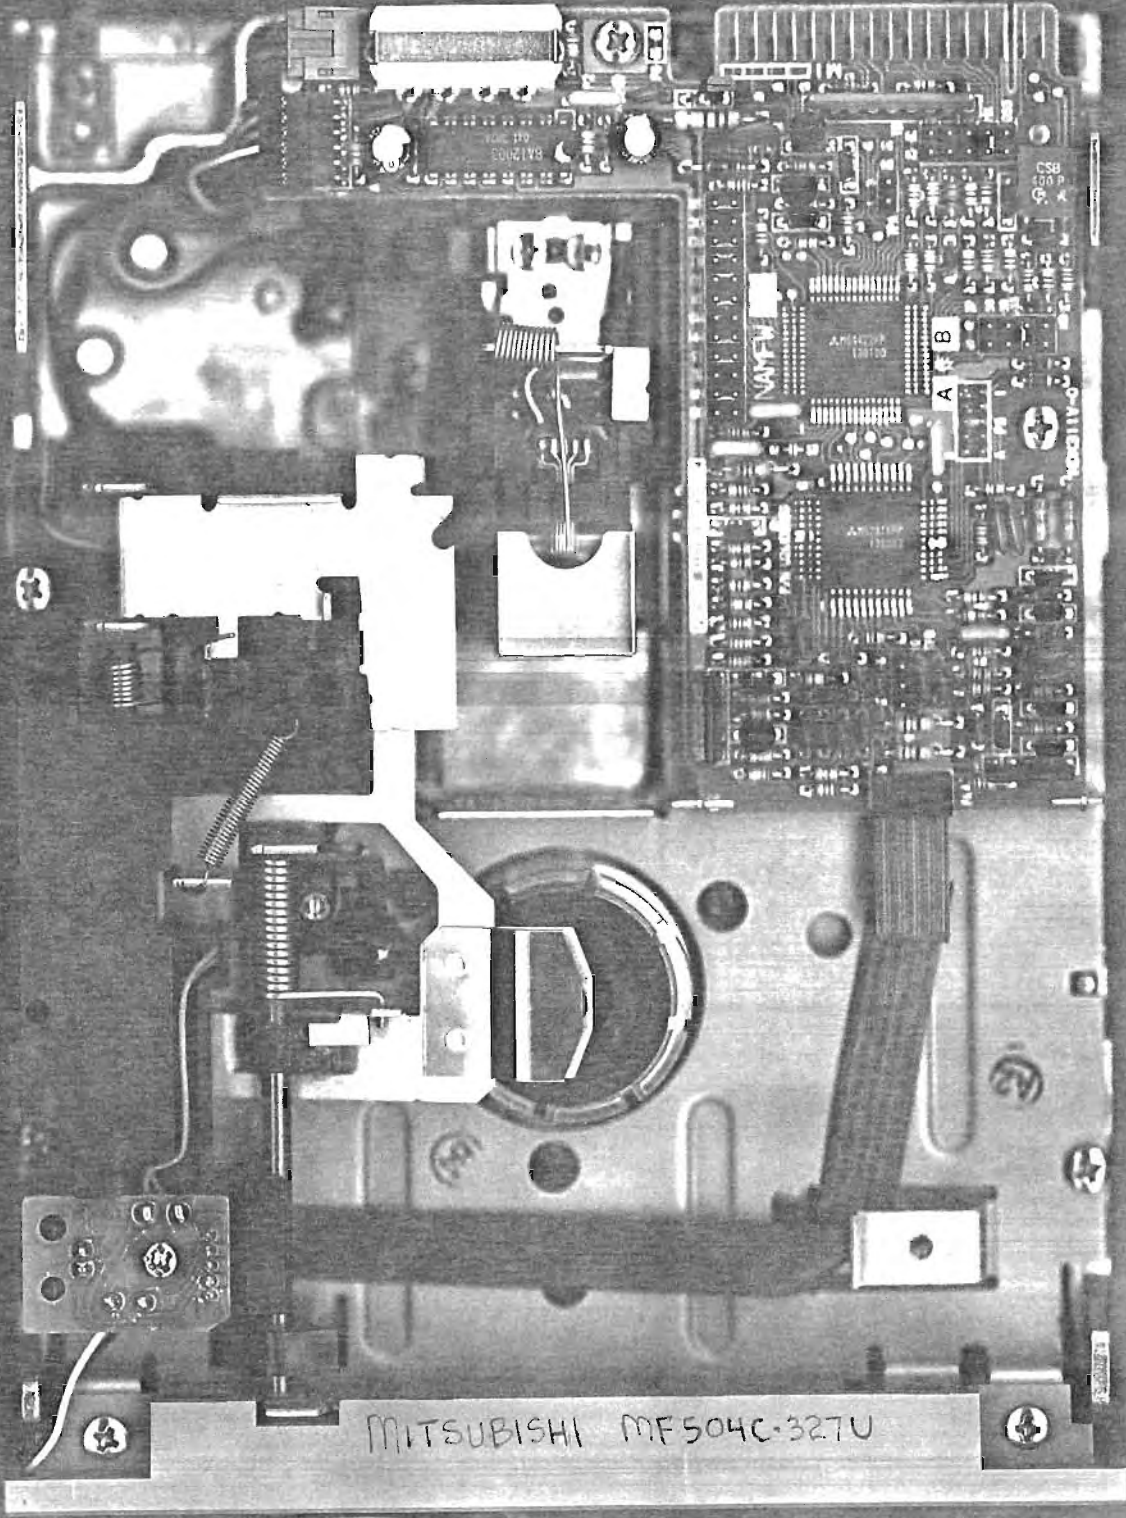
MITSUBISHI MF504C-327U
 FOR V55000 RCU SW2 #16 MUST BE OPEN CLOSED FOR PINS
 C.M.L.Z.L.U.C. VER. 1.06.03 OF HIGHBA

4609X-N74 SIP
TERMINATOR

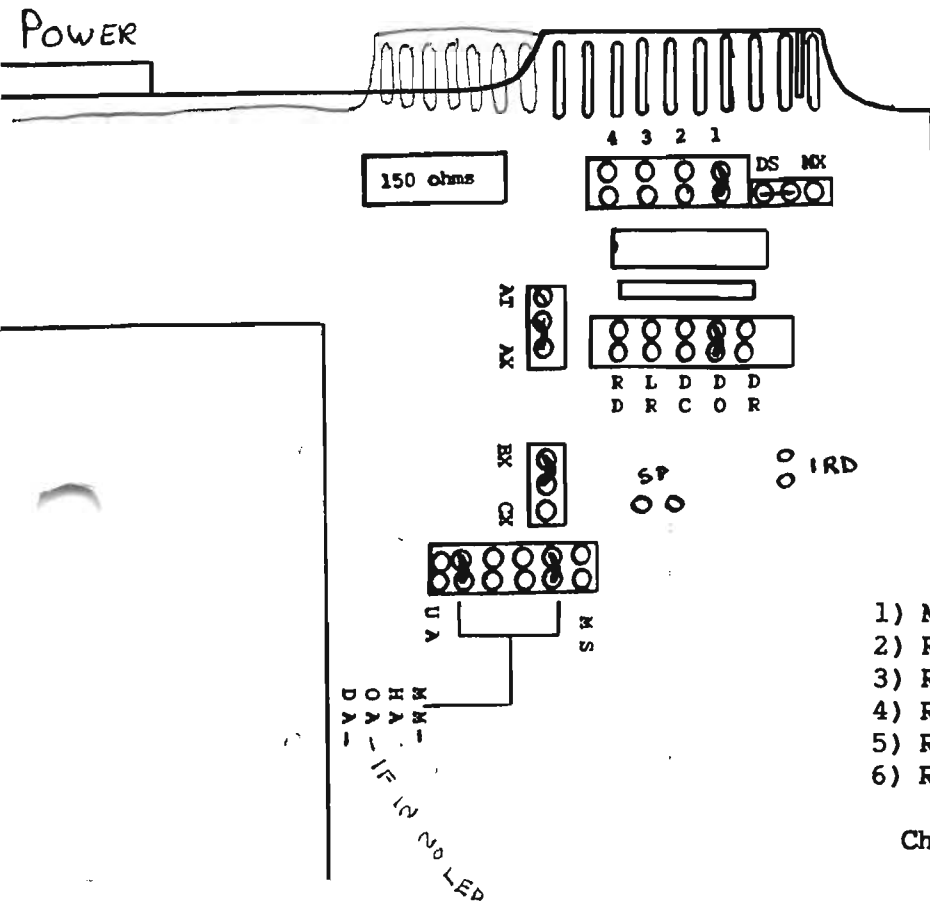
VISUAL AIDS: Amber led - no snowflake / also: PCB IS 1/2 THE NORMAL SIZE.

DRIVE SAYS 1.2 ON FRONT

- 1) Move jumper from "DS 2" to "DS 1"
- 2) Remove "DR" jumper
- 3) Remove "SP" jumper
- 4) Remove "DC" jumper / install "DO" jumper
- 5) Remove "AT" jumper / install "AX" jumper
- 6) Remove "CX" jumper / install "BX" jumper

Check that "MM" and "DA" are jumped

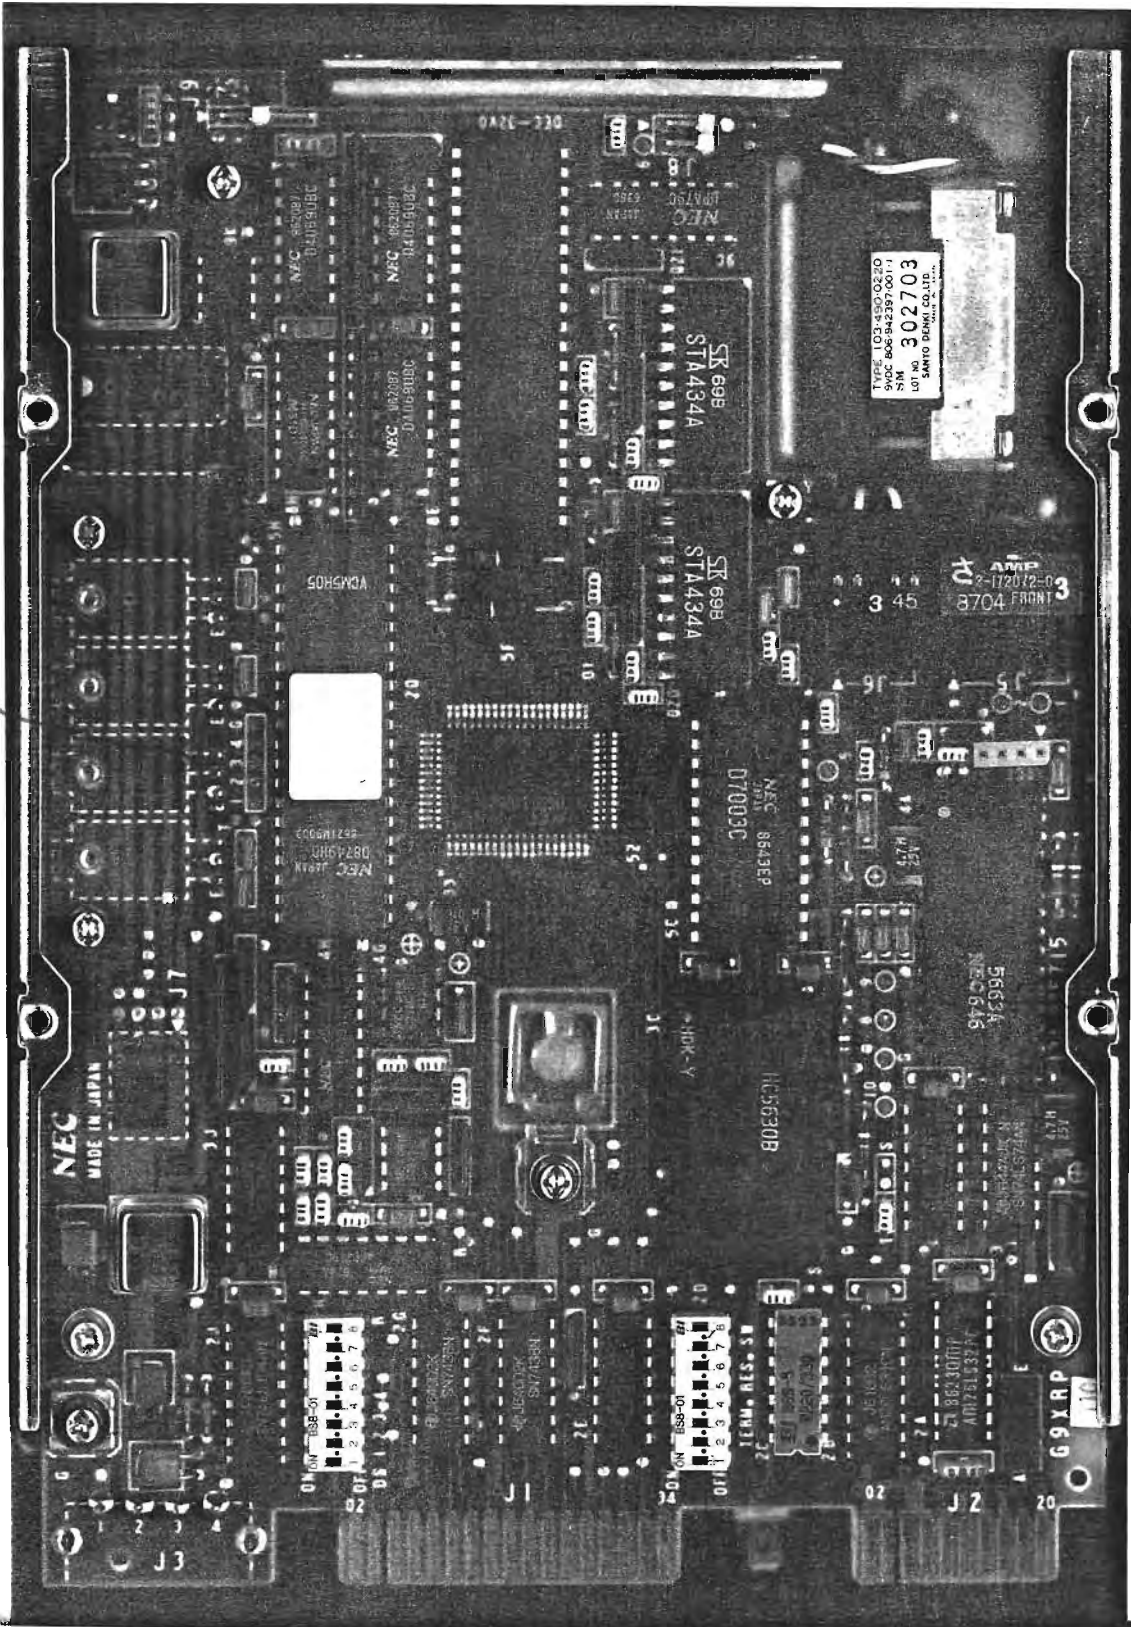
NEC D5126 20 MEG 278-4062

1 2 3 4 G (ALL OPEN)

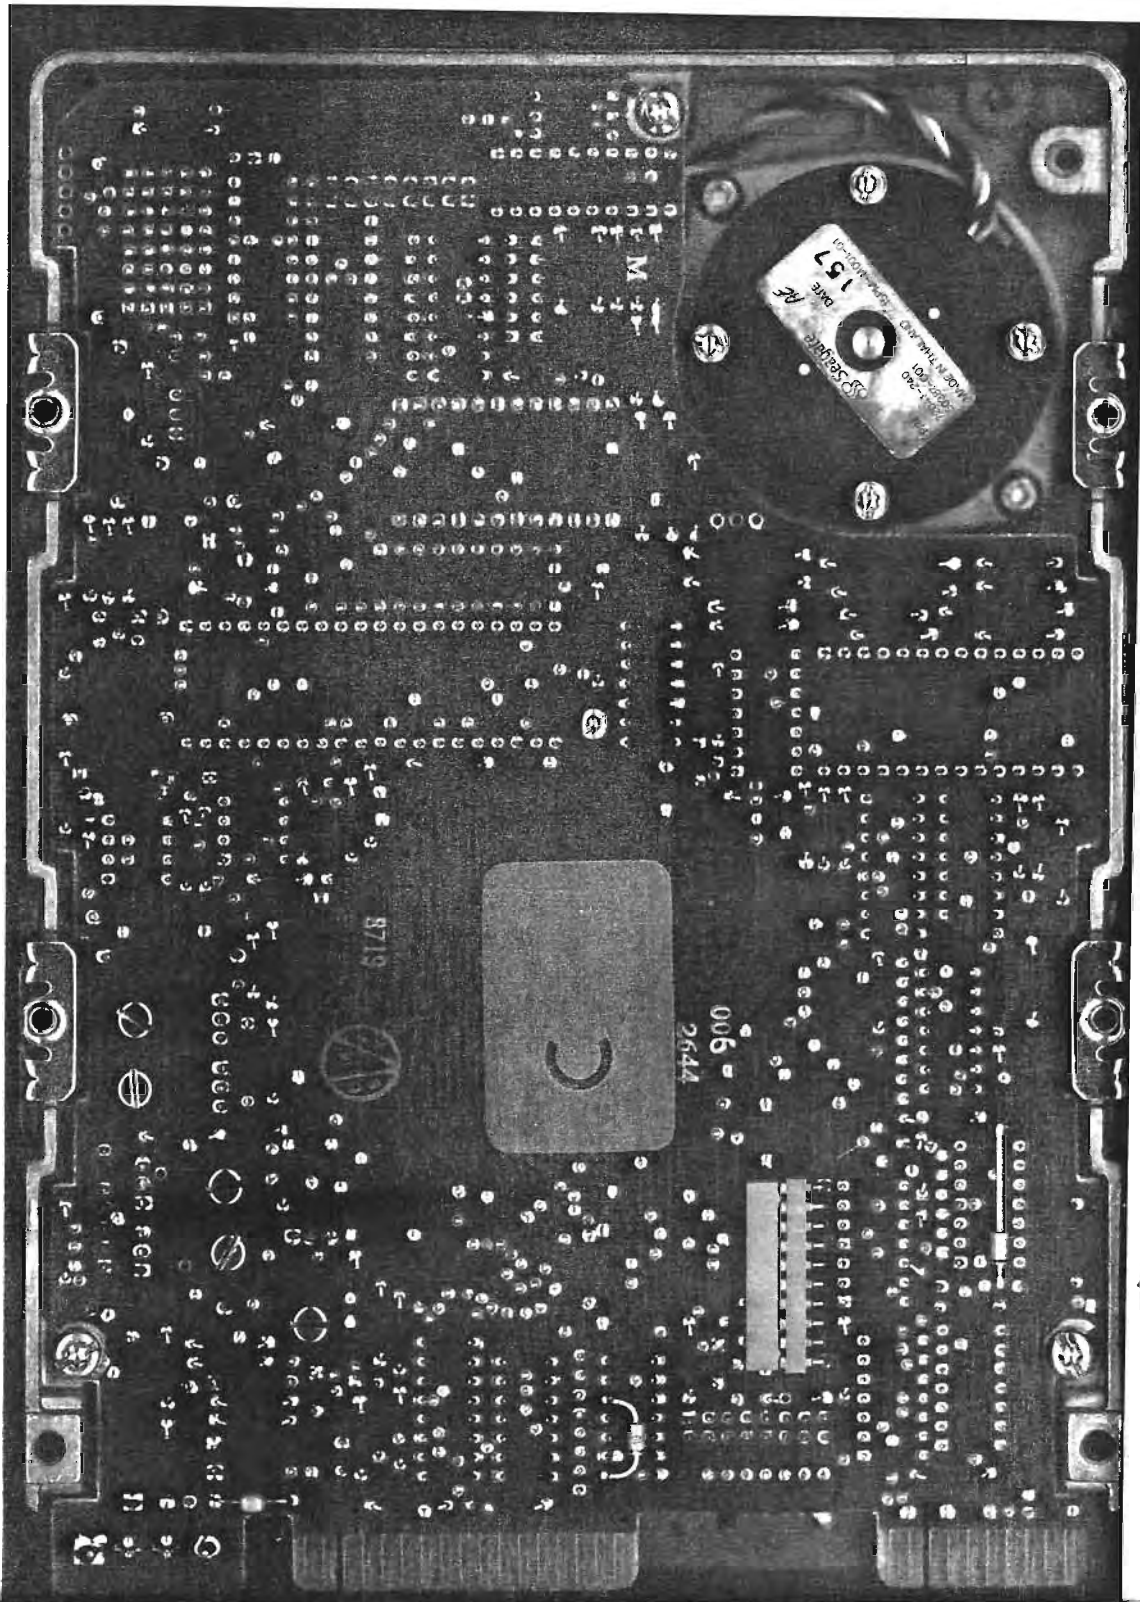
SEAGATE ST-225 20MEG 725-0242

↑
TERMINATION
ALL ON TO TERMINATE
ALL OFF OTHERWISE
