PUBLICATION UPDATE BULLETIN

This Publication Update Bulletin (PUB) documents the phase-lock-loop (PLL) adjustment procedure for the 210-8694/8794 board in the 2200LVP/SVP Disk Processing Unit (DPU). The adjustment procedure in this PUB supercedes the one in Section 11.3 of the Model 2200LVP Product Maintenance Manual (729-0602-A). This PUB also serves as an addendum to the 2200SVP Product Maintenance Manual (729-0935-A).

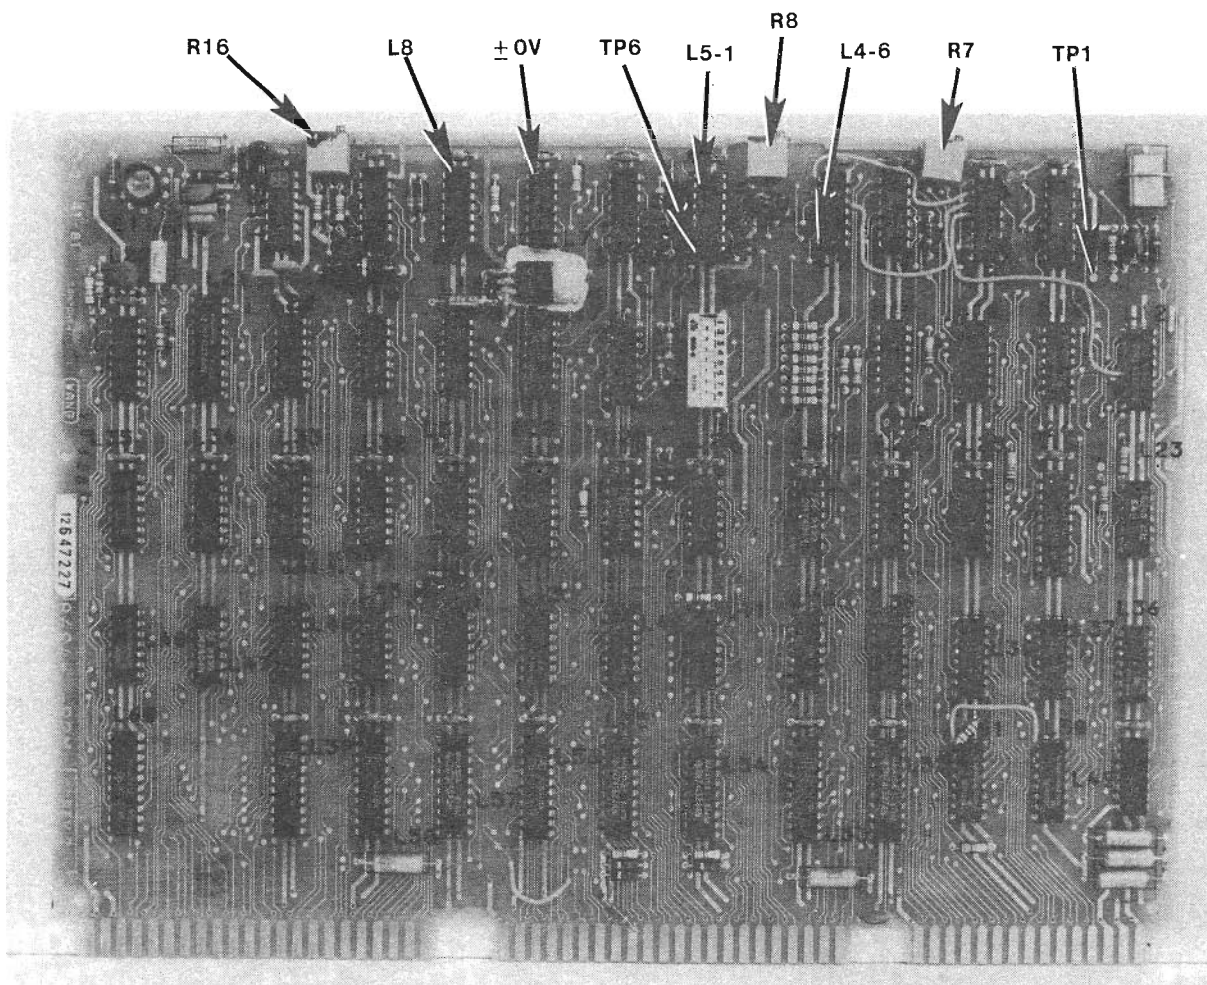
FIGURE 1 WL NO. 210-8694 TEST POINTS AND POTENTIOMETERS

1. Using a jumper wire, connect TP1 (Test Point #1) to +0V (GND).
2. Set the DVM (or oscilloscope) controls to measure +4.00V dc.
3. Connect the DVM (or oscilloscope) ground probe to +0V (GND).
4. Connect the DVM (or oscilloscope) signal probe to L5 pin 1 or 2.
5. Adjust potentiometer R16 for a +4.00V dc indication.
6. Carefully remove the jumper wire from TP1.
7. Connect both oscilloscope probe ground leads to +0V (GND).
8. Connect oscilloscope Channel 1 (or A) probe to L8 pin 11 (phase detector reference clock).
9. Connect oscilloscope Channel 2 (or B) probe to L4 pin 6 (voltage controlled oscillator-VCO-output).

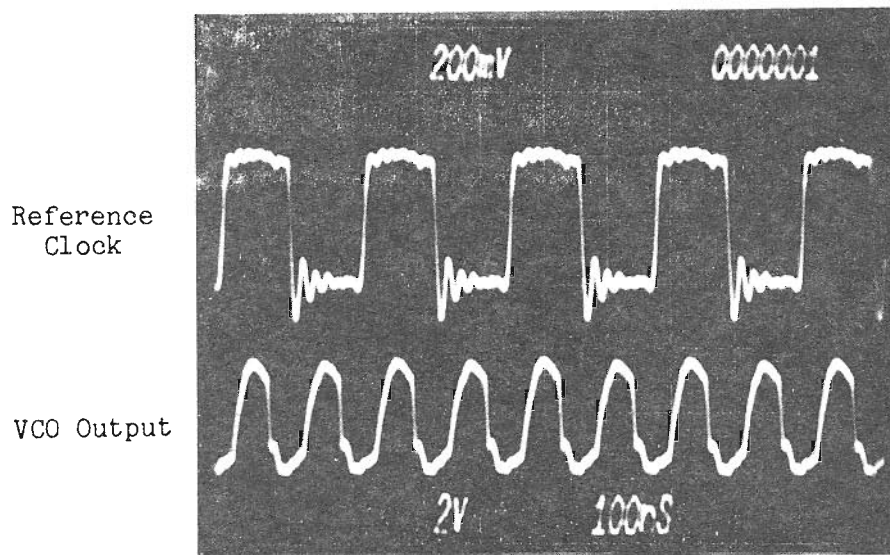
FIGURE 2 PLL CORRECTLY ADJUSTED FOR WINCHESTER DISK DRIVE

- b. Turn R7 slowly clockwise until the VCO output signal (Channel 2 or Channel B) is stable--not free running.
- c. Continue adjusting R7 clockwise until all the VCO output pulses are centered with respect to the phase detector reference clock pulses (see figure 2). When this condition occurs, the PLL is "locked". When the output pulses are centered, the VCO output pulse period will be approximately 0.115 usec (figure 2).

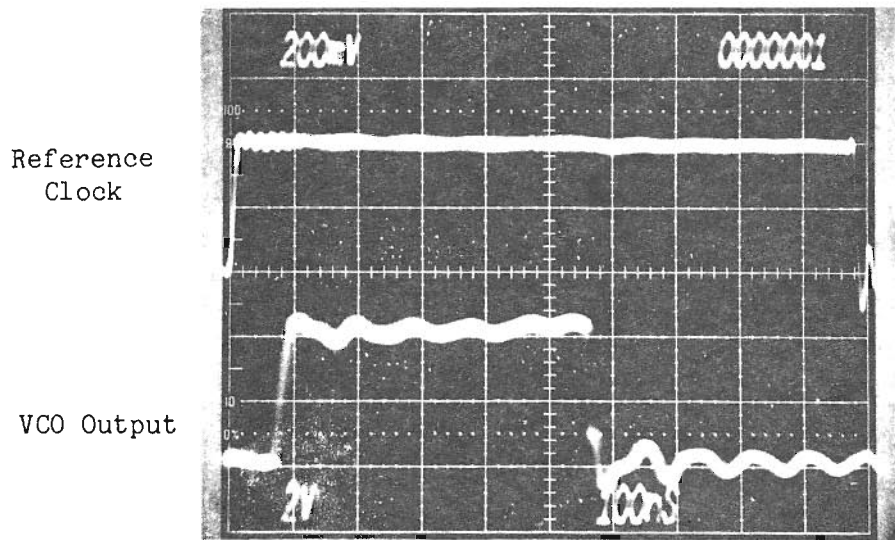
FIGURE 5 PLL CORRECTLY ADJUSTED FOR DISKETTE DRIVE

14. Select the diskette drive frequency by connecting a jumper between TP6 and +0V (GND).
15. Slowly adjust potentiometer R8 (diskette drive adjustment) until the leading edge of the VCO output pulse (Channel 2) occurs 0.075 usec after the leading edge of the phase detector reference clock as shown in figure 5. Figures 6 and 7 show incorrect VCO output signals.

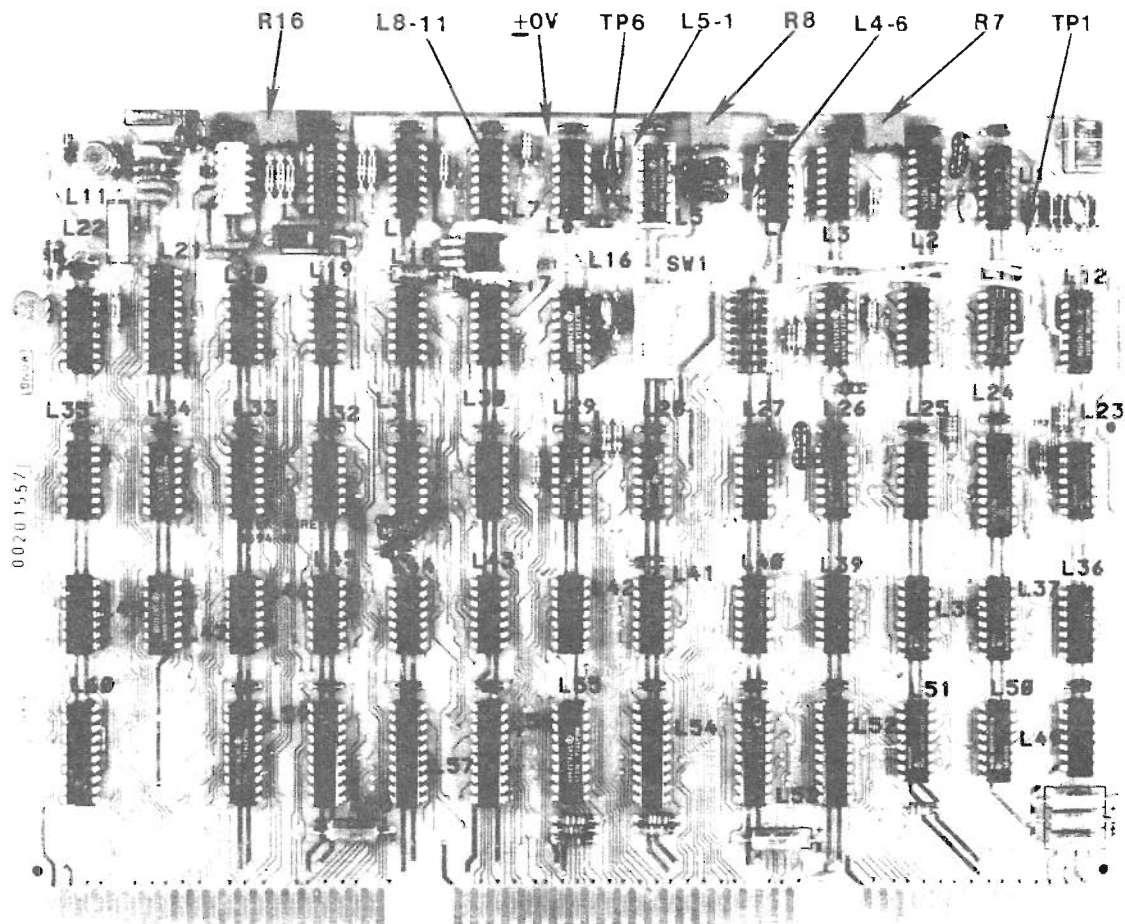
FIGURE 1 WL NO. 210-8694 TEST POINTS AND POTENTIOMETERS

NOTE: TP6 IS L6-9 ON 210-7694 BOARD

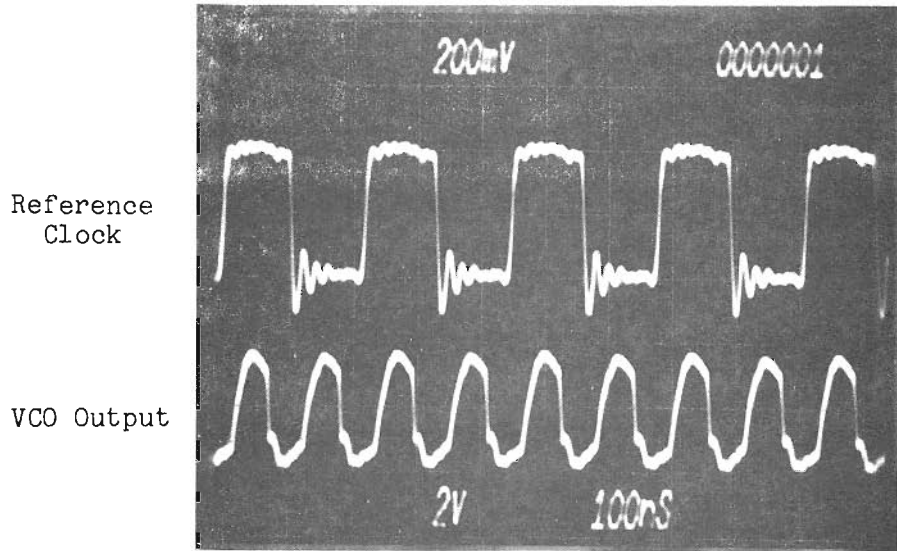
FIGURE 2 PLL CORRECTLY ADJUSTED FOR WINCHESTER DISK DRIVE

10. Turn potentiometer R7 (Winchester drive adjustment) completely counterclockwise, and then slowly adjust R7 clockwise until the VCO output signal (Channel 2) is stable--not free running. Continue adjusting R7 until all the VCO output pulses are centered with respect to the phase detector reference clock pulses (ref: FIGURE 2). When this condition occurs, the PLL is said to be "locked". When the output pulses are centered, the signal will have a period of approximately 0.115 usec (ref: FIGURE 2). FIGURE 3 shows an incorrect VCO output signal. Note that the higher frequency of the VCO output in the figure results in an extra pulse (ten instead of nine) in the VCO output.

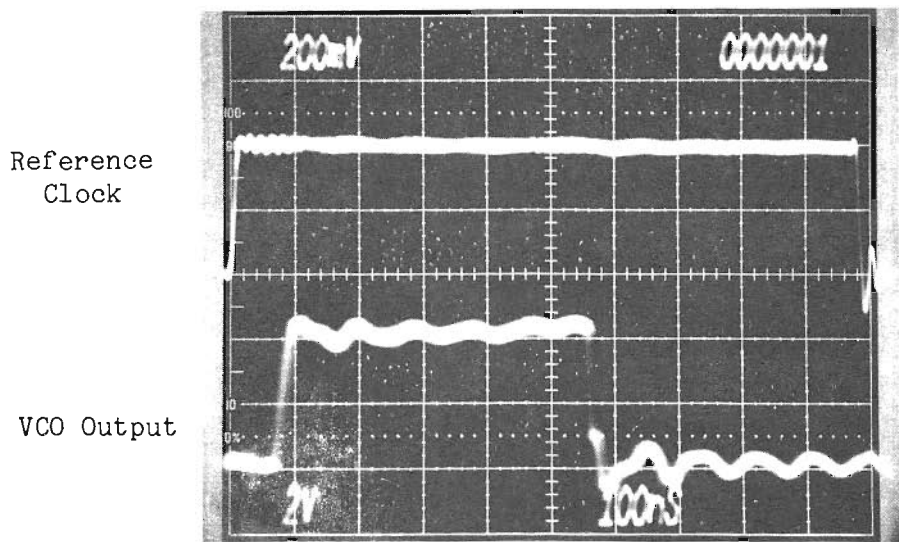
FIGURE 5 PLL CORRECTLY ADJUSTED FOR DISKETTE DRIVE

14. Slowly adjust potentiometer R8 (diskette drive adjustment) until the leading edge of the VCO output pulse (Channel 2) occurs 0.075 usec after the leading edge of the phase detector reference clock (ref: FIGURE 5). FIGURE 6 and FIGURE 7 show incorrect VCO output signals.

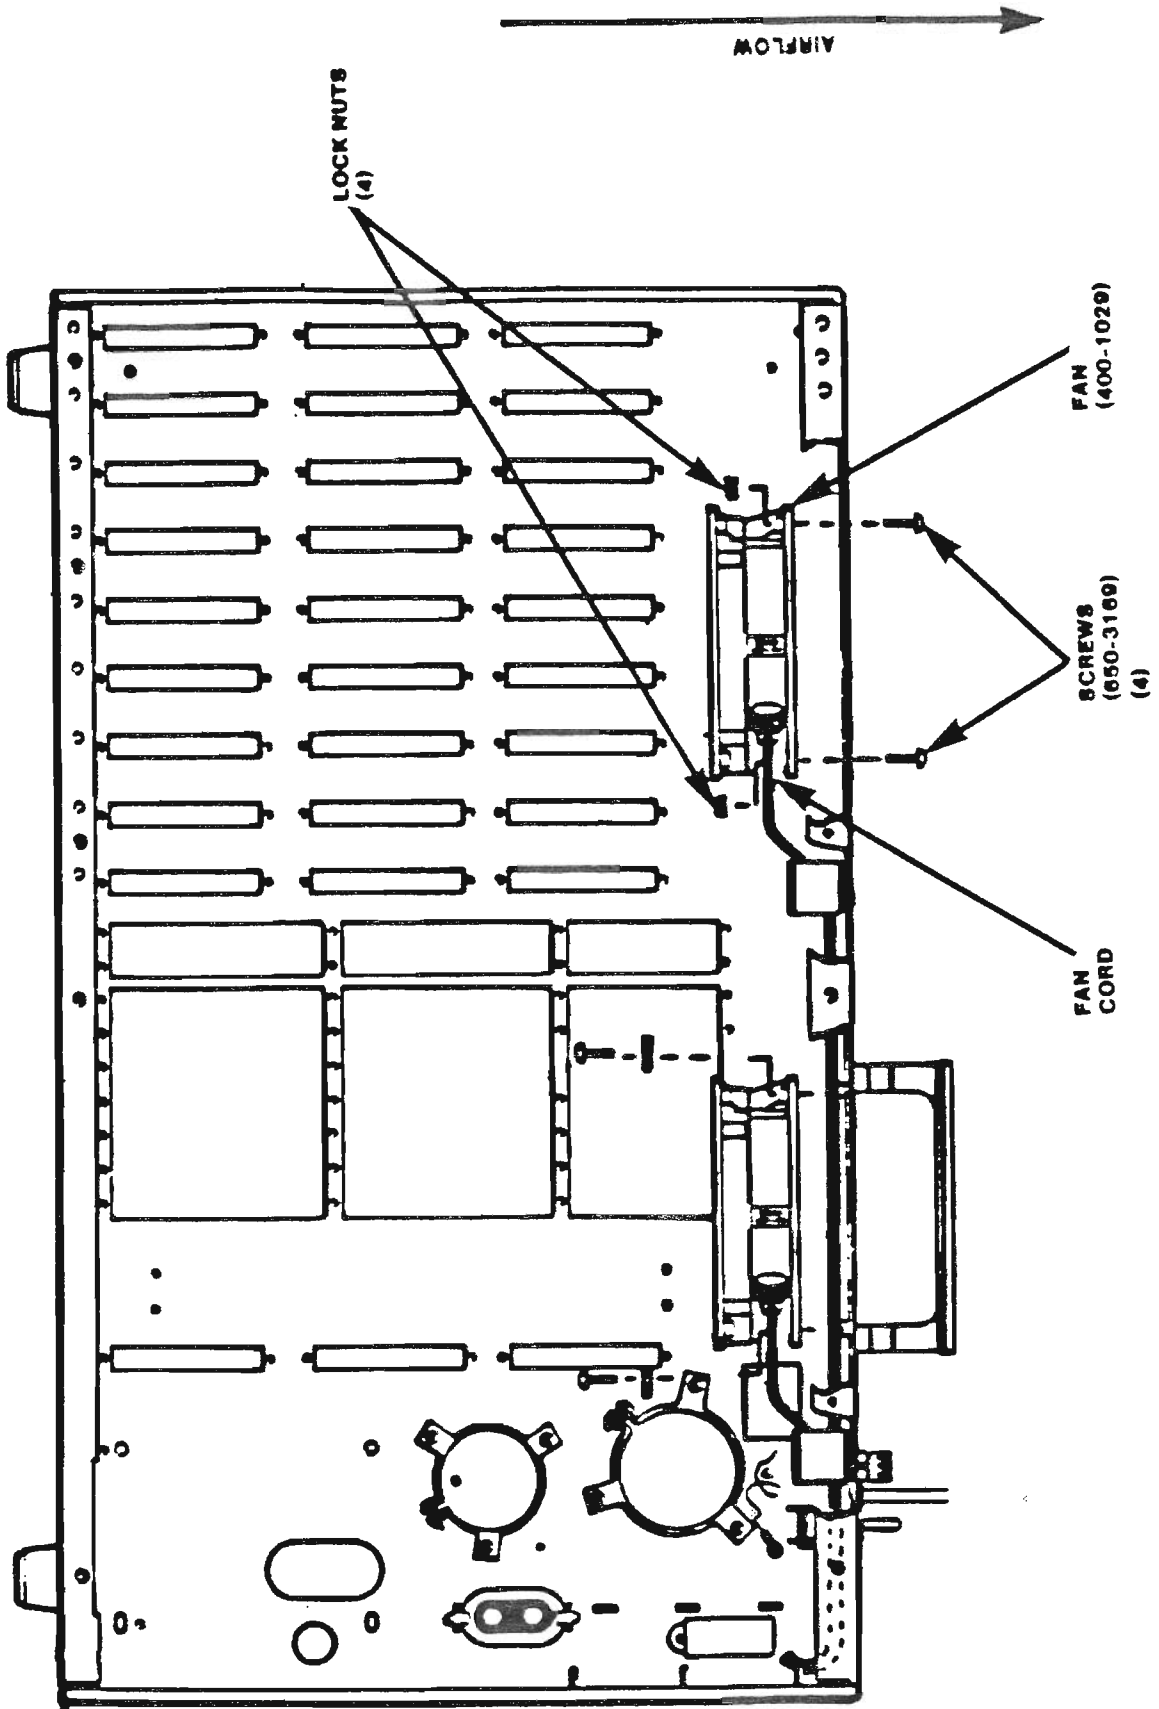
FIGURE 2 MVP FAN INSTALLATION

The fan in the I/O section of the chassis is replaced by a thinner fan (400-1029).

B. Refer to Figure 2. Replace the fan in the I/O section of the MVP chassis as follows:

6. Connect the fan cord to the new fan.
7. Replace the I/O controllers and CPU cards if removed. Proceed to Step D below.

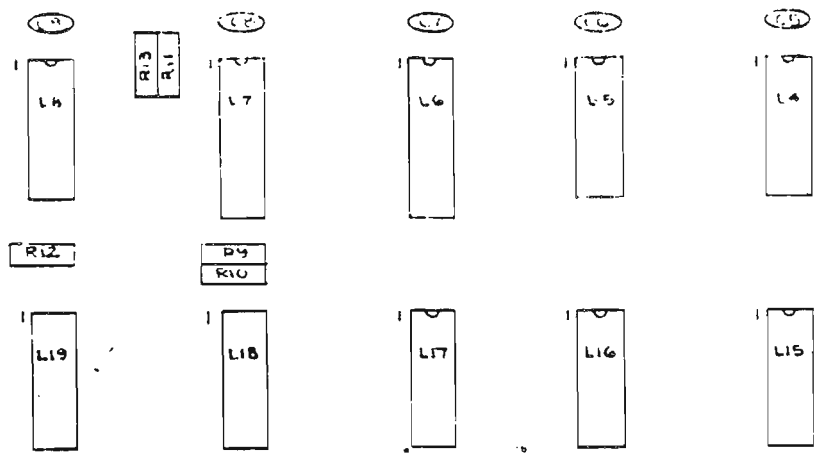
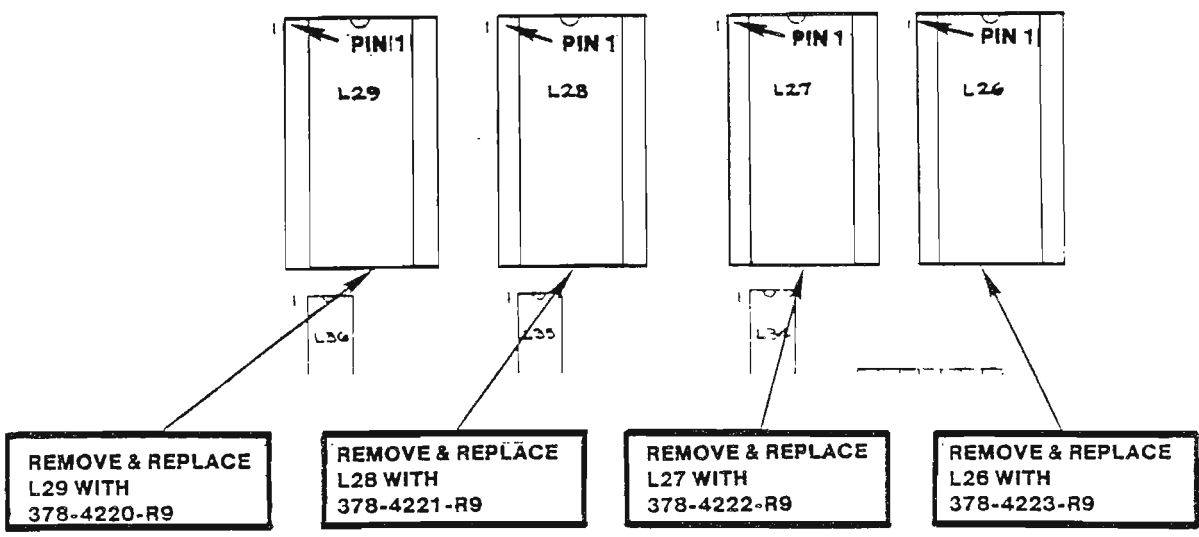
210-8696-B
R1
FCO 1005A

NOTE THE LOCATIONS OF PIN 1

- o Remove EPROM's of the 210-8696-A in locations L29, L28, L27 and L26.
 - * o Replace with updated EPROM's - 378-4220-R9 (L29), 378-4221-R9 (L28), 378-4222-R9 (L27) and 378-4223-R9 (L26).

- D. 210-8696-B Procedures
 - o Remove EPROM's of the 210-8696-B in locations L29, L28, L27 and L26.
 - * o Replace with updated EPROM's - 378-4220-R9 (L29), 378-4221-R9 (L28), 378-4222-R9 (L27) and 378-4230-R9 (L26).

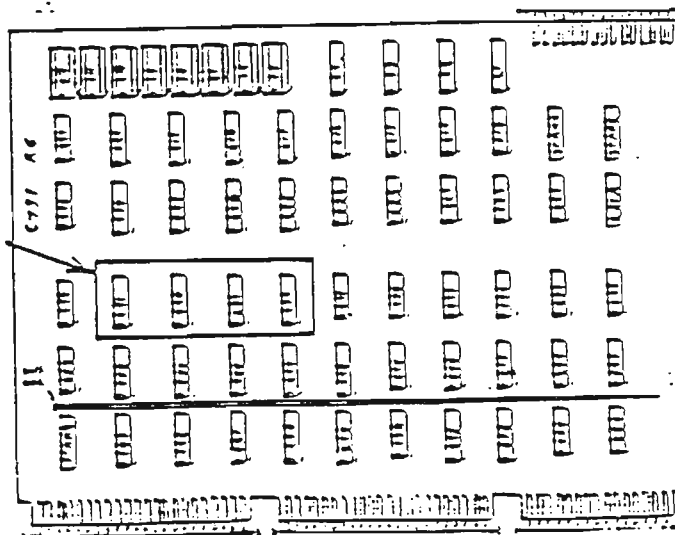
If experiencing intermittent parity errors with a C chassis, updating the 6791 board to a 6791-1 might help. Although any board in the CPU can cause a PEDM, a problem has been found with some 6791 boards which updating should correct. To upgrade from a 6791 to a 6791-1 change the 4 chips at L38, L39, L40, and L41 to Fairchilds. The 6791 board must be at least an E-REV 3 to be used in a LVPC. All C chassis should have the 6791-1 board.

Fairchild Chip - 376-0203-1

Fairchild chips can be identified by the letter F on them followed by the number 74191 PC.

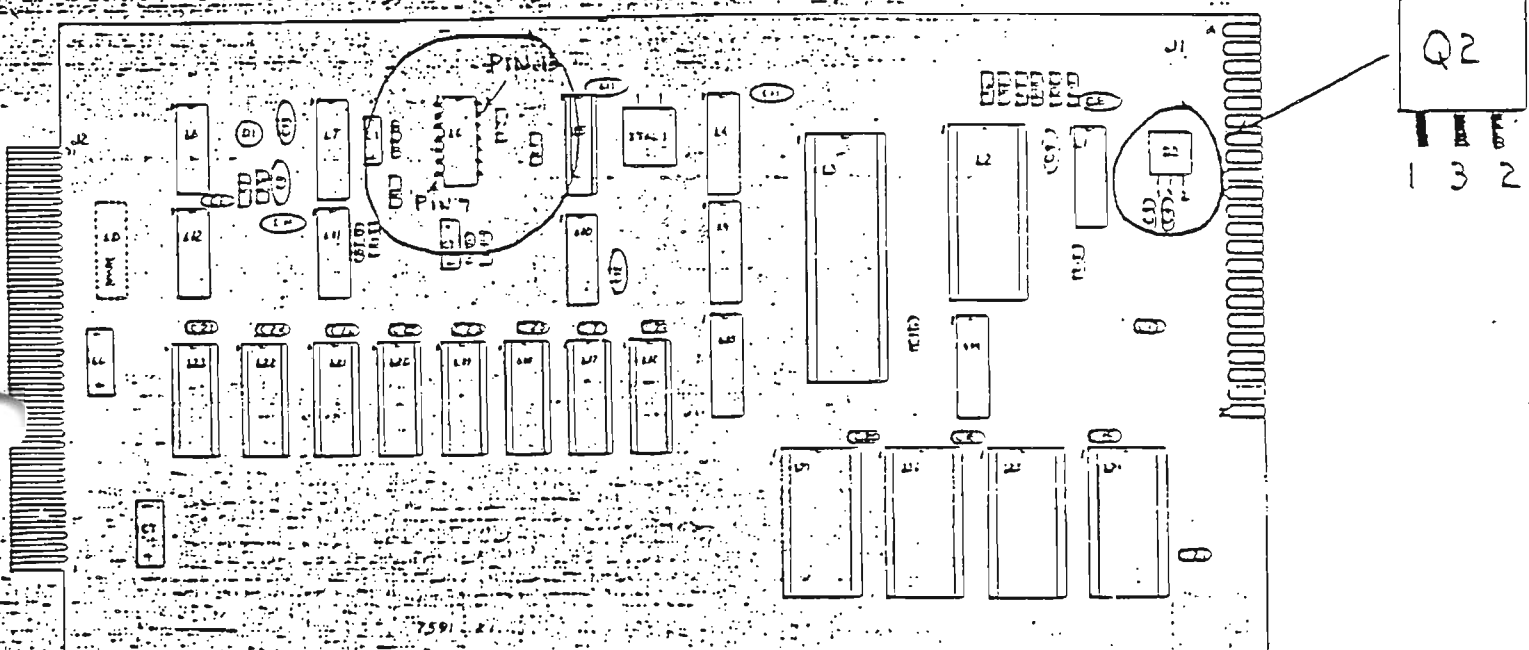
A legitimate solution has been found for terminals hanging up using the MUXD board with 210-7591 daughterboard and R7 proms. Previously the solution was to either downgrade the proms or the daughterboard if both weren't needed for 2200 Word Processing.

1. Add a 390 pf capacitor (WLI 300-1390) between L6-pin 13 and plus/minus 0 volts. (use L6 pin 7 for +/- 0V)
2. Add a 35uf capacitor (WLI 300-3009), negative side to Q2 - pin 2 (-5V output) and positive side to plus/minus 0V. (use Q2 pin 1 for +/- 0V).

Another aid in eliminating intermittent hangups may be to insert the MUX D Board into the first I/O slot closest to 210-6793 board of the CPU section. After insertion, adjust 12 volts at the last I/O slot to approximately 12.1 volts. 12 volts can be adjusted at connector 3, bottom connector, of I/O slot, pin 15. (bottom pin). Ground reference is pin 13 (3rd from bottom).

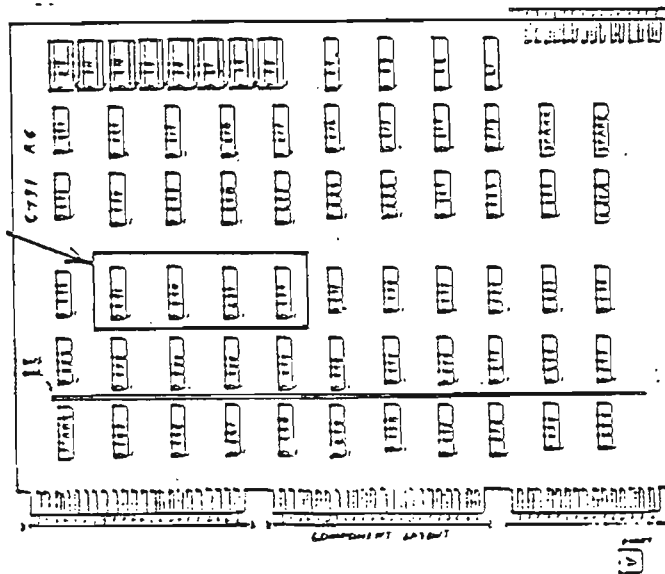
INTERMITTENT PARITY ERRORS (PEDM) WITH C CHASSIS

If experiencing intermittent parity errors with a C chassis, updating the 6791 board to a 6791-1 might help. Although any board in the CPU can cause a PEDM, a problem has been found with some 6791 boards which updating should correct. To upgrade from a 6791 to a 6791-1 change the 4 chips at L38, L39, L40, and L41 to Fairchilds. The 6791 board must be at least an E-REV 3 to be used in a LVPC. All C chassis should have the 6791-1 board.

Fairchild Chip - 376-0203-1

Fairchild chips can be identified by the letter F on them followed by the number 74191 PC.

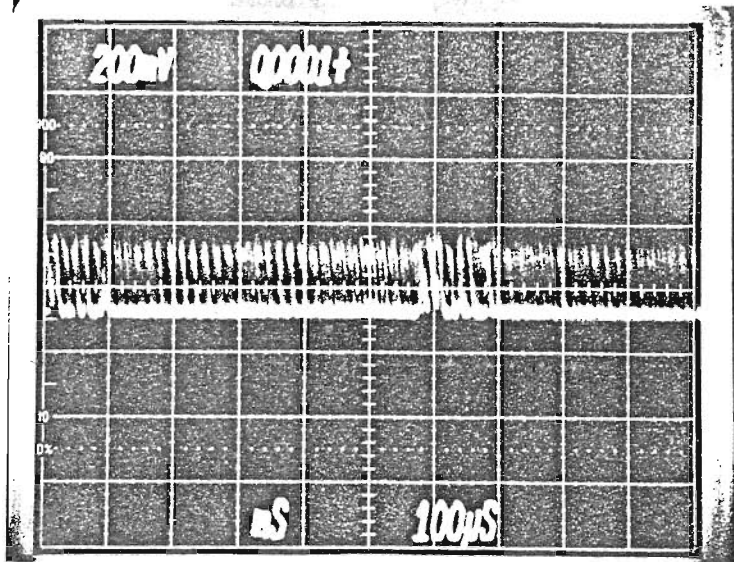
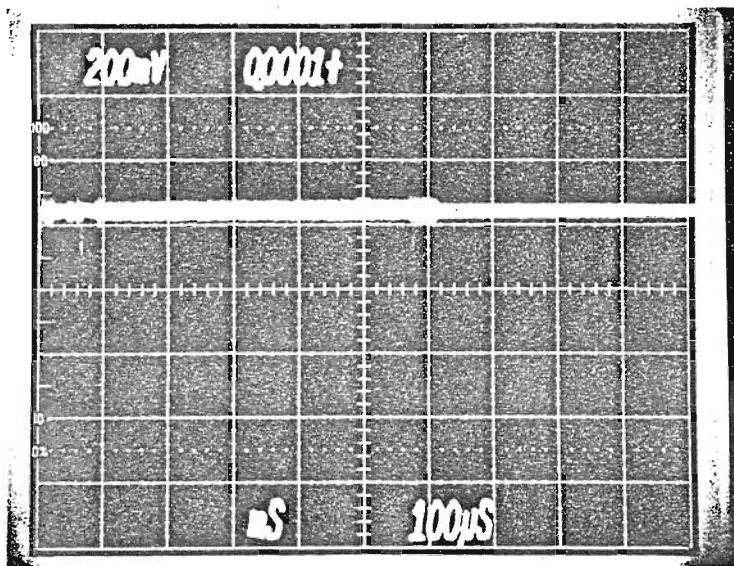
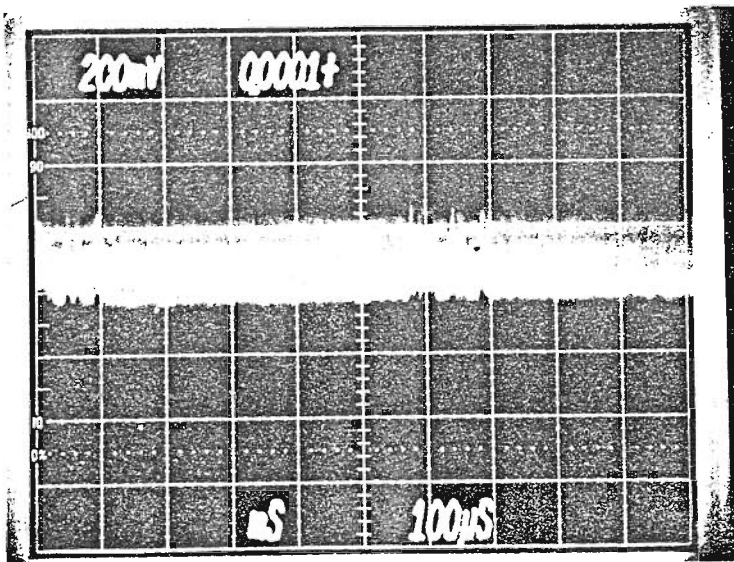
17. Depress RETURN, RUN, RETURN to load and run the verify program. (The program verifies the last sector on the Fixed-Disk Drive, and prints a "period" on the system console when the operation is completed. An ERROR message will be displayed if a read error is detected.)
18. Adjust R7 until a waveform similar to FIGURE 11-2C is observed. Adjust R7 until noise is minimized, as in FIGURE 11-2C. FIGURES 11-2B and 11-2D show typical waveforms when R7 is turned too far counterclockwise (FIGURE 11-2B) or too far clockwise (FIGURE 11-2D).

If R7 is adjusted properly, FIGURE 11-2C will be observed, and the "periods" (.) from the verify program in step 16 will be displayed at a constant rate of speed. If R7 is turned in either direction (CW or CCW) until a verify ERROR occurs, either FIGURE 11-2B or 11-2D will be observed (dependent on direction). Watching the rate at which the "periods" (or the "ERRORs") are being displayed may help in setting R7 correctly. It may be helpful to purposefully create errors (by turning R7 to its extremes) in order to see what the waveform (noise) looks like when R7 is maladjusted.

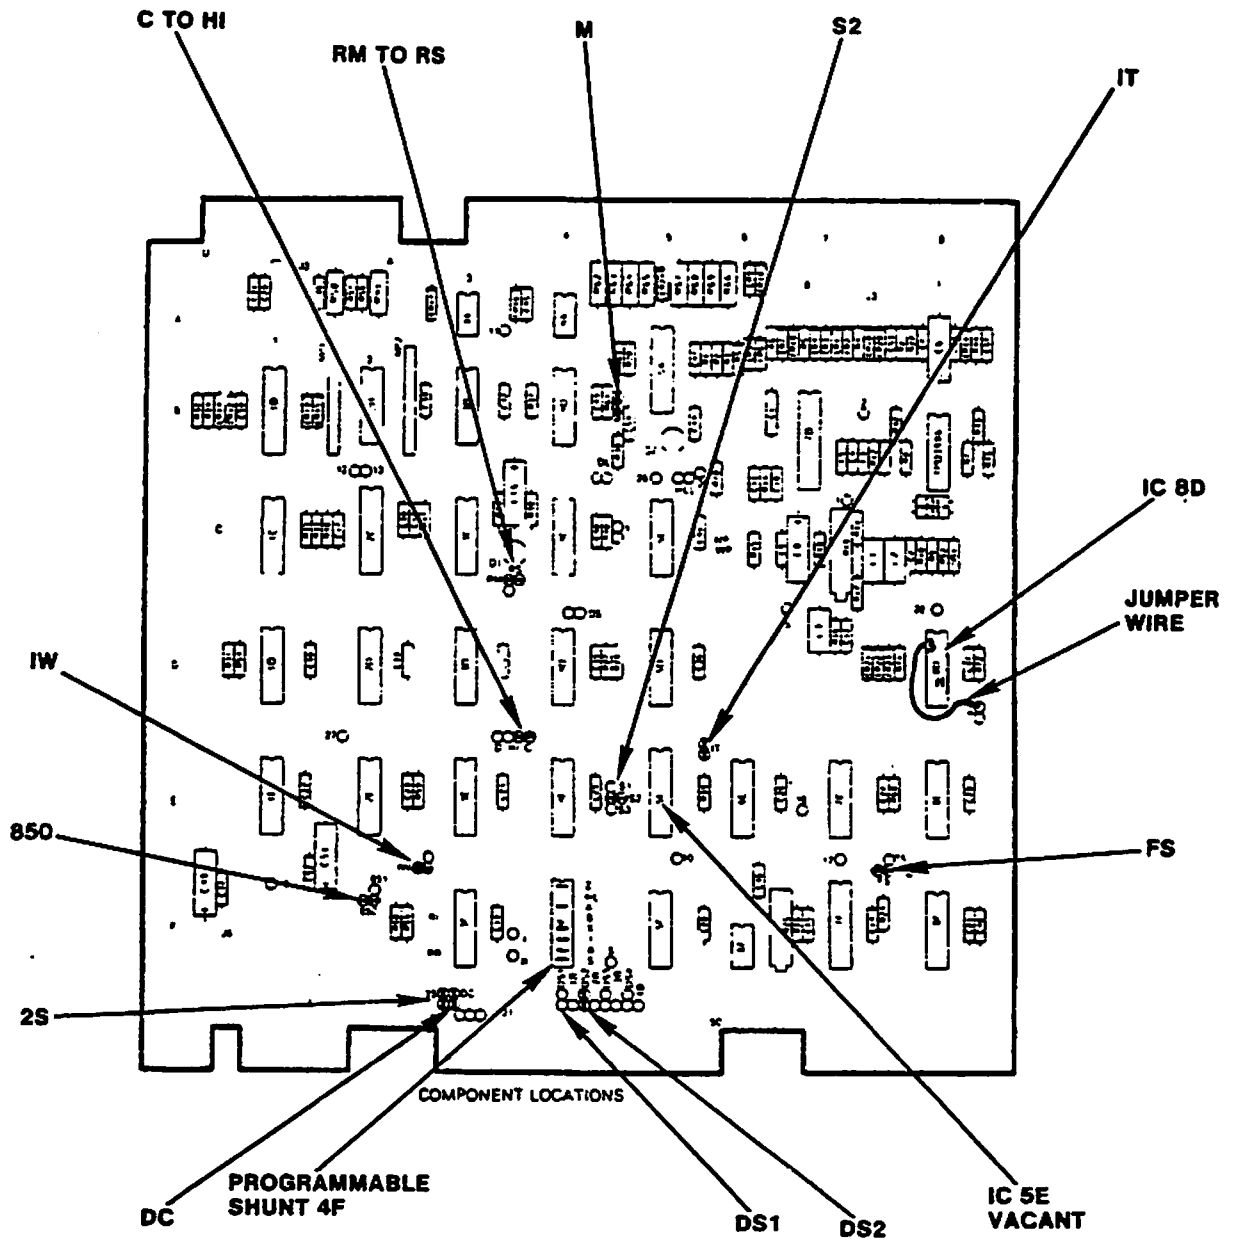
FIGURE 1 2200LVP/SVP JUMPER CONFIGURATION (MLC10).

Board MLC 10 must have pins 3 and 11 of IC 8D jumpered together. (Pin 11 is connected to one end of jumper location F. See Figures 1 and 2.) This modification is required for both LVP/SVP and VS-AWS operation. On boards MLC 11 and higher, Shugart has provided a jumper (AF) and a NOR gate (5D) to eliminate the need for this jumper wire.

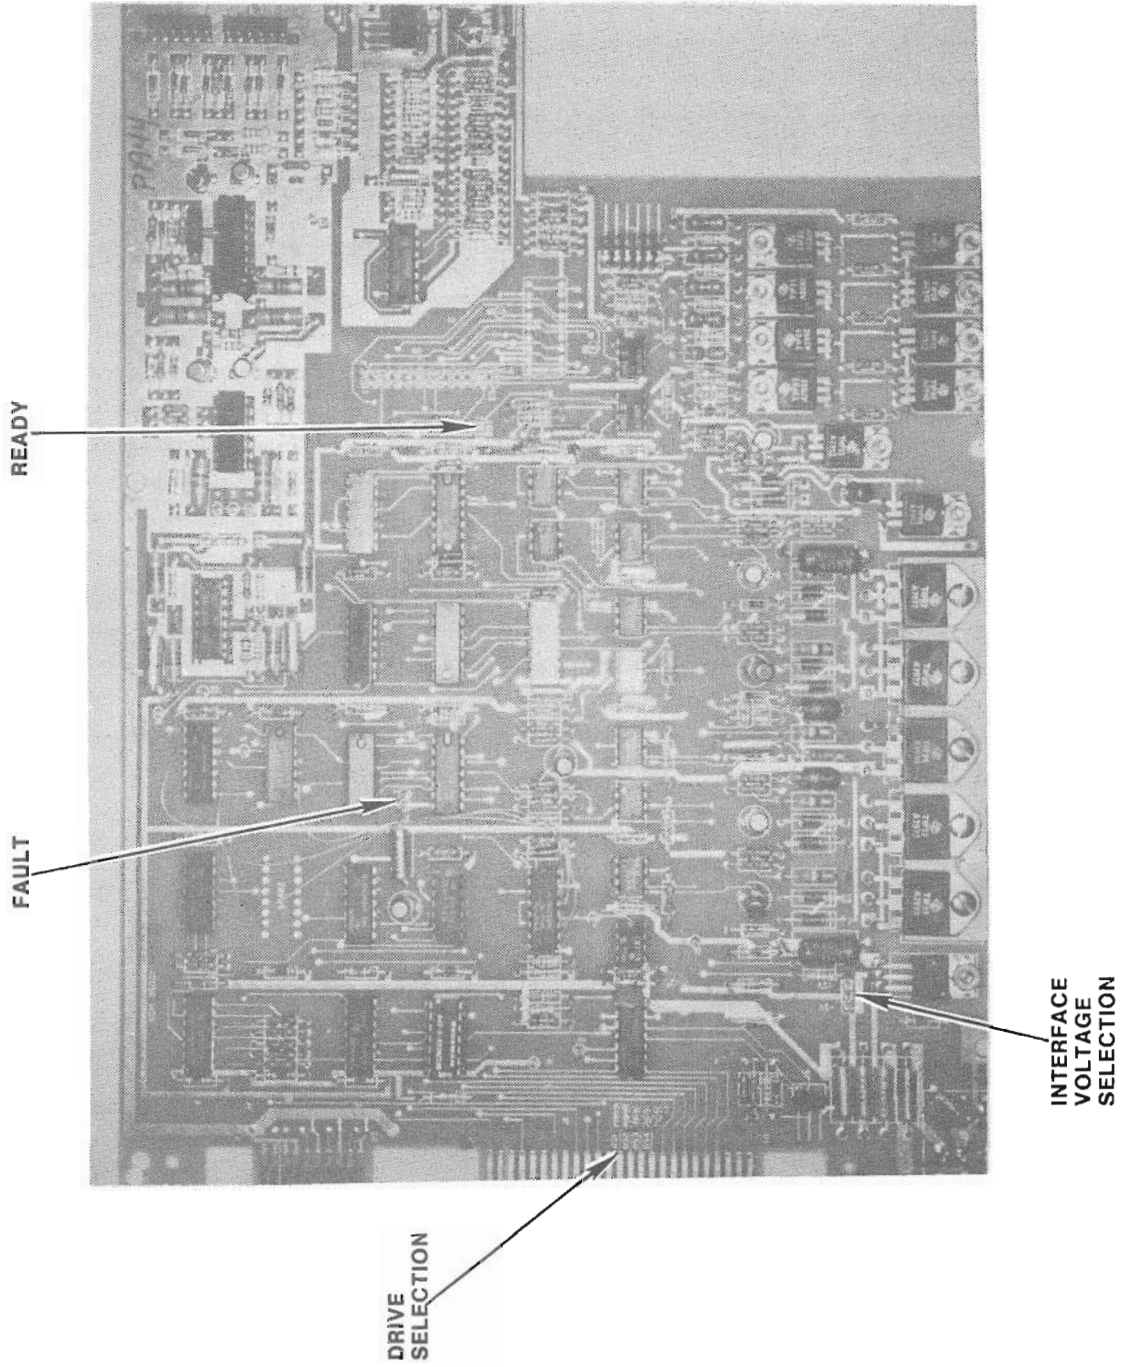
FIGURE 1
26051 CONTROL BOARD

Some SA1000 "Winchester" disk drives are being received at the Lawrence stock room from Shugart Associates with the options jumpers installed incorrectly. These jumpers are on the 26051 Control PCB (WLI #726-1907). It is vital that these options jumpers be verified when a replacement drive is installed in the field. Remove or install the jumpers as described below. Refer to Figure 1 for jumper locations.

1. Fault - When removed, enables the Fault Detection logic. This jumper should be REMOVED.
2. Ready - When removed, enables the Ready signal at the interface. This jumper should be REMOVED.
3. Drive Selection - Selects the disk drive number 1 through 4. INSTALL this jumper for the correct drive number as shown in figure 2.
4. Interface Voltage Selection - Selects the correct interface voltage. INSTALL this jumper for the -5 Volt dc configuration for Wang systems as shown in figure 3.
