Service Newsletter

No. 121

2200/2600 #23

2200VP/MVP FAN REPLACEMENT WITH LARGE I/O CONTROLLERS

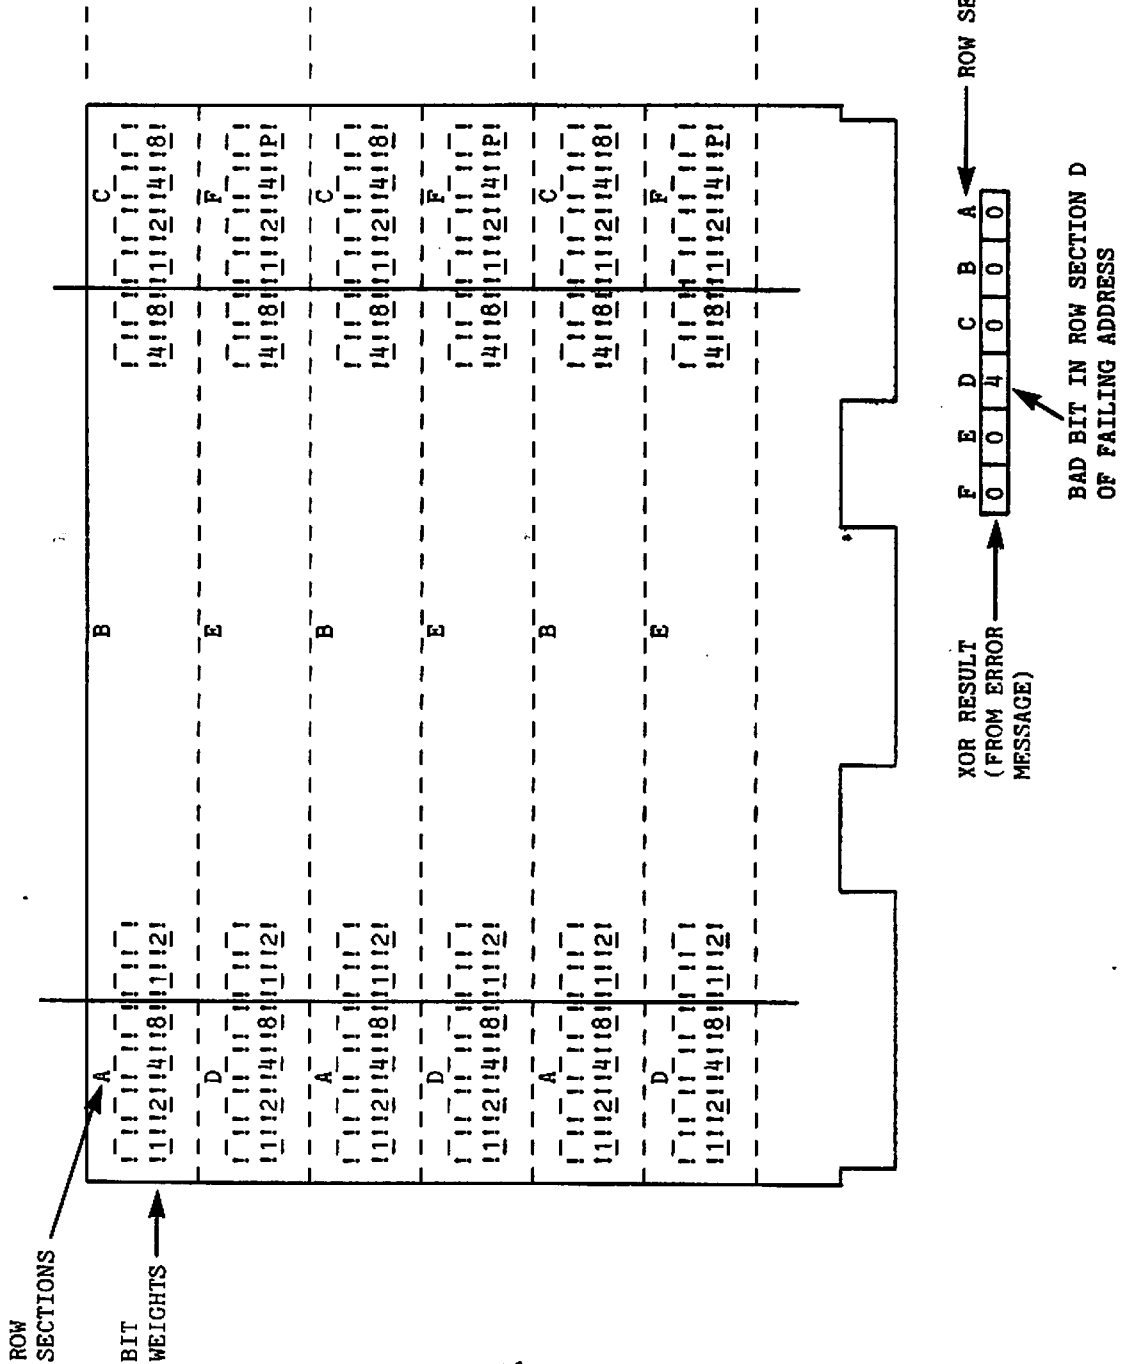
FIGURE 3 WL #210-7588 CONTROL MEMORY ADDRESS CONFIGURATION

FIGURE 3 shows that the failing location is contained in the top two rows of RAM's (error was between 0000 and 3FFFF (HEX)).

The bits that failed were 4 and 8 (from XOR--HEX(C) is equal to bits 4 and 8 ON); therefore, the bad RAM's are in the second row from the top of the board, and are the fifth and sixth RAM's from the right side of the board.

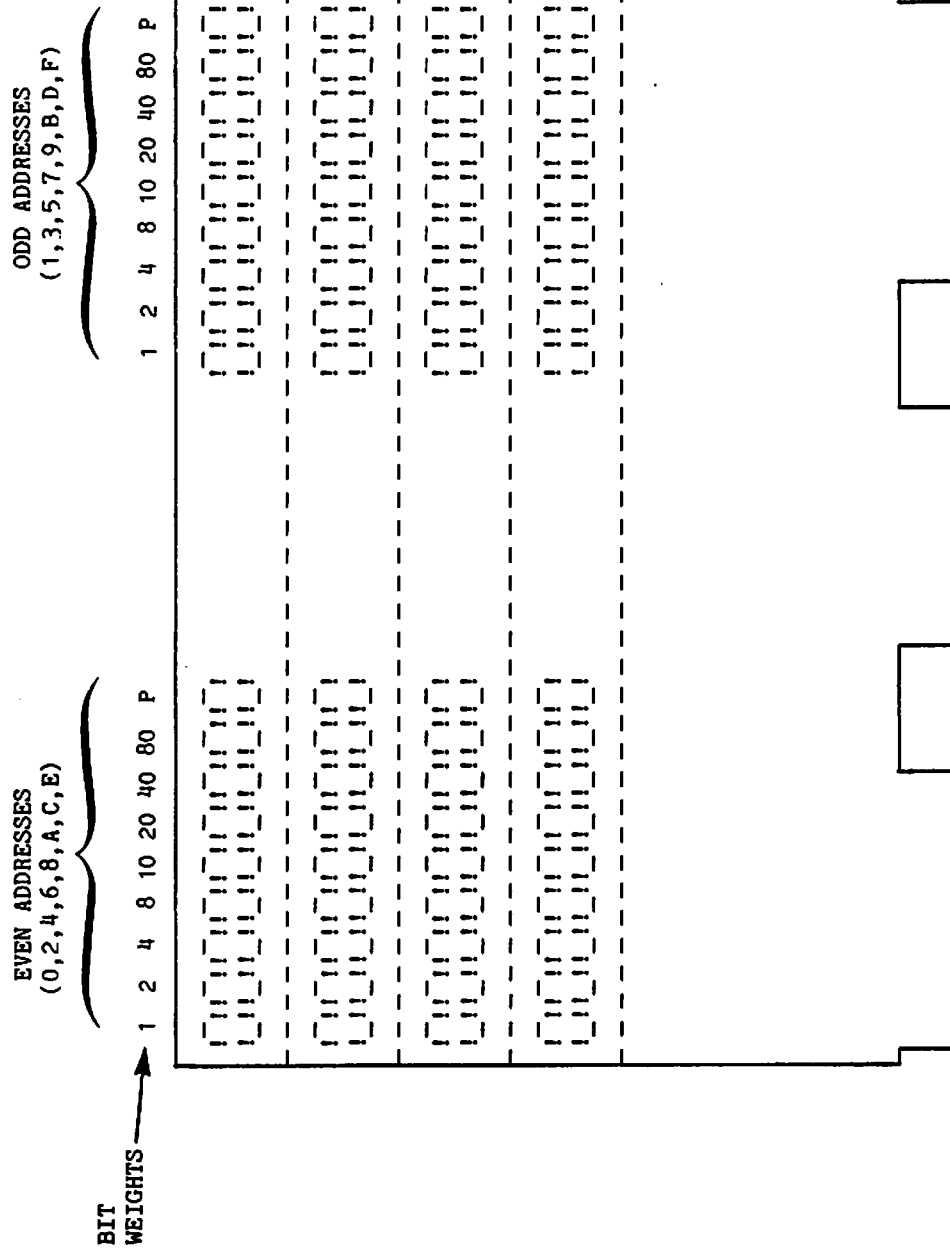
FIGURE 5 WL #210-7587 DATA MEMORY ADDRESS CONFIGURATION

FIGURE 5 shows that the failing address is in the top two rows of RAM's (error was in bank #2).

The figure also shows that the failing location is contained in the top row of RAM's (error was between 8000 and FFFF (HEX)).

The failing address was even (A3C4); therefore, the faulty RAM('s) is somewhere on the left side of the top row of RAM's.
