# PRODUCT SERVICE NOTICE

PRODUCT/APPL. WANG MATRIX MODEL 77

PCB #210-7131, ECN's #11307 and #11497, E REV 2  
for 2261V and 2261W Matrix Printers

PERIPHERALS #29  
MODEL 77 (2261W) MATRIX PRINTER  
STATIC CAUSING DESELECTING

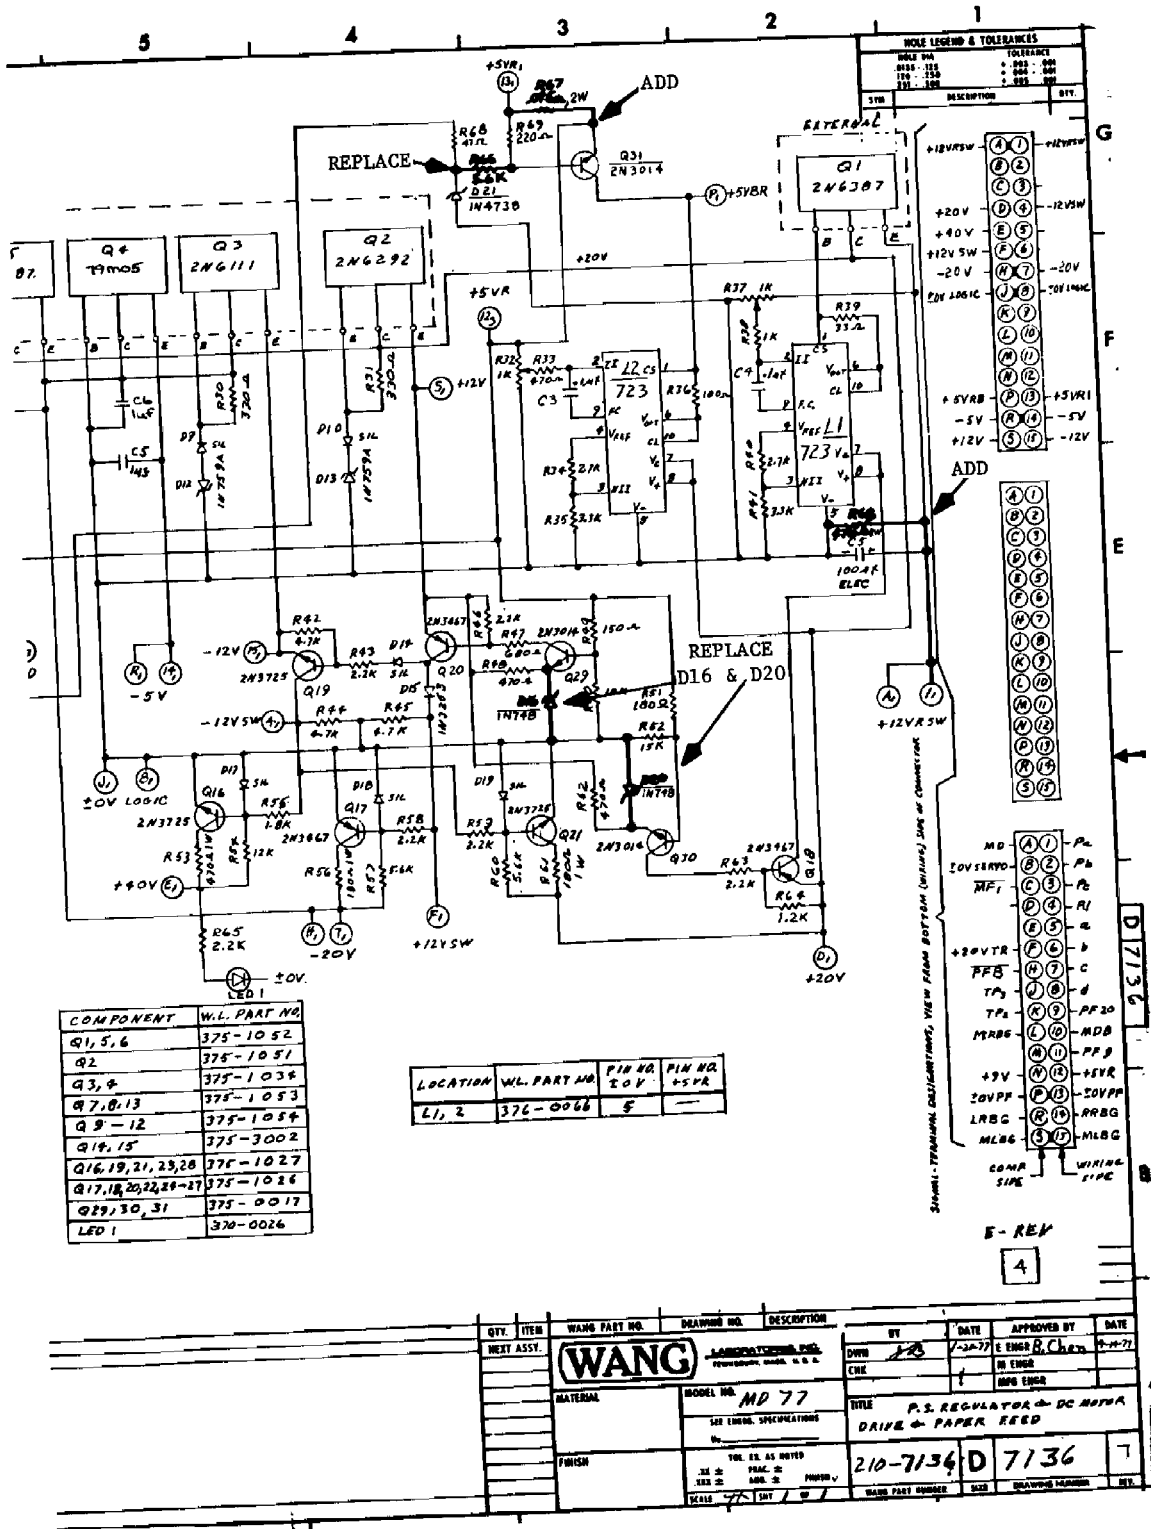
FIGURE 2 ECN #10883

To improve the -5V regulator circuit. The existing component tolerances cause high failure rates.
