CUSTOMER ENGINEERING
SERVICE HANDBOOK

CARTRIDGE TAPE DRIVES

MODELS: 2229
2529
6529

2229/2529/6529 TAPE DRIVES

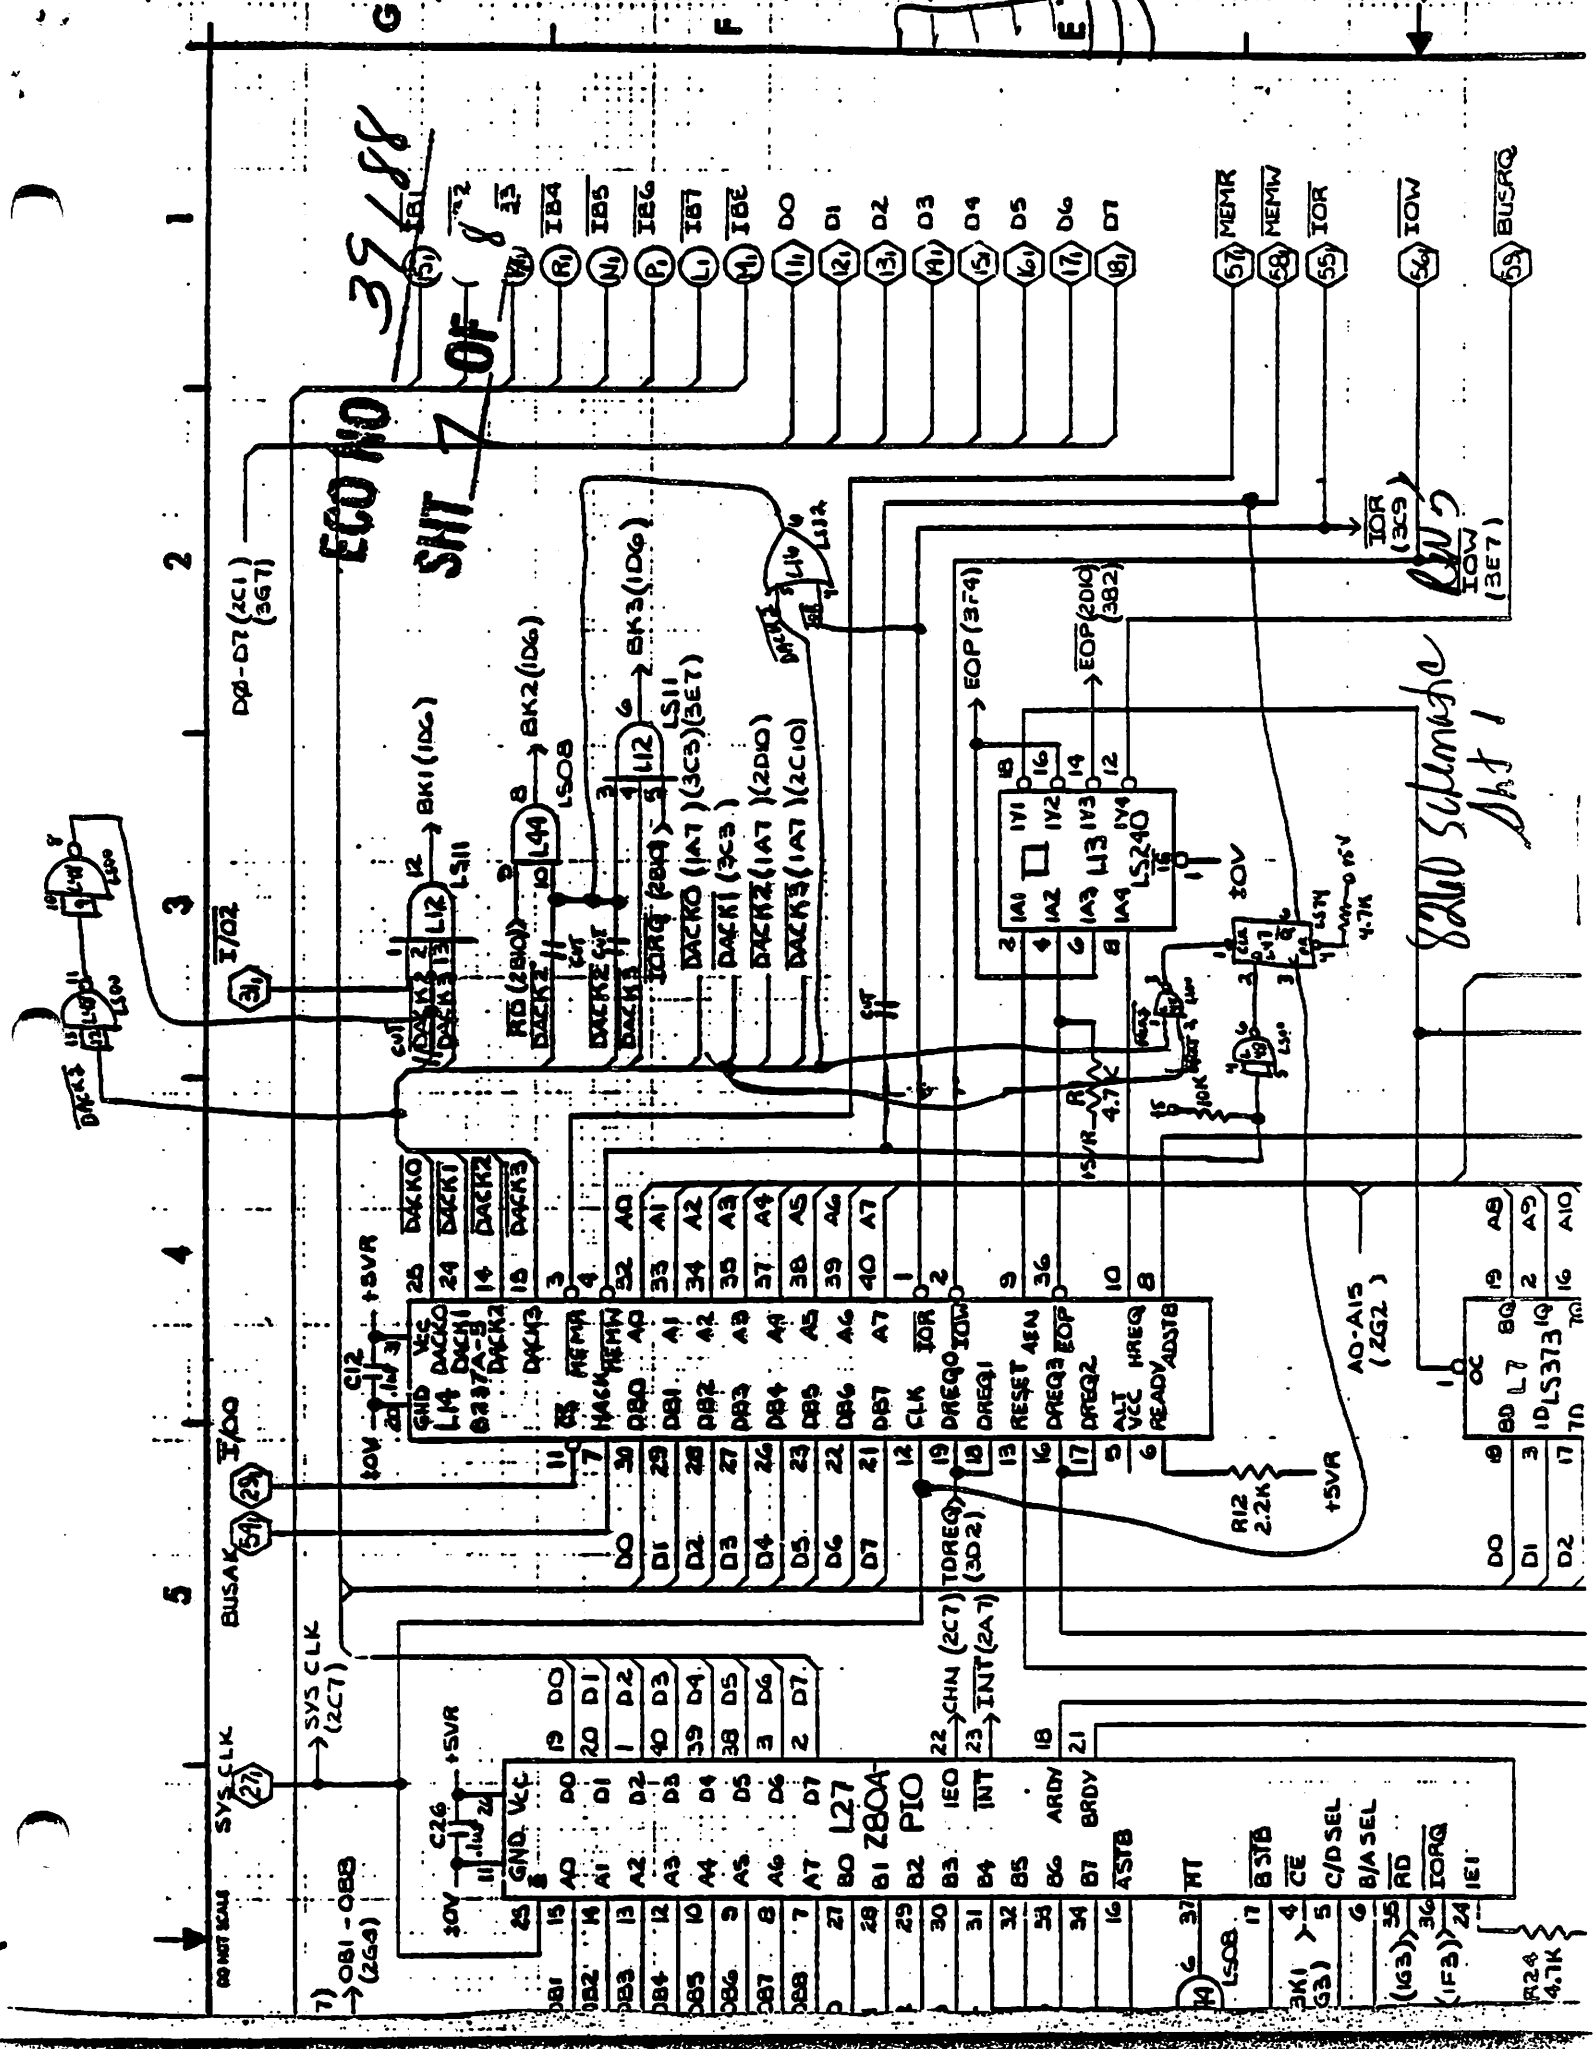
TEMPORARY MANUFACTURING DEVIATION		TND		TR 0150		ISSUE 1	
PART. NO. 209-8260		DESCRIPTION		2200 TAPE DRIVE CONTROLLER		MODEL 2229

ECO 39188 WAS SUBMITTED SEVERAL WEEKS AGO TO CORRECT A TIMING PROBLEM ON THE 8260 PCB. WITHOUT THE ECO, ONLY MOSTER PIDS WOULD WORK ON THE BOARD. ALL OTHER VENDORS FAILED (TMD, SHARP & ZILIG). IN THE INTERIM, FINAL LINES HAS BEEN INSPECTING MOSTER AT THEIR TEST STATION. THE FIELD IS AWARE OF THE SITUATION. IN ORDER TO ELIMINATE THE EXTRA WORK AND STOCK CONTROL PROBLEMS, ALL 8260 PCB'S SHOULD BE BUILT WITHOUT THE CHIP AT LOCATION C27.
