# PRODUCT BULLETIN

# NO. 172

## THE MODEL 2260BC AND MODEL 2260C SERIES DISK DRIVES

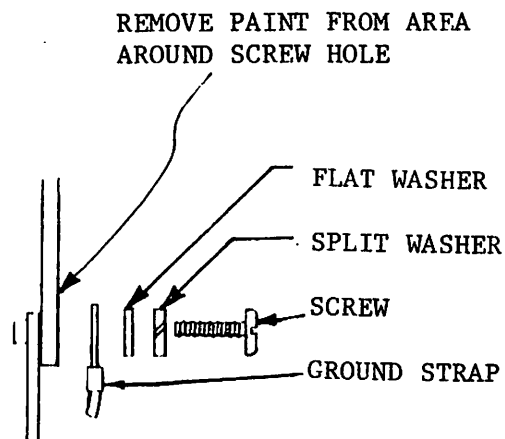
FIGURE 1

To improve card cage/motherboard grounding, a ground strap should be installed as follows:

1. Install one end of the ground strap to the right rear mounting screw of the power supply. To insure a solid ground, use the emery paper provided to remove the paint from around the screw hole. Then, use a flat washer, a split lockwasher, and a 6-32 x .500" (1.27 cm) screw in the following manner:

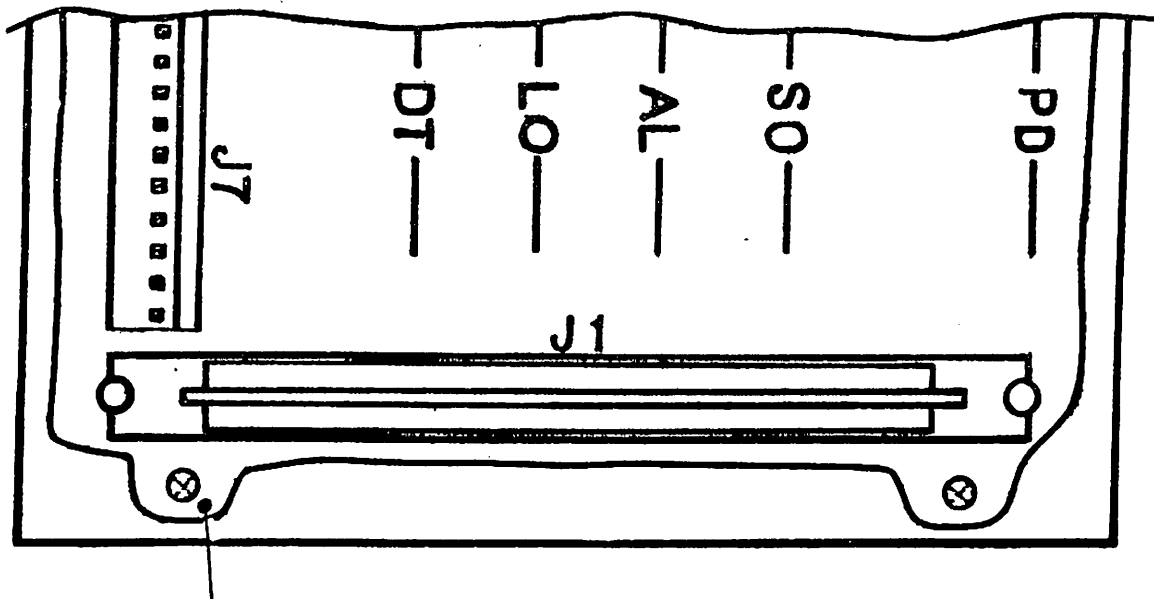
FIGURE 2

SOLDER GROUND IN THIS AREA

2. Remove the terminal lug from the other end of the ground strap. Strip the insulation back 3/8" (approx. 1 cm) and solder to the motherboard as shown in Figure 2.

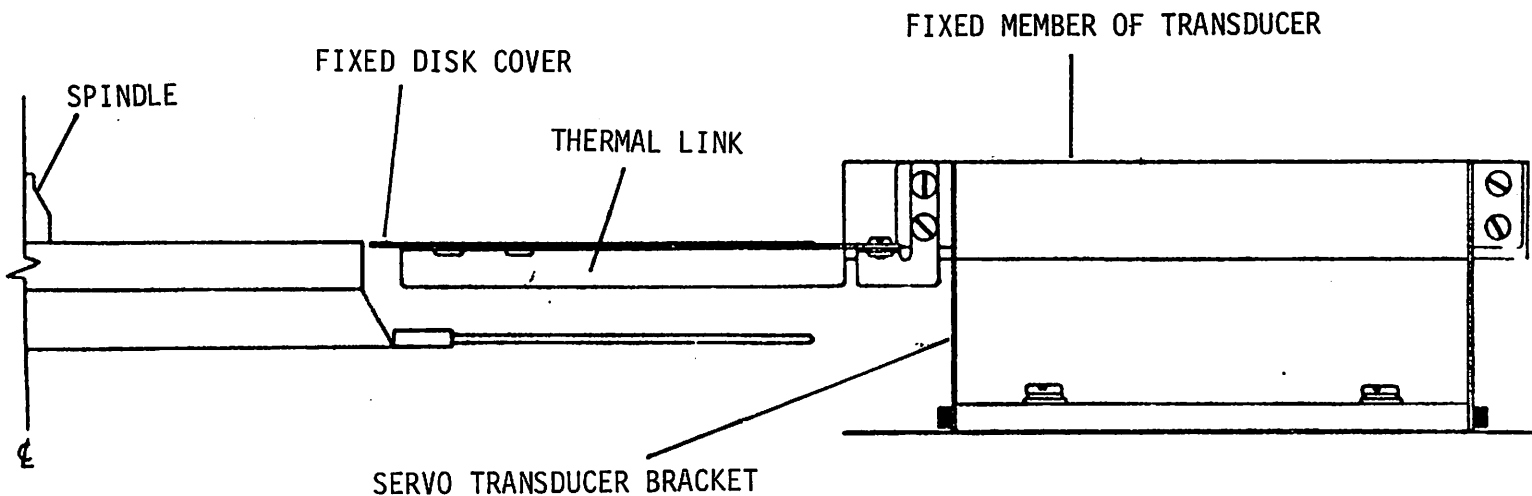
1. TEMPERATURE COMPENSATION

Temperature compensation in the Diablo Model 44B Disk Drive is accomplished mechanically. One end of a thermal link attaches to the fixed member of the Servo Transducer. The opposite end of this thermal link connects to the fixed disk cover, which expands at the same rate as a disk platter. If either end of the Servo Transducer fixed member has a poor connection, a positioning error will result as disk drive temperature changes.

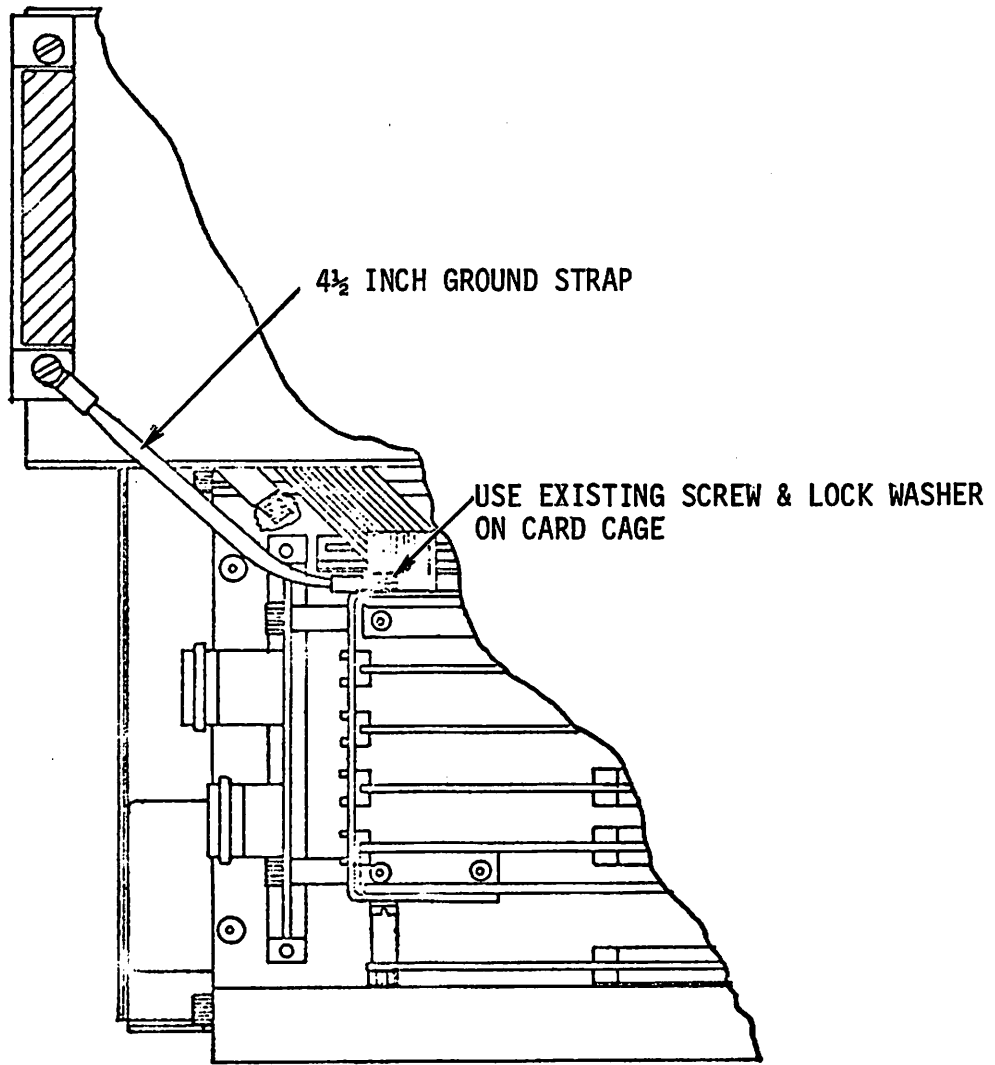
FIGURE 5

2. Some power supplies were assembled using Potter or Hopkins AC line filters. These two filters are inadequate for the application, and should be changed to a Corcom filter. The filter type can be determined as follows:
  - a) Corcom - Silver-colored, with a schematic of the filter printed on top of the casing. A green safety wire lug

6. Replace the filter in the power supply assembly by sliding it back until the tabs snap into place, securing the filter.
7. Cut and relocate the green ground wire as shown in Figure 5.

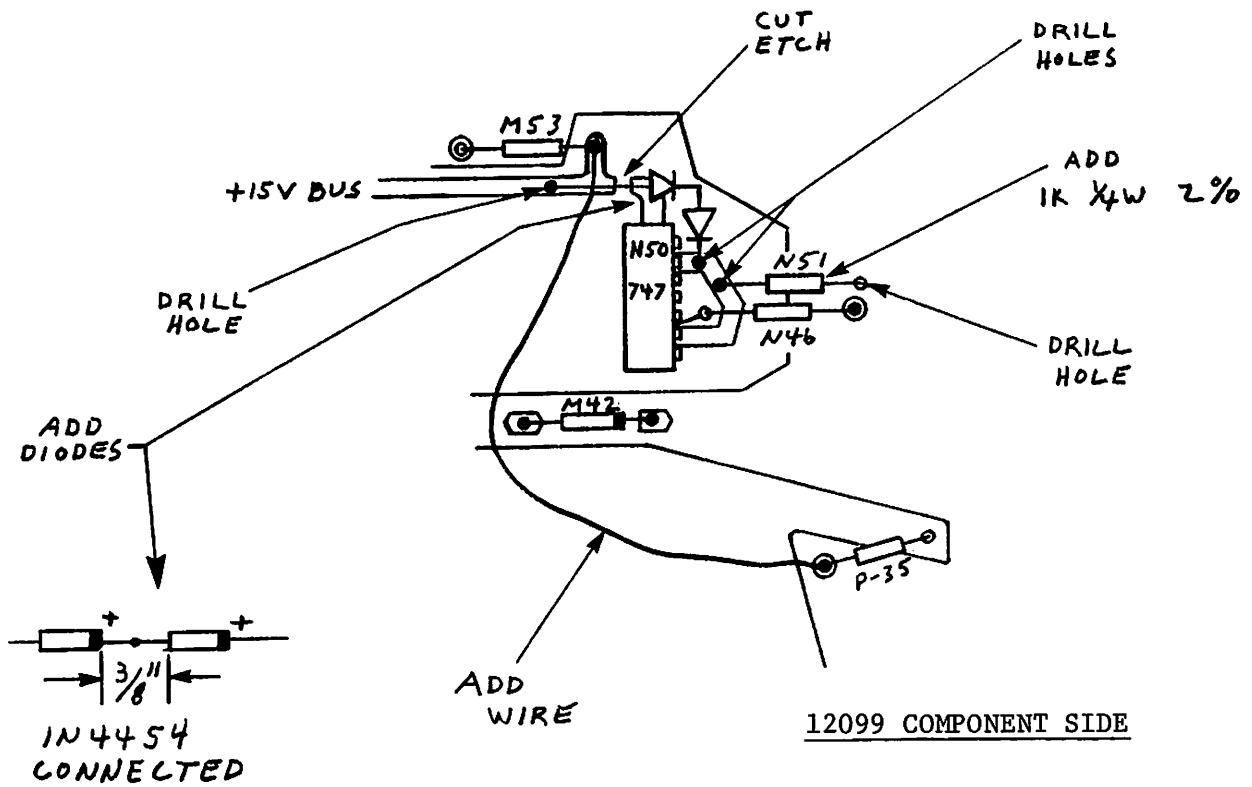
There is a slight possibility that overshoot can occur at track zero during long reverse seeks, due to an unbalanced condition of the 747 op-amp at location N50 on the #12099 Servo PCB. The effect of this overshoot is mispositioning of the carriage causing continuous address errors.

2. Change the resistor at D23 from 1K to 1.2K 1/4W 2%.

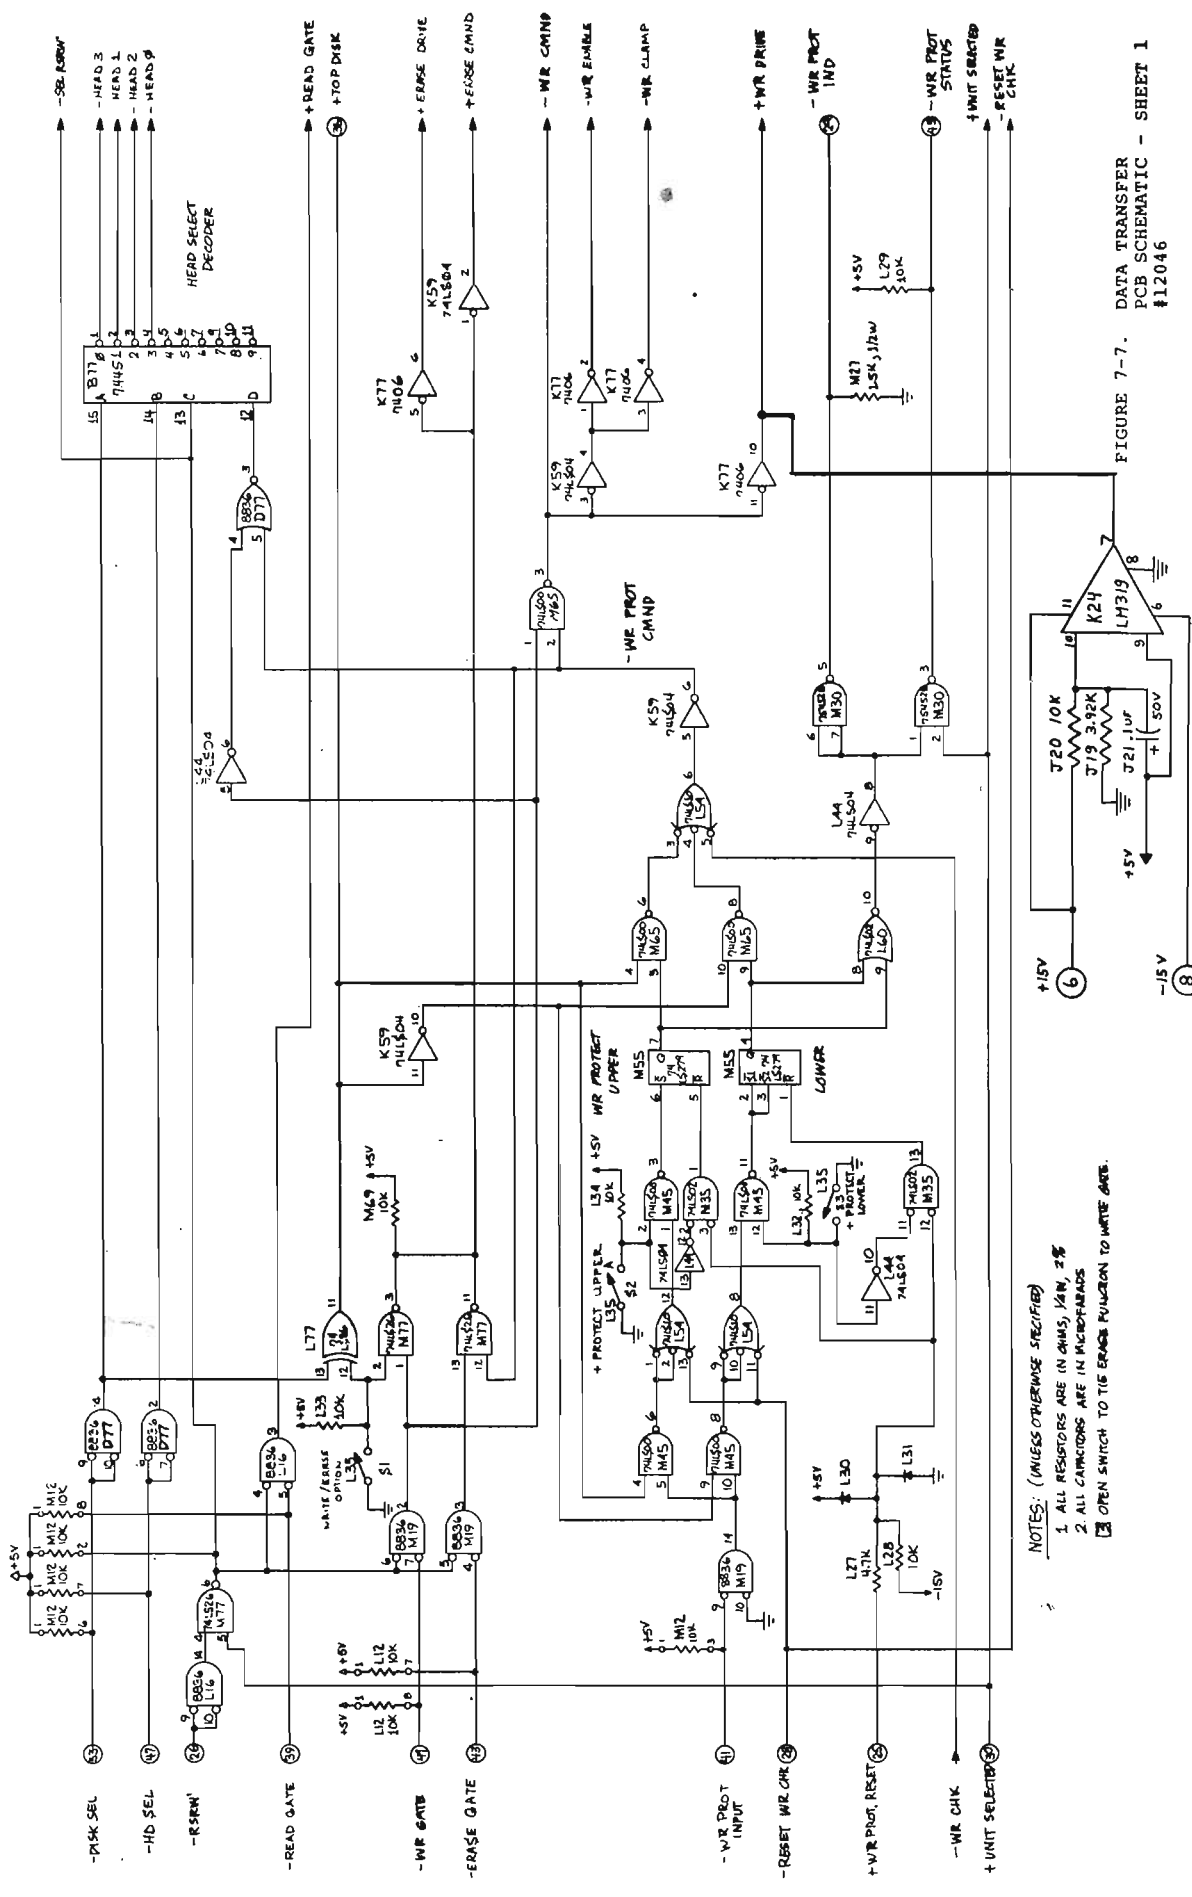
FIGURE 7-7. DATA TRANSFER PCB SCHEMATIC - SHEET 1 #12046

To prevent a possible spiral write during emergency retract, the following should be incorporated on the 12046-xx Data Transfer PCB. This modification clamps write drive during emergency retract.

Update Data Transfer PCB Schematic sheet 1 (12046) according to Figure 7-7.

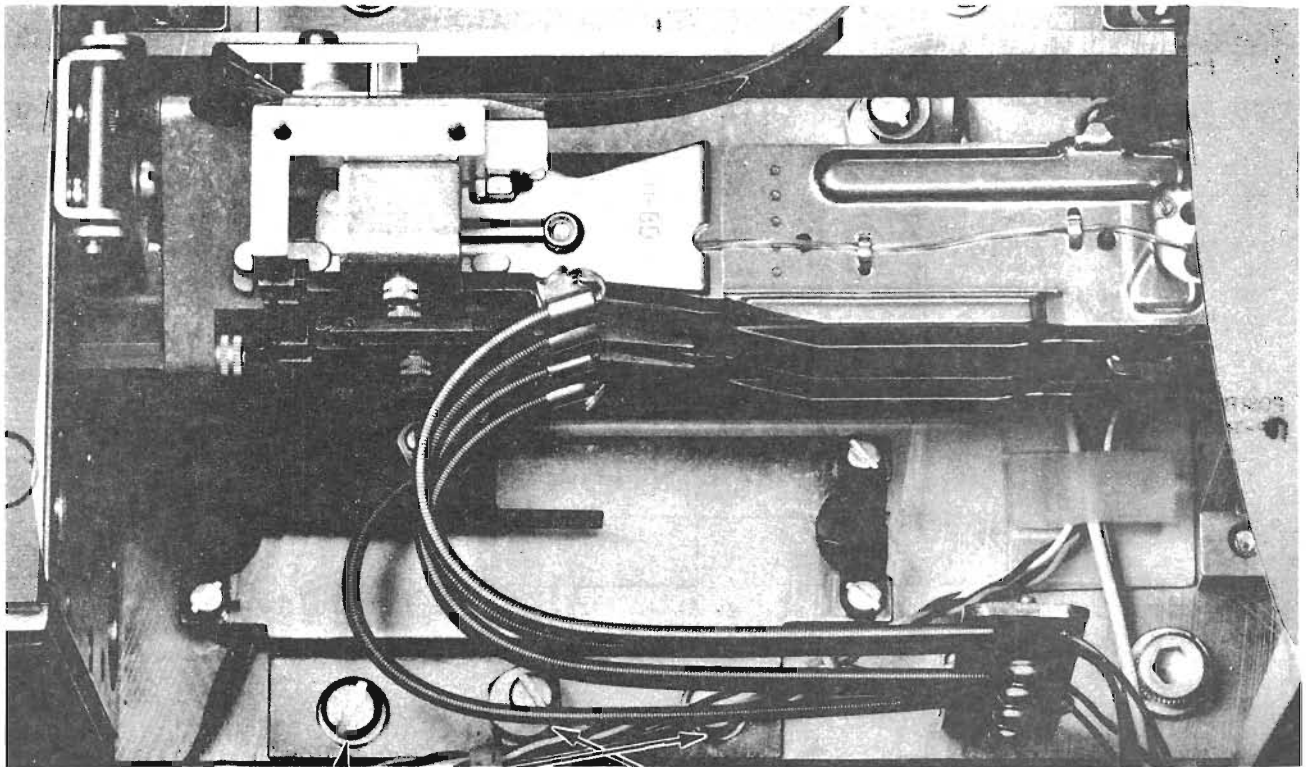
TRACK 0 ASSEMBLY SECURING SCREWS

ECCENTRIC AND LOCK SCREW

7. If the Index Burst Pattern is not found at track 10, seek to the tracks around 10 until the Index Burst Pattern is obtained, by altering the track address switch settings on the exerciser. See Figure 4.
8. Loosen the track zero assembly screws (Figure 5) slightly (approx. 1/4 turn).
9. Loosen the eccentric lock screw.
10. Note the track address where the burst is obtained, by checking the track address switches; then adjust the track zero eccentric accordingly. Refer to Figure 5.

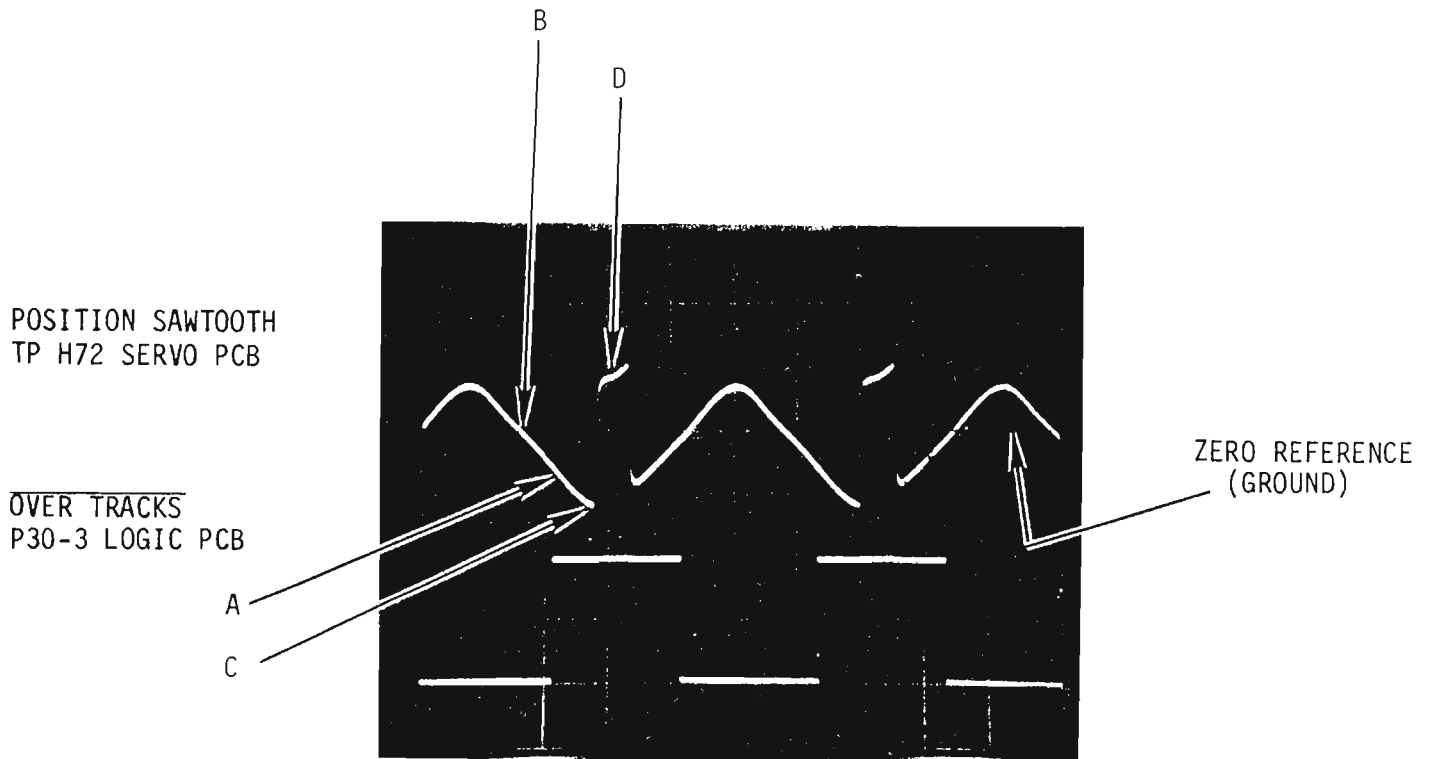
FIGURE 6 TRACK 0 SENSOR FINE ADJUSTMENT WAVESHAPES

The Track 0 fine adjustment procedure ensures that track 0 detenting occurs at the proper position on the Position Sawtooth Ramp. In this procedure, the position of Track 0 is adjusted to compensate for mechanical overshoot and temperature variations.

3. Initiate a continuous RESTORE operation by turning the RST switch on the 7013 exerciser ON.
4. Adjust the position of the Track 0 sensor until P30-3 (TP P74 for 12065-01 artwork) switches high at point "A" in the Position Sawtooth waveshape as in Figure 6. Point "A" occurs at the vertical midpoint between points "B" (Reference point) and "C" (negative peak of Position Sawtooth waveshape). This may be seen more easily by superimposing the two waveshapes via readjustment of vertical position controls. When the adjustment is correct, pulse "D" will not exceed 1.5 ms in duration.

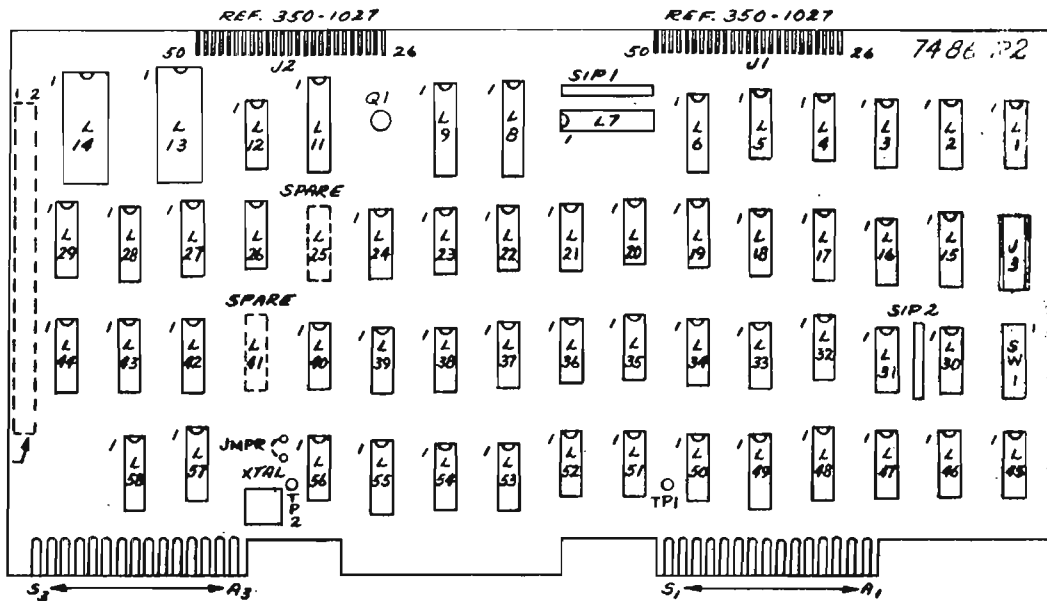
FIGURE 3  
7486 BOARD

- 2) ECN #9462 - Change C1 from .01 uf. to .002 uf. (WL #300-1913). On R1 boards, this capacitor is located between L22 and L23; on R2 boards between L18 & L19. On the schematic diagram for the 7486 board, the capacitor can be found at coordinates 2F10 (Sheet 2, @ F10). Without this change, an intermittent error 61 (I92) may occur. This ECN changes the E REV from 1 to 2.

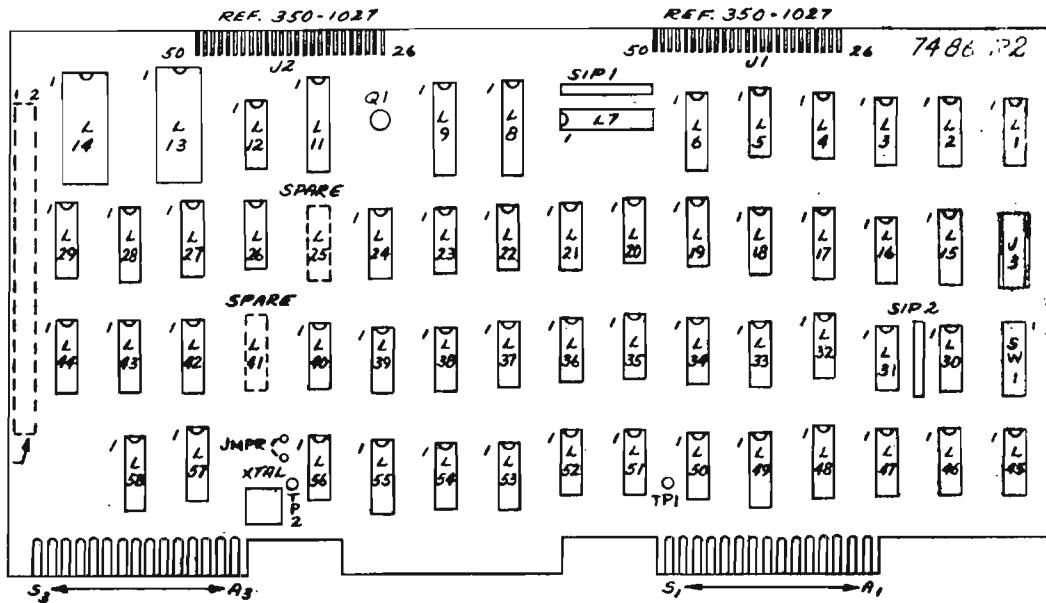
FIGURE 3  
7486 BOARD

- 2) ECN #9462 - Change C1 from .01 uf. to .002 uf. (WL #300-1913). On R1 boards, this capacitor is located between L22 and L23; on R2 boards between L18 & L19. On the schematic diagram for the 7486 board, the capacitor can be found at coordinates 2F10 (Sheet 2, @ F10). Without this change, an intermittent error 61 (I92) may occur. This ECN changes the E REV from 1 to 2.

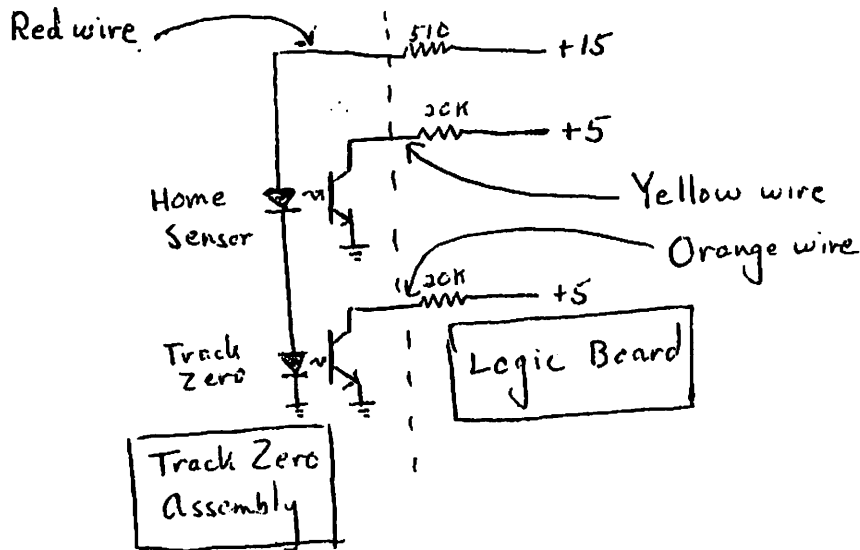
I have sent a Track Zero Assembly to every office. If you suspect either a Track Zero or Home Sensor failure, use the following procedure to check the sensors:

1. Move Servo Release switch 'ON'.
2. Power unit up, wait until spindle is up to normal speed.
3. Measure DC voltage between Red wire and ground - should be about 2.4 volts, (LEDs typically drop about 1.2 volts - two LEDs are in series).
4. Measure DC voltage between Yellow wire and ground while moving carriage such that flag cuts home sensor - voltage should shift between approximately .4 volts and 4.8 volts.
5. Measure DC voltage between Orange wire and ground while cutting Track Zero sensor - results should be the same as in step 4.

Using a long pointed probe, it is easy to measure these voltages right on the connector that goes to the Mother board.

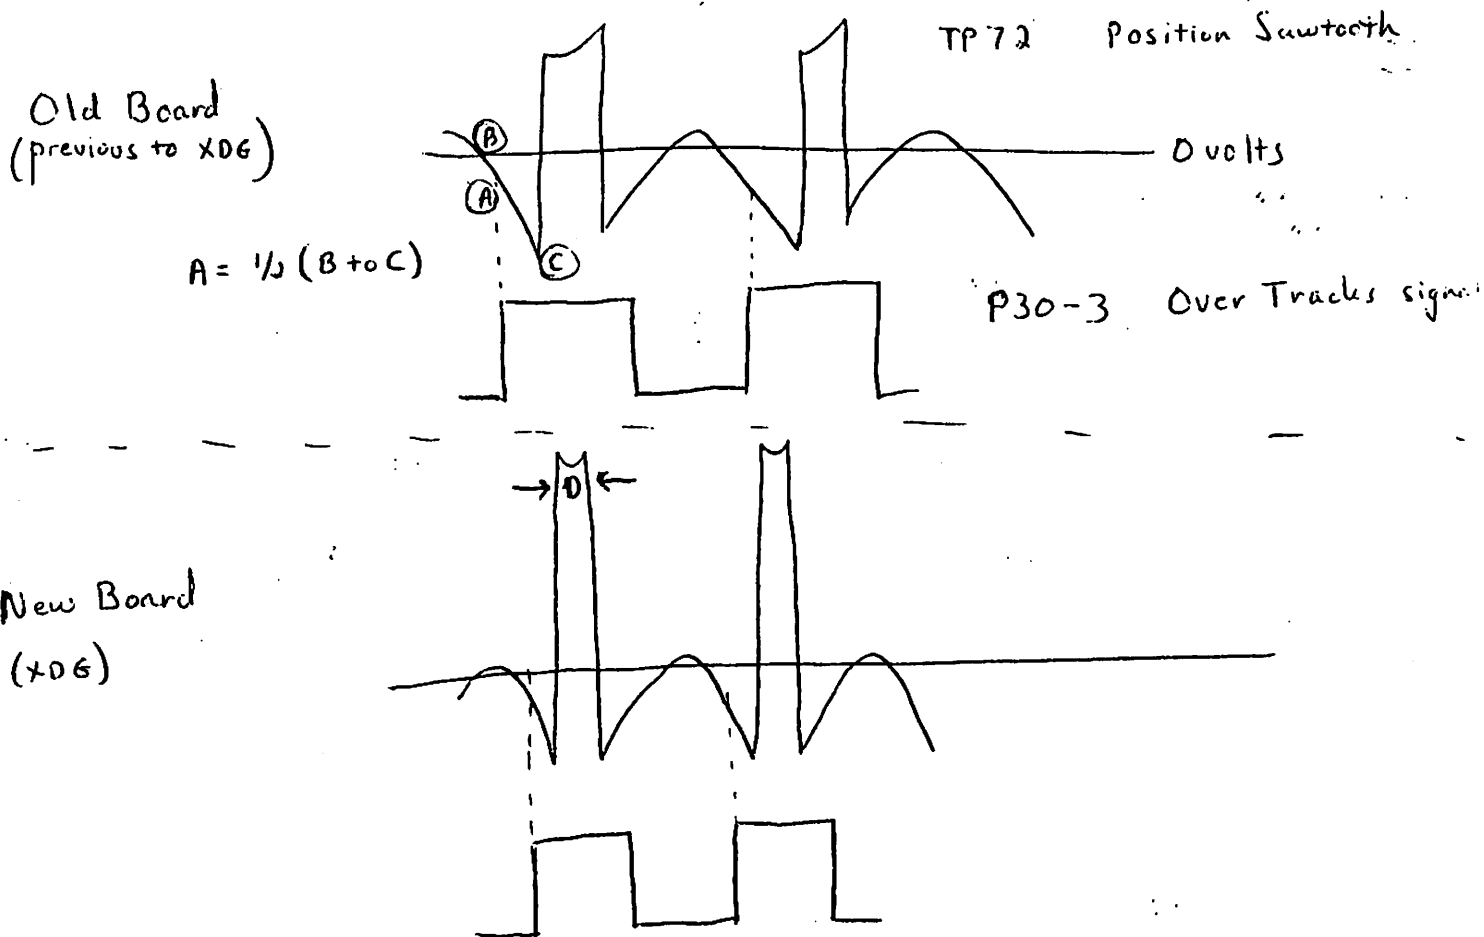
The latest curve ball thrown to us by Diablo is a new Servo Board 12099 Rev XDG. This is an entirely new layout with different test points. When doing alignments, -5 volts may be obtained at H25-9, and for Track Zero alignment Position Sawtooth is TP76 (TP72 on old boards). This wave form appears slightly different from the older board.

When doing the fine adjustment with the new board, the width at point D should be about 1.5 milliseconds, and should concur with the high level of Over Tracks signal.

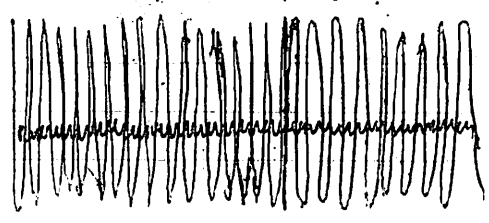
GOOD

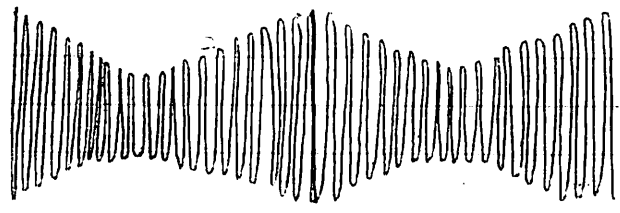
BAD
