# WANG FIELD CHANGE ORDER

FCO NO.  
1004

Equipment Affected 2280 AND 6580 PHOENIX DRIVES (BLOCK POINT 3 AND BELOW)  
Class NEXT CALL FCO Kit # 728-0018-25 Page 1 of 9  
Org. Code III.A.7 FCO Doc. # 729-1090 Approval Date:  
Est. Install. Time 45 MINUTES Ref. ECO # CDC# 33779 **JUN 28 1982**

To provide protection to heads and media in the event of severely restricted air flow or blower motor failure.

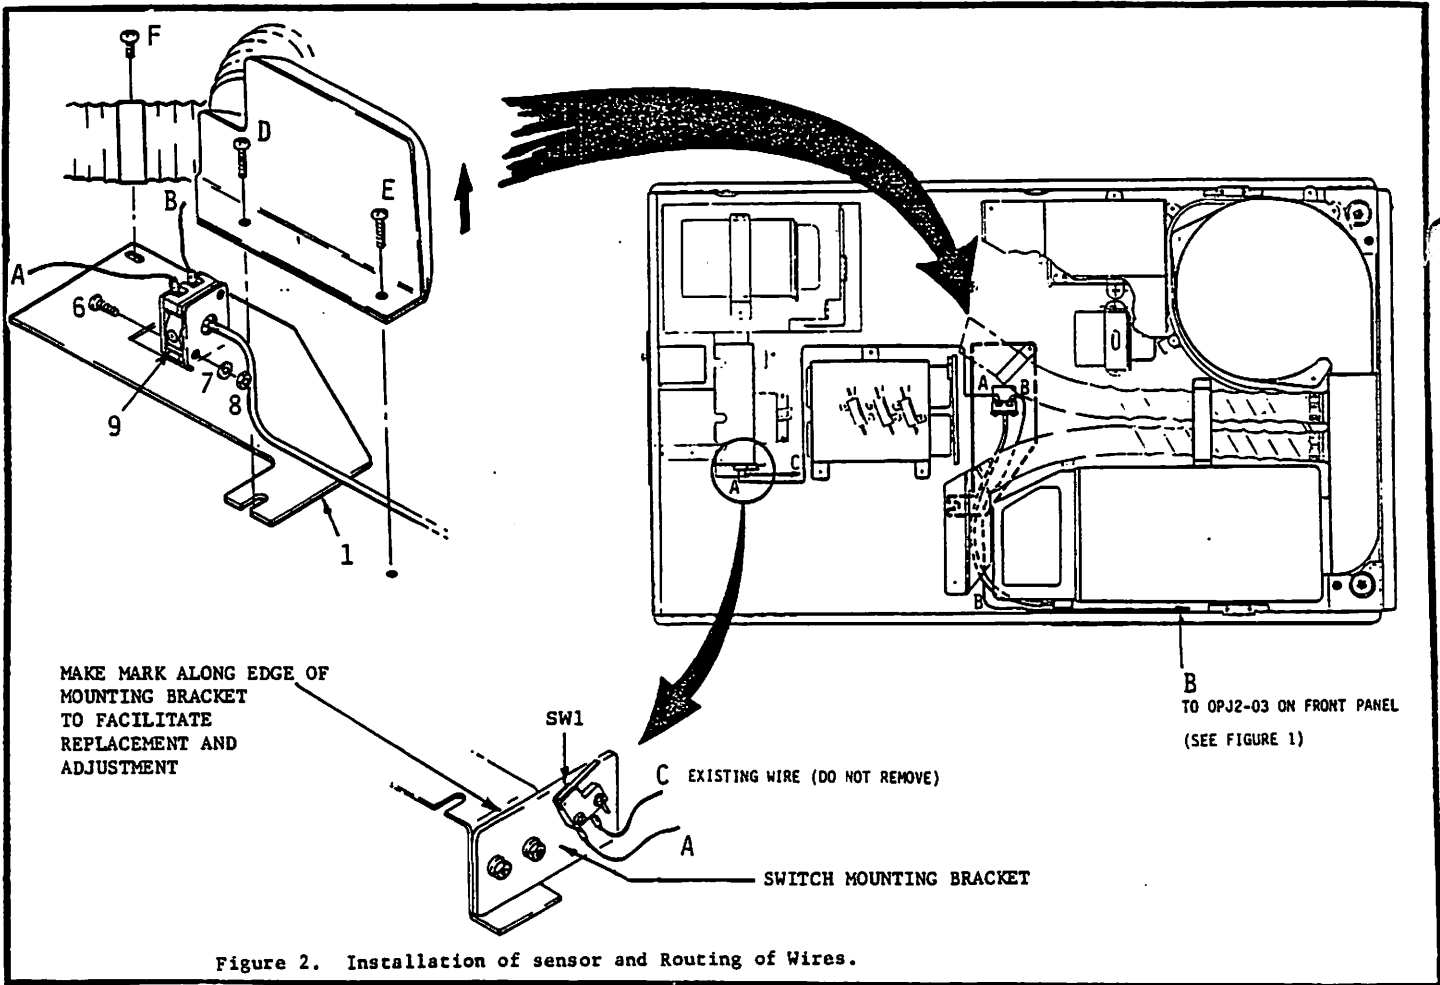
Figure 1. Views Showing Location of Wire to be Replaced for this FCO.

- F. Refer to Figure 1. Disconnect eight-pin connector OPJ2 from the operator control panel at the left front of the base pan. Extract terminal at OP02-03. Refer to View S, Figure 1. To extract terminal, lift retaining tab slightly using a narrow pointed object such as a small, very thin knife blade, and with a small pull force on the wire, slide the terminal from the connector body. Now refer to Figure 2. Disconnect opposite end of the wire at SW1-0C (deck down switch) located near the electronics module under the left side of the deck. Cut the ends of the disconnected wire and leave in the harness.
