LABORATORIES, INC.

M-E-M-O-R-A-N-D-U-M

TO: Northeast Area ATS's & DTS's
FROM: Bill Dini
DATE: April 24, 1981
SUBJECT: Series 24 TB216A FTU

PERIPHERALS-DISK DRIVES-CDC PHOENIX 9448 CMD.

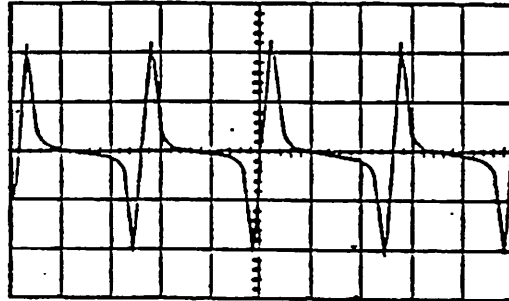
FIGURE 9-3 GUARD-BAND WAVEFORM PATTERN

3. Move the cartridge servo head to the rear of the drive until the outer guard band is reached. (see top fig. 9-3)

4. Once the guard band has been located move the cartridge servo head forward until cylinder zero is reached.(see bottom fig. 9-3).

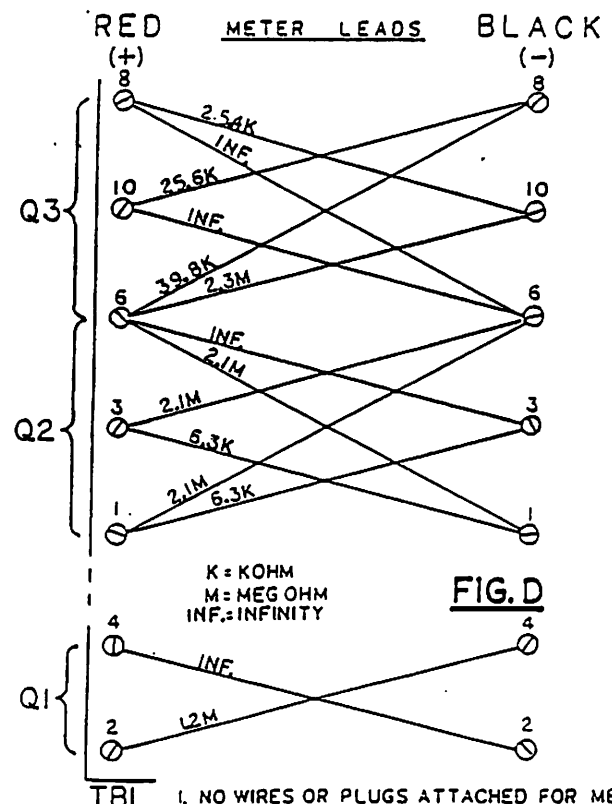
FIG. C

5. Now, you can shut down the power, disconnect terminals 1,3,8 & 10 from the power amp; reconnect the input to the 32 volt filter, then bring up the power again. This will reconnect all 32 volt circuitry except the power amplifier. If the power amp was the only problem left to be repaired, the front door lock will open (click) and the ready lite will flash once, the fault light will be off and CR6 will not be lit. If this is the case, replace the power amp or replace the determined defective transistors which are bad using the power amp representative schematic and resistance chart, (Figs. C&D), included with this blurb as a guide.

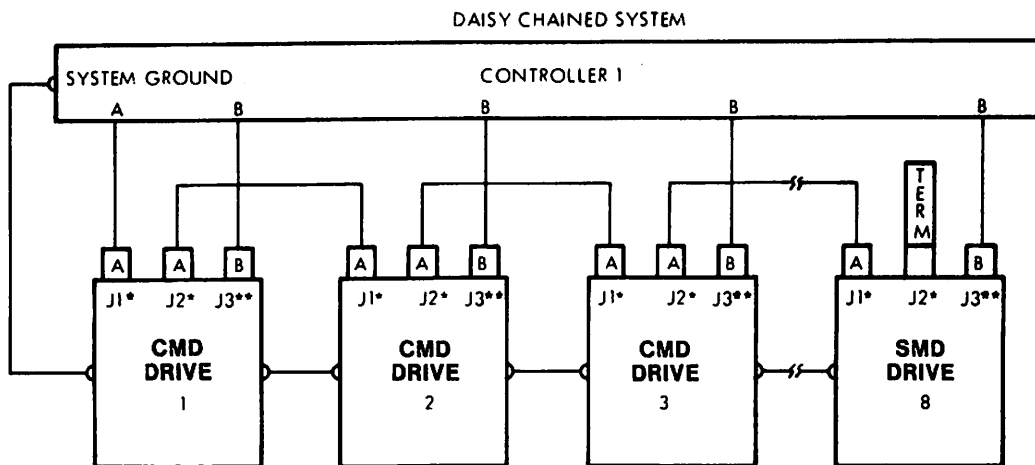
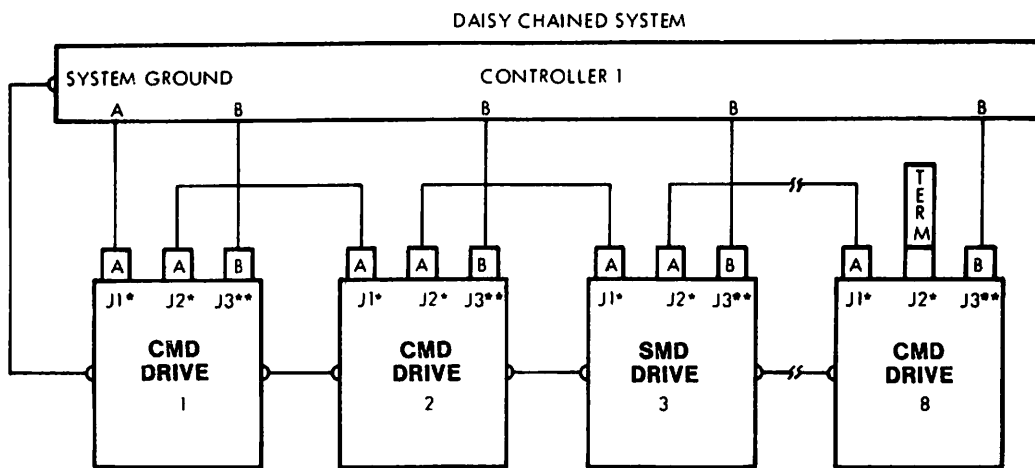
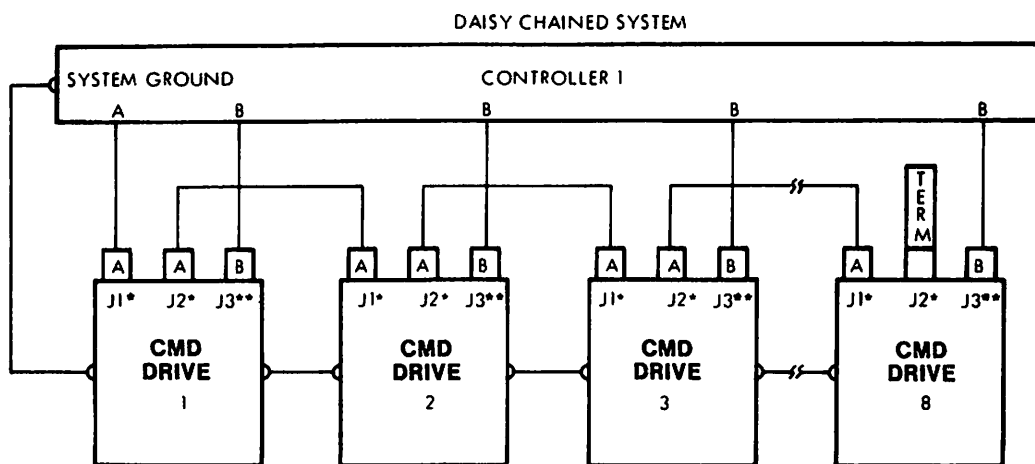
- a. If the SMD unit is the last unit of the daisy chain in a mixed SMD/CMD VS System (see figure 1A) there is no terminator compatibility problem.

- b. If the CMD unit is the last unit of the daisy chain in a mixed SMD/CMD VS System (see figure 1B) the following three corrective options are available:
 1. Rearrange the SMD/CMD units so that an SMD unit is the last unit in the daisy chain
 2. Replace incompatible terminator (726-5790 or 75886100) with compatible terminator (WANG P/N 210-7177 or 210-7477)
 3. Modify terminator 726-5790 or 75886100 as described in paragraph 3 and shown in figure 2
- c. If the VS System has only CMD units in the daisy chain (see figure 1C), the terminator must be either replaced with a compatible terminator or the existing terminator modified to be made compatible as described in paragraph 3 and shown in figure 2.
