Product Name: CS/386 Turbo System

Model Number	Description
CS/386-400N	4MB CS/386 Turbo CPU
CS/386-800N	8MB CS/386 Turbo CPU
CS/386-1600N	16MB CS/386 Turbo CPU
CS/386-3200N	32MB CS/386 Turbo CPU
2236MXF	16-port Terminal I/O Controller
22C11-HS	High-Speed Printer/Disk Controller
2236MXF- CABLE	MXF 7 PORT OCTOPUS CABLE
MICROVP-TURBO	MICROVP To 4MB CS/386 Turbo CPU
CS-TURBO	CS To 4MB CS/386 Turbo CPU
CS-N-TURBO	CS-N+CS/386-N To 4MB CS/386 Turbo CPU
CS-D-TURBO	CS-D+CS/386-D To 4MB CS/386 Turbo CPU

Replaces: The CS/386-40N, CS/386-80N, CS/386-40D and CS/386-80D as these models, will be replaced by the new high-speed 4 and 8MB Turbo models, e.g., the CS/386-400N and CS/386-800N.

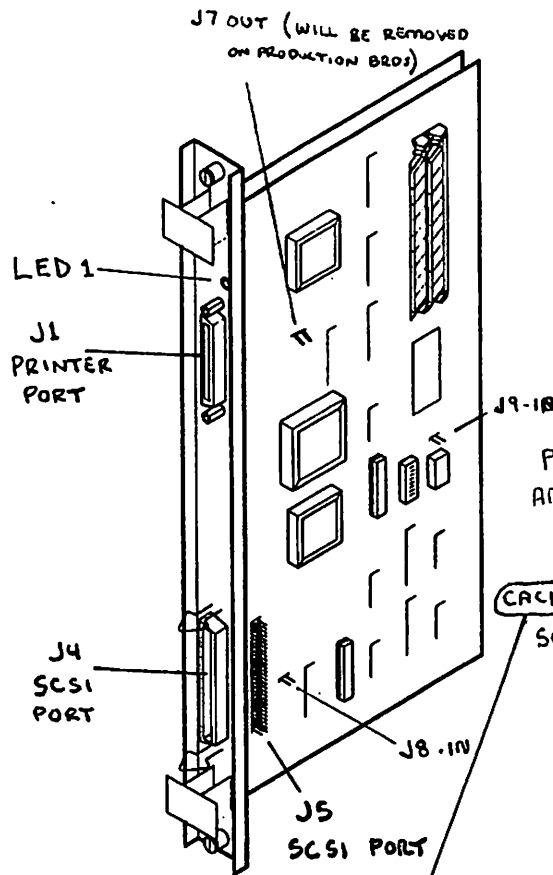
SCSI/PRINTER CONTROLLER 210-9582

O/S 1.15
EARLY
VERSION PROMS
PRINTER ADDRESS

5	6	7	8
215	OFF	ON	OFF	ON
216	ON	OFF	OFF	ON
217	OFF	OFF	OFF	ON

O/S 1.18 + HIGHER
RØ + PROMS
W/ DATE CODE 7/7 + ↑

5	6	7	8
	SAME			
	OFF	ON	ON	OFF
	ON	ON	ON	ON

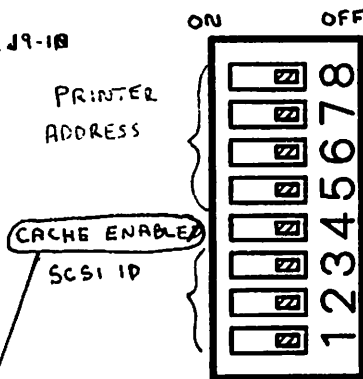
~~CACHE DISABLED~~

O/S 1.15
EARLY
VERSION PROMS
4 ON - CACHE ENABLE

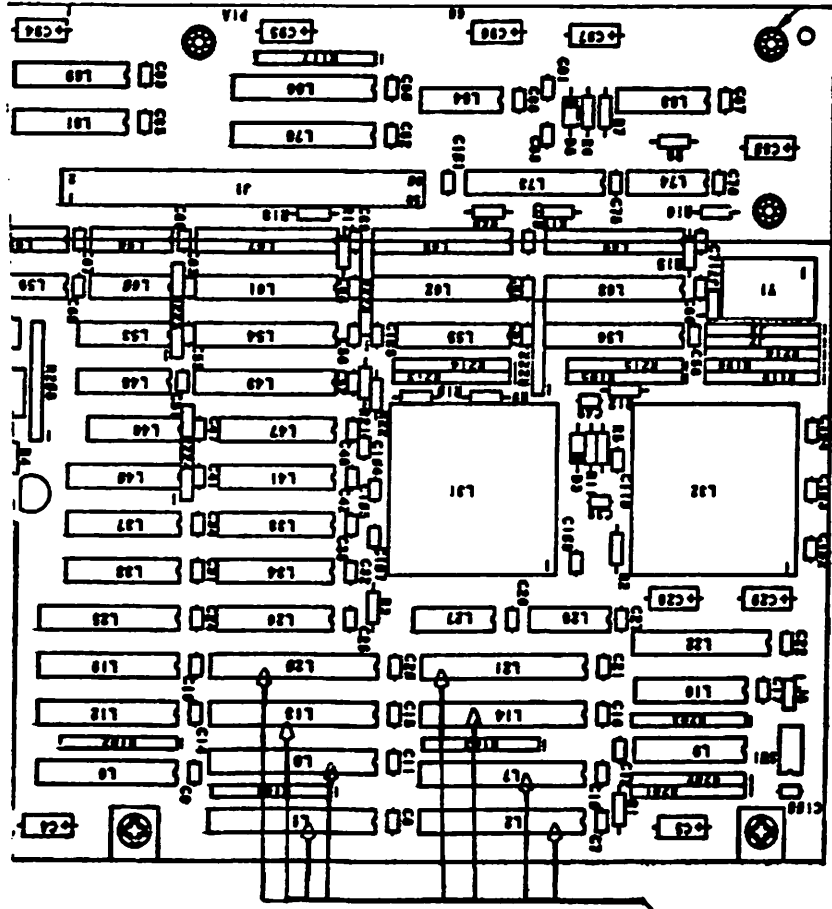
ECO NO 60545  
SHT 3 OF 10

1. REMOVE L1,L2,L7,L8,L13,L14,L20, AND L21.  
REPLACE WITH 377-1168.
